# Hazardous Building Materials Assessment, Property DNE1 formerly EV1, Calgary Housing Company

750 5 Street NE, Calgary, Alberta

*Assessment Completed: August 18 and September 13, 2021*

4 February 2022

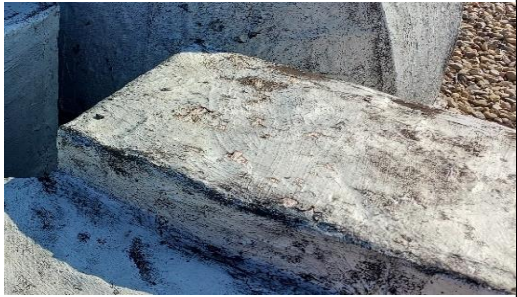
| Building / Component Name (#) | Location | Material Category | Material & Description | Homogeneous Sample Group (HSG) / Sample # | Sample I.D. | Quantity <sup>(1)</sup> | Friable | Condition | Accessibility | % Asbestos and Type | Asbestos Abatement Category | Lead Concentration (mg/kg) | Representative Photograph |
|---|---|---|---|---|---|---|---|---|---|---|---|---|---|
| 750 - 5 Street SE (DNE1, formerly EV1) | Exterior - Rooftop | Asbestos | Tar Over Fiberglass Insulation | DNE1-A-04 | A to C | 120 Square Feet | Low | Good | Low | 5% to 10% Chrysotile | Low-Risk | N/A | |

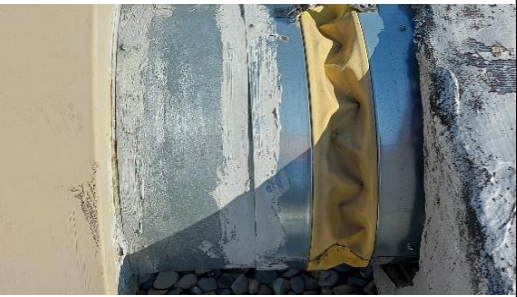
| Building / Component Name (#) | Location | Material Category | Material & Description | Homogeneous Sample Group (HSG) / Sample # | Sample I.D. | Quantity <sup>(1)</sup> | Friable | Condition | Accessibility | % Asbestos and Type | Asbestos Abatement Category | Lead Concentration (mg/kg) | Representative Photograph |
|---|---|---|---|---|---|---|---|---|---|---|---|---|---|
| 750 - 5 Street SE (DNE1, formerly EV1) | Exterior | Asbestos | Light Grey Duct Joint Mastic | DNE1-A-05 | A | 20 Linear Feet | Low | Good | Moderate | None Detected | N/A | N/A | |

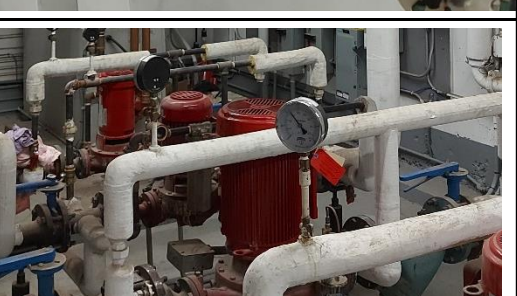
| Building / Component Name (#) | Location | Material Category | Material & Description | Homogeneous Sample Group (HSG) / Sample # | Sample I.D. | Quantity <sup>(1)</sup> | Friable | Condition | Accessibility | % Asbestos and Type | Asbestos Abatement Category | Lead Concentration (mg/kg) | Representative Photograph |
|---|---|---|---|---|---|---|---|---|---|---|---|---|---|
| 750 - 5 Street SE (DNE1, formerly EV1) | Boiler Room / Elevator Motor Room | Asbestos | Mechanical Pipe Fitting Insulation on 3" Pipe | DNE1-A-02 | A to C | 20 Each | High | Good | Low | None Detected | N/A | N/A | |

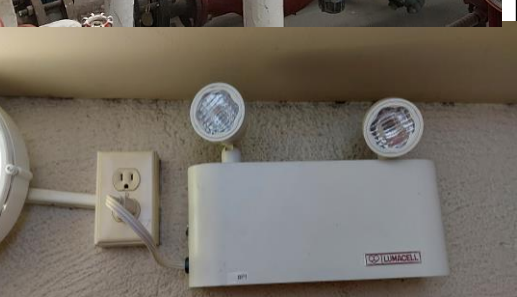
| Building / Component Name (#) | Location | Material Category | Material & Description | Homogeneous Sample Group (HSG) / Sample # | Sample I.D. | Quantity <sup>(1)</sup> | Friable | Condition | Accessibility | % Asbestos and Type | Asbestos Abatement Category | Lead Concentration (mg/kg) | Representative Photograph |
|---|---|---|---|---|---|---|---|---|---|---|---|---|---|
| 750 - 5 Street SE (DNE1, formerly EV1) | Boiler Room/ Elevator Motor Room | Lead Batteries | Lead-Acid Batteries in Emergency Light | N/A | N/A | 1 Each | N/A | N/A | N/A | N/A | N/A | N/A | |

Lead-acid batteries were observed in the emergency lighting system throughout the building during the assessment. Prior to or during renovation or demolition activities, the lead-acid batteries must be collected for recycling. Lead-acid batteries cannot be landfilled in Alberta and therefore must be recycled upon decommissioning at a licensed recycling facility.

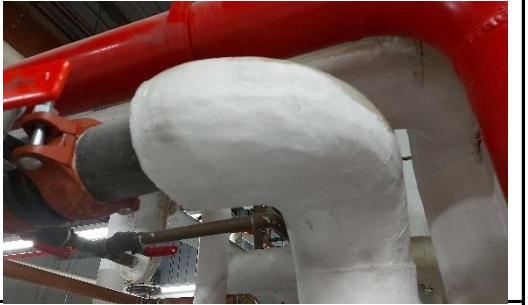
| Building / Component Name (#) | Location | Material Category | Material & Description | Homogeneous Sample Group (HSG) / Sample # | Sample I.D. | Quantity <sup>(1)</sup> | Friable | Condition | Accessibility | % Asbestos and Type | Asbestos Abatement Category | Lead Concentration (mg/kg) | Representative Photograph |
|---|---|---|---|---|---|---|---|---|---|---|---|---|---|
| 750 - 5 Street SE (DNE1, formerly EV1) | Boiler Room / Elevator Motor Room | Asbestos | Mechanical Pipe Fitting Insulation on 5" Pipe | DNE1-A-03 | A to C | 30 Each | High | Good | Low | None Detected | N/A | N/A | |

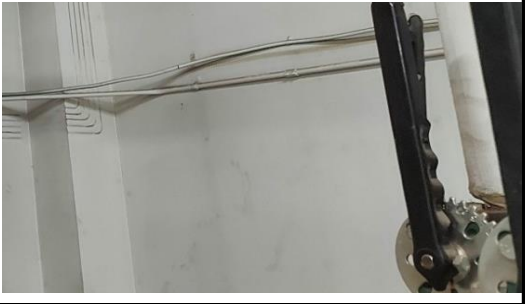
| Building / Component Name (#) | Location | Material Category | Material & Description | Homogeneous Sample Group (HSG) / Sample # | Sample I.D. | Quantity <sup>(1)</sup> | Friable | Condition | Accessibility | % Asbestos and Type | Asbestos Abatement Category | Lead Concentration (mg/kg) | Representative Photograph |
|---|---|---|---|---|---|---|---|---|---|---|---|---|---|
| 750 - 5 Street SE (DNE1, formerly EV1) | Boiler Room/ Elevator Motor Room | Lead Paint | White Paint on Drywall | DNE1-L-01 | DNE1-L-01 | 1,300 Square Feet | N/A | Good | N/A | N/A | N/A | <5 (Not considered to be lead-containing) | |

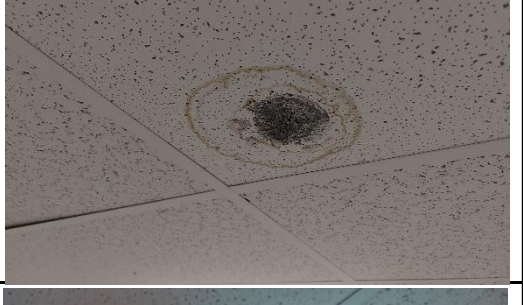
| Building / Component Name (#) | Location | Material Category | Material & Description | Homogeneous Sample Group (HSG) / Sample # | Sample I.D. | Quantity <sup>(1)</sup> | Friable | Condition | Accessibility | % Asbestos and Type | Asbestos Abatement Category | Lead Concentration (mg/kg) | Representative Photograph |
|---|---|---|---|---|---|---|---|---|---|---|---|---|---|
| 750 - 5 Street SE (DNE1, formerly EV1) | Common Areas (16th Floor Ceiling Tile) | Fungal Contamination | Fungal Contamination | DNE1-F-02 | DNE1-F-02 | 16 Square Feet | N/A | N/A | N/A | N/A | N/A | N/A | |

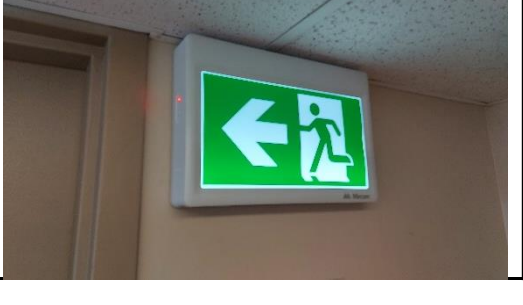
| Building / Component Name (#) | Location | Material Category | Material & Description | Homogeneous Sample Group (HSG) / Sample # | Sample I.D. | Quantity <sup>(1)</sup> | Friable | Condition | Accessibility | % Asbestos and Type | Asbestos Abatement Category | Lead Concentration (mg/kg) | Representative Photograph |
|---|---|---|---|---|---|---|---|---|---|---|---|---|---|
| 750 - 5 Street SE (DNE1, formerly EV1) | Common Areas (Corridors, Garbage Rooms, and Electrical Rooms 4 - 16th Floors) | Lead Batteries | Lead-Acid Batteries in Emergency Light | N/A | N/A | 120 Each | N/A | N/A | N/A | N/A | N/A | N/A | |

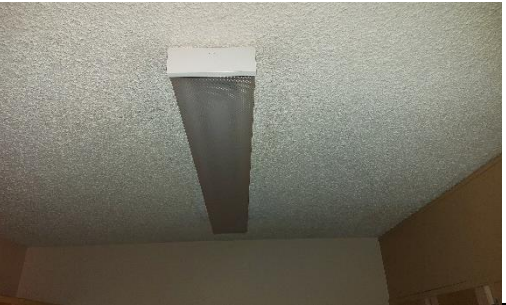
| Building / Component Name (#) | Location | Material Category | Material & Description | Homogeneous Sample Group (HSG) / Sample # | Sample I.D. | Quantity <sup>(1)</sup> | Friable | Condition | Accessibility | % Asbestos and Type | Asbestos Abatement Category | Lead Concentration (mg/kg) | Representative Photograph |
|---|---|---|---|---|---|---|---|---|---|---|---|---|---|
| 750 - 5 Street SE (DNE1, formerly EV1) | Common Areas (Corridors, Garbage Rooms, and Electrical Rooms 4 - 16th Floors) | PCB | PCB-Containing Ballasts in Fluorescent Light Fixtures | N/A | N/A | 150 Each | N/A | N/A | N/A | N/A | N/A | N/A | |

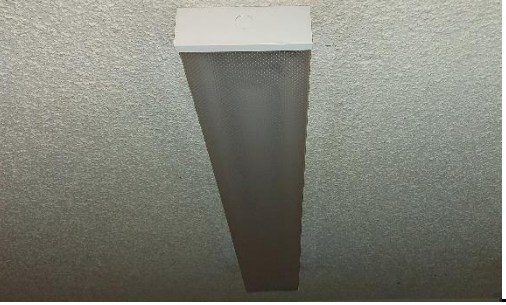
| Building / Component Name (#) | Location | Material Category | Material & Description | Homogeneous Sample Group (HSG) / Sample # | Sample I.D. | Quantity <sup>(1)</sup> | Friable | Condition | Accessibility | % Asbestos and Type | Asbestos Abatement Category | Lead Concentration (mg/kg) | Representative Photograph |
|---|---|---|---|---|---|---|---|---|---|---|---|---|---|
| 750 - 5 Street SE (DNE1, formerly EV1) | Common Areas (Corridors, Garbage Rooms, and Electrical Rooms 4 - 16th Floors) | Mercury | Fluorescent Light Tubes Containing Mercury-Vapour | N/A | N/A | 300 Each | N/A | N/A | N/A | N/A | N/A | N/A | |

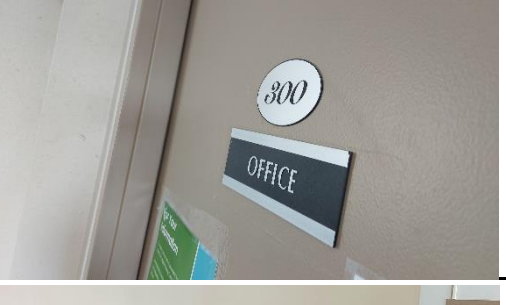
| Building / Component Name (#) | Location | Material Category | Material & Description | Homogeneous Sample Group (HSG) / Sample # | Sample I.D. | Quantity <sup>(1)</sup> | Friable | Condition | Accessibility | % Asbestos and Type | Asbestos Abatement Category | Lead Concentration (mg/kg) | Representative Photograph |
|---|---|---|---|---|---|---|---|---|---|---|---|---|---|
| 750 - 5 Street SE (DNE1, formerly EV1) | Common Areas (Corridor, Laundryroom, Community Room, Meeting Room - 3rd Floor) | Lead Paint | Taupe Paint on Metal | DNE1-L-03 | Reference | 600 Square Feet | N/A | Good | N/A | N/A | N/A | 1,360 (Considered to be lead-containing) | |

The lead-containing paint was observed to be in good condition, at the time of the assessment. If the condition of the paints degrades, they should be abated following methods and requirements outlined in the Alberta OHS *Lead at the Work Site* bulletin. The lead-containing paint waste generated from the abatement activities should be analyzed for lead leachability by toxicity characteristic leaching procedure (TCLP) prior to disposal to ensure transportation and disposal of lead-containing waste materials is conducted in accordance with the requirements of AEP and the Federal *Transportation of Dangerous Goods Act* and Regulations, current to the date of the work. The AEP Waste Control Regulation prescribes the disposal pathways for lead-containing waste. Non-metal building materials (bricks, wood, concrete, cinderblock etc.) coated with lead-containing paint should not be recycled for re-use.

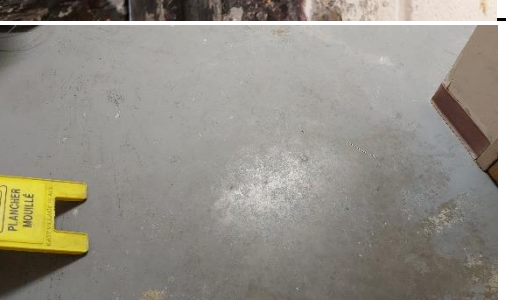
| Building / Component Name (#) | Location | Material Category | Material & Description | Homogeneous Sample Group (HSG) / Sample # | Sample I.D. | Quantity <sup>(1)</sup> | Friable | Condition | Accessibility | % Asbestos and Type | Asbestos Abatement Category | Lead Concentration (mg/kg) | Representative Photograph |
|---|---|---|---|---|---|---|---|---|---|---|---|---|---|
| 750 - 5 Street SE (DNE1, formerly EV1) | Common Areas (Lobby, Service Areas - Main Floor) | Lead Paint | Grey Paint on Concrete | DNE1-L-02 | Reference | 300 Square Feet | N/A | Good | N/A | N/A | N/A | 888 (Considered to be lead-containing) | |

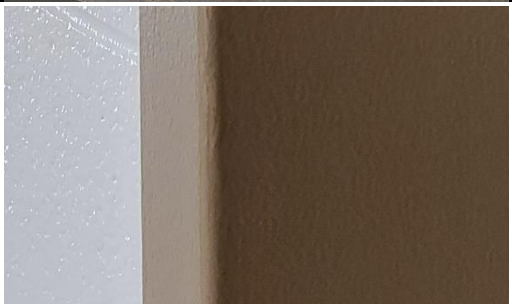
| Building / Component Name (#) | Location | Material Category | Material & Description | Homogeneous Sample Group (HSG) / Sample # | Sample I.D. | Quantity <sup>(1)</sup> | Friable | Condition | Accessibility | % Asbestos and Type | Asbestos Abatement Category | Lead Concentration (mg/kg) | Representative Photograph |
|---|---|---|---|---|---|---|---|---|---|---|---|---|---|
| 750 - 5 Street SE (DNE1, formerly EV1) | Common Areas (Lobby, Service Areas - Main Floor) | Lead Paint | Taupe Paint on Metal | DNE1-L-03 | Reference | 420 Square Feet | N/A | Good | N/A | N/A | N/A | 1,360 (Considered to be lead-containing) | |

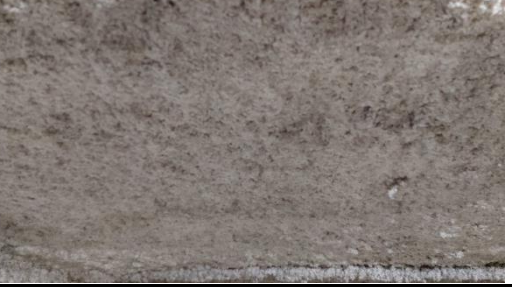
| Building / Component Name (#) | Location | Material Category | Material & Description | Homogeneous Sample Group (HSG) / Sample # | Sample I.D. | Quantity <sup>(1)</sup> | Friable | Condition | Accessibility | % Asbestos and Type | Asbestos Abatement Category | Lead Concentration (mg/kg) | Representative Photograph |
|---|---|---|---|---|---|---|---|---|---|---|---|---|---|
| 750 - 5 Street SE (DNE1, formerly EV1) | Common Area (Parkade) | Asbestos | Spray-Applied Acoustic Insulation | DNE1-A-19 | A to C | 9,600 Square Feet | High | Good | High | None Detected | N/A | N/A | |

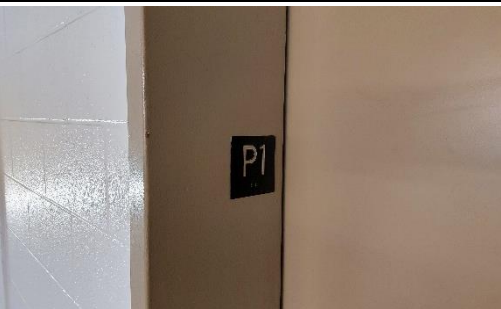
| Building / Component Name (#) | Location | Material Category | Material & Description | Homogeneous Sample Group (HSG) / Sample # | Sample I.D. | Quantity <sup>(1)</sup> | Friable | Condition | Accessibility | % Asbestos and Type | Asbestos Abatement Category | Lead Concentration (mg/kg) | Representative Photograph |
|---|---|---|---|---|---|---|---|---|---|---|---|---|---|
| 750 - 5 Street SE (DNE1, formerly EV1) | Common Area (Parkade) | Lead Paint | Taupe Paint on Metal | DNE1-L-03 | Reference | 120 Square Feet | N/A | Good | N/A | N/A | N/A | 1,360 (Considered to be lead-containing) | |

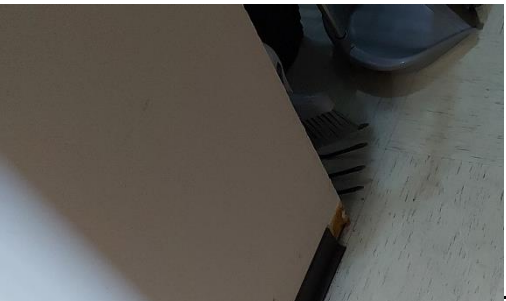
| Building / Component Name (#) | Location | Material Category | Material & Description | Homogeneous Sample Group (HSG) / Sample # | Sample I.D. | Quantity <sup>(1)</sup> | Friable | Condition | Accessibility | % Asbestos and Type | Asbestos Abatement Category | Lead Concentration (mg/kg) | Representative Photograph |
|---|---|---|---|---|---|---|---|---|---|---|---|---|---|
| 750 - 5 Street SE (DNE1, formerly EV1) | Unit 1511 | Asbestos | Drywall Joint Compound on Walls | DNE1-A-01 | D | 2,100 Square Feet | Moderate | Good | High | None Detected | N/A | N/A | |

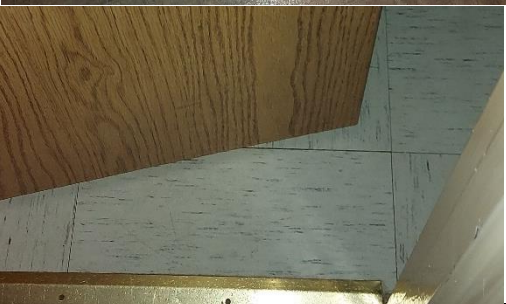
| Building / Component Name (#) | Location | Material Category | Material & Description | Homogeneous Sample Group (HSG) / Sample # | Sample I.D. | Quantity <sup>(1)</sup> | Friable | Condition | Accessibility | % Asbestos and Type | Asbestos Abatement Category | Lead Concentration (mg/kg) | Representative Photograph |
|---|---|---|---|---|---|---|---|---|---|---|---|---|---|
| 750 - 5 Street SE (DNE1, formerly EV1) | Unit 1405 | Asbestos | 12" x 12" White with Blue Streaks Patterned Vinyl Floor Tile Mastic | DNE1-A-13 | Reference | 60 Square Feet | Low | Good | High | 5% Chrysotile<br>None Detected | Low-Risk | N/A | |

Prior to renovation or demolition activities, ACM that may be impacted must be removed. Asbestos removal should be completed by workers certified by Alberta OHS. Throughout the abatement activities, appropriate air monitoring and inspections should be conducted by qualified personnel to document that the ACM are removed and disposed of appropriately. It is recommended that a proper scope of work and asbestos removal specifications be written to scope the complete and proper removal of the identified ACM.

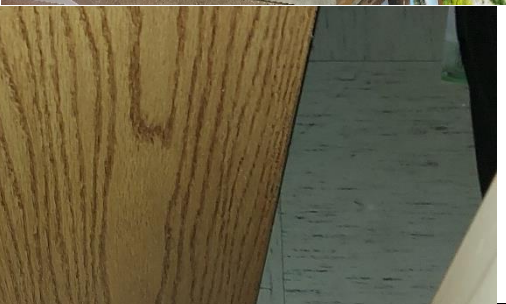
| Building / Component Name (#) | Location | Material Category | Material & Description | Homogeneous Sample Group (HSG) / Sample # | Sample I.D. | Quantity <sup>(1)</sup> | Friable | Condition | Accessibility | % Asbestos and Type | Asbestos Abatement Category | Lead Concentration (mg/kg) | Representative Photograph |
|---|---|---|---|---|---|---|---|---|---|---|---|---|---|
| 750 - 5 Street SE (DNE1, formerly EV1) | Unit 1214 | Asbestos | 12" x 12" White with Blue Streaks Patterned Vinyl Floor Tile<br>Mastic | DNE1-A-13 | C | 60 Square Feet | Low | Good | High | 5% Chrysotile<br>None Detected | Low-Risk | N/A | |

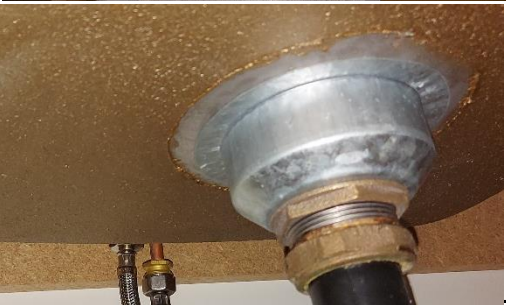
| Building / Component Name (#) | Location | Material Category | Material & Description | Homogeneous Sample Group (HSG) / Sample # | Sample I.D. | Quantity <sup>(1)</sup> | Friable | Condition | Accessibility | % Asbestos and Type | Asbestos Abatement Category | Lead Concentration (mg/kg) | Representative Photograph |
|---|---|---|---|---|---|---|---|---|---|---|---|---|---|
| 750 - 5 Street SE (DNE1, formerly EV1) | Unit 1102 | Asbestos | Brown Acoustic Sink Insulation | DNE1-A-24 | Reference | 1 Each | Low | Good | High | 5% Chrysotile | Low-Risk | N/A | |
