# Hazardous Building Materials Assessment Property HIL2 (formerly HU2), Calgary Housing Company

*325 - 10 Street NW, Calgary, Alberta*

*Assessment Completed: July 22, 2021*

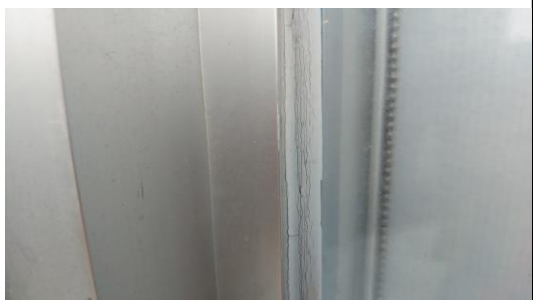
| Building / Component Name (#) | Location | Material Category | Material & Description | Homogeneous Sample Group (HSG) / Sample # | Sample I.D. | Quantity <sup>(1)</sup> | Friable | Condition | Accessibility | % Asbestos and Type | Asbestos Abatement Category | Lead Concentration (mg/kg) | Representative Photograph |
|---|---|---|---|---|---|---|---|---|---|---|---|---|---|
| 325 - 10 Street NW (HIL2, formerly HU2) | Exterior | Asbestos | White Window Caulking | HIL2-A-01 | A to C | 260 Linear Feet | Low | Good | Moderate | None Detected | N/A | N/A | |

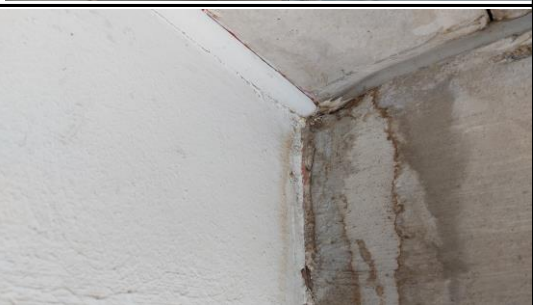
| Building / Component Name (#) | Location | Material Category | Material & Description | Homogeneous Sample Group (HSG) / Sample # | Sample I.D. | Quantity <sup>(1)</sup> | Friable | Condition | Accessibility | % Asbestos and Type | Asbestos Abatement Category | Lead Concentration (mg/kg) | Representative Photograph |
|---|---|---|---|---|---|---|---|---|---|---|---|---|---|
| 325 - 10 Street NW (HIL2, formerly HU2) | Exterior | Asbestos | White Wall Caulking | HIL2-A-02 | A to C | 150 Linear Feet | Low | Good | Moderate | 3% Chrysotile | Low-Risk | N/A | |

Prior to renovation or demolition activities, ACM that may be impacted must be removed. The work should be completed by workers certified by Alberta OHS. Throughout the abatement activities, appropriate air monitoring and inspections should be conducted by qualified personnel to document that the ACM are removed and disposed of appropriately. It is recommended that a proper scope of work and asbestos removal specifications be written to scope the complete and proper removal of the identified ACM.

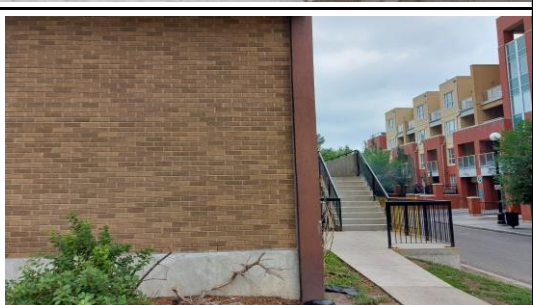
| Building / Component Name (#) | Location | Material Category | Material & Description | Homogeneous Sample Group (HSG) / Sample # | Sample I.D. | Quantity <sup>(1)</sup> | Friable | Condition | Accessibility | % Asbestos and Type | Asbestos Abatement Category | Lead Concentration (mg/kg) | Representative Photograph |
|---|---|---|---|---|---|---|---|---|---|---|---|---|---|
| 325 - 10 Street NW (HIL2, formerly HU2) | Exterior | Lead-Paint | Dark Brown Paint on Concrete | HIL2-L-01 | HIL2-L-01 | 2,100 Square Feet | N/A | Good | N/A | N/A | N/A | 30 (Not considered to be lead-containing) | |

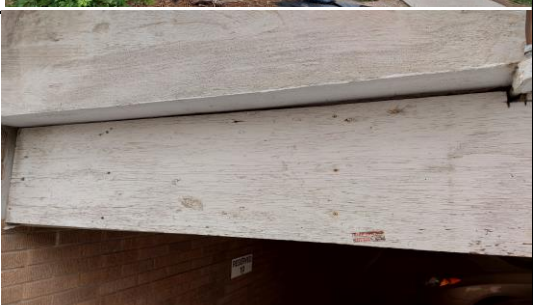
| Building / Component Name (#) | Location | Material Category | Material & Description | Homogeneous Sample Group (HSG) / Sample # | Sample I.D. | Quantity <sup>(1)</sup> | Friable | Condition | Accessibility | % Asbestos and Type | Asbestos Abatement Category | Lead Concentration (mg/kg) | Representative Photograph |
|---|---|---|---|---|---|---|---|---|---|---|---|---|---|
| 325 - 10 Street NW (HIL2, formerly HU2) | Exterior | Lead-Paint | White Paint on Wood Overhang | HIL2-L-02 | HIL2-L-02 | 1,400 Square Feet | N/A | Good | N/A | N/A | N/A | 8 (Not considered to be lead-containing) | |

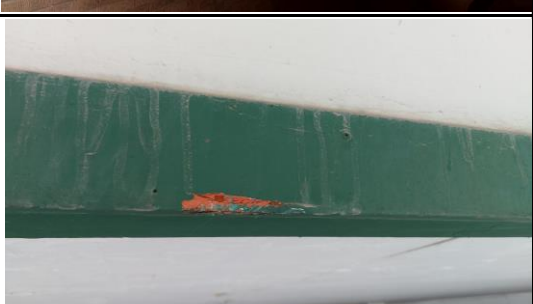
| Building / Component Name (#) | Location | Material Category | Material & Description | Homogeneous Sample Group (HSG) / Sample # | Sample I.D. | Quantity <sup>(1)</sup> | Friable | Condition | Accessibility | % Asbestos and Type | Asbestos Abatement Category | Lead Concentration (mg/kg) | Representative Photograph |
|---|---|---|---|---|---|---|---|---|---|---|---|---|---|
| 325 - 10 Street NW (HIL2, formerly HU2) | Exterior | Lead-Paint | Forest Green Paint on Wood Trim | HIL2-L-03 | HIL2-L-03 | 1,200 Square Feet | N/A | Good | N/A | N/A | N/A | 141 (Considered to be lead-containing) | |

The lead-containing paint was observed to be in good condition, at the time of the assessment. If the condition of the paints degrades, they should be abated following methods and requirements outlined in the Alberta OHS *Lead at the Work Site* bulletin. The lead-containing paint waste generated from the abatement activities should be analyzed for lead leachability by toxicity characteristic leaching procedure (TCLP) prior to disposal to ensure transportation and disposal of lead-containing waste materials is conducted in accordance with the requirements of AEP and the Federal *Transportation of Dangerous Goods Act* and Regulations, current to the date of the work. The AEP Waste Control Regulation prescribes the disposal pathways for lead-containing waste. Non-metal building materials (bricks, wood, concrete, cinderblock etc.) coated with lead-containing paint should not be recycled for re-use.

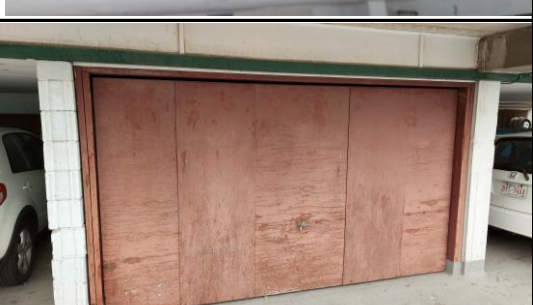
| Building / Component Name (#) | Location | Material Category | Material & Description | Homogeneous Sample Group (HSG) / Sample # | Sample I.D. | Quantity <sup>(1)</sup> | Friable | Condition | Accessibility | % Asbestos and Type | Asbestos Abatement Category | Lead Concentration (mg/kg) | Representative Photograph |
|---|---|---|---|---|---|---|---|---|---|---|---|---|---|
| 325 - 10 Street NW (HIL2, formerly HU2) | Exterior | Lead-Paint | Reddish Brown Paint on Wood Garage Door | HIL2-L-04 | HIL2-L-04 | 110 Square Feet | N/A | Good | N/A | N/A | N/A | 753 (Considered to be lead-containing) | |

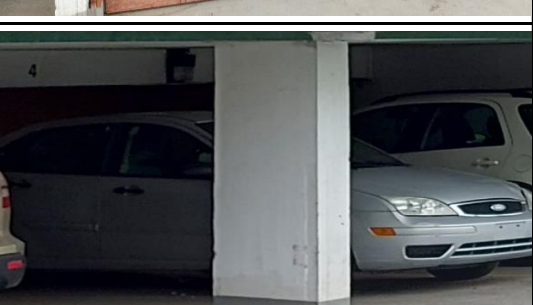
| Building / Component Name (#) | Location | Material Category | Material & Description | Homogeneous Sample Group (HSG) / Sample # | Sample I.D. | Quantity <sup>(1)</sup> | Friable | Condition | Accessibility | % Asbestos and Type | Asbestos Abatement Category | Lead Concentration (mg/kg) | Representative Photograph |
|---|---|---|---|---|---|---|---|---|---|---|---|---|---|
| 325 - 10 Street NW (HIL2, formerly HU2) | Exterior | Lead-Paint | White Paint on Concrete Columns | HIL2-L-05 | HIL2-L-05 | 700 Square Feet | N/A | Good | N/A | N/A | N/A | 29 (Not considered to be lead-containing) | |

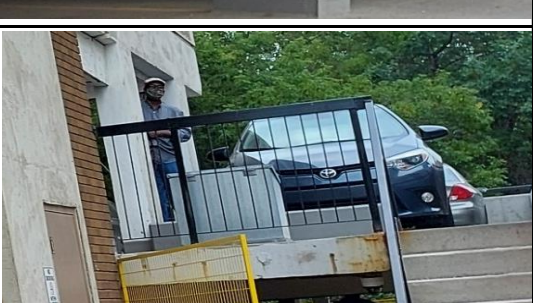
| Building / Component Name (#) | Location | Material Category | Material & Description | Homogeneous Sample Group (HSG) / Sample # | Sample I.D. | Quantity <sup>(1)</sup> | Friable | Condition | Accessibility | % Asbestos and Type | Asbestos Abatement Category | Lead Concentration (mg/kg) | Representative Photograph |
|---|---|---|---|---|---|---|---|---|---|---|---|---|---|
| 325 - 10 Street NW (HIL2, formerly HU2) | Exterior | Lead-Paint | Black Paint on Metal | HIL2-L-09 | HIL2-L-09 | 120 Square Feet | N/A | Good | N/A | N/A | N/A | 25 (Not considered to be lead-containing) | |

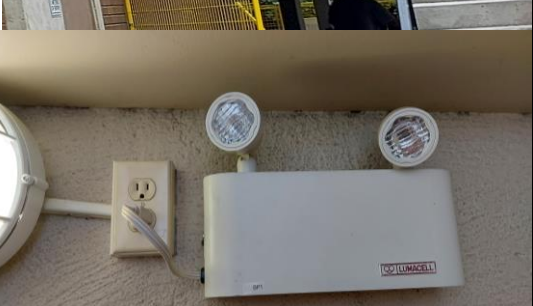
| Building / Component Name (#) | Location | Material Category | Material & Description | Homogeneous Sample Group (HSG) / Sample # | Sample I.D. | Quantity <sup>(1)</sup> | Friable | Condition | Accessibility | % Asbestos and Type | Asbestos Abatement Category | Lead Concentration (mg/kg) | Representative Photograph |
|---|---|---|---|---|---|---|---|---|---|---|---|---|---|
| 325 - 10 Street NW (HIL2, formerly HU2) | Boiler/Generator Room | Lead Batteries | Emergency Lights | N/A | N/A | 1 Each | N/A | N/A | N/A | N/A | N/A | N/A | |

Lead-acid batteries were observed in the emergency lighting system throughout the building during the assessment. Additionally, lead packing in bell and spigot joints were observed in the Boiler Room. Prior to or during renovation or demolition activities, the lead-acid batteries and bell and spigot joints with lead packing must be collected for recycling. Lead-acid batteries cannot be landfilled in Alberta and therefore must be recycled upon decommissioning at a licensed recycling facility.

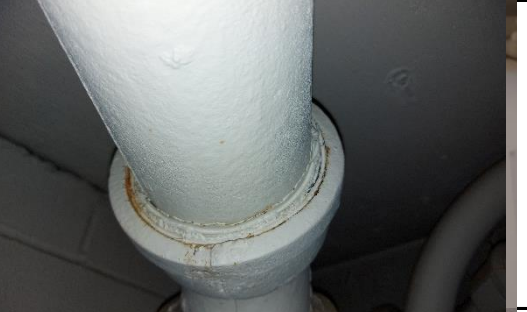
| Building / Component Name (#) | Location | Material Category | Material & Description | Homogeneous Sample Group (HSG) / Sample # | Sample I.D. | Quantity <sup>(1)</sup> | Friable | Condition | Accessibility | % Asbestos and Type | Asbestos Abatement Category | Lead Concentration (mg/kg) | Representative Photograph |
|---|---|---|---|---|---|---|---|---|---|---|---|---|---|
| 325 - 10 Street NW (HIL2, formerly HU2) | Boiler/Generator Room | Lead Packing | Lead Packing in Bell and Spigot Joints | N/A | N/A | 12 Each | N/A | N/A | N/A | N/A | N/A | N/A | |

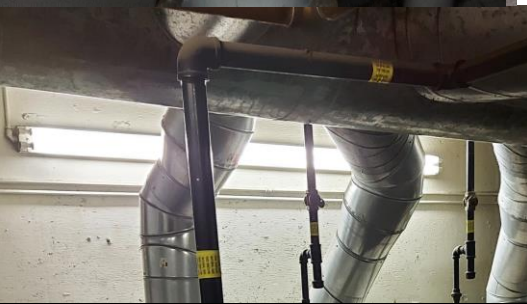
| Building / Component Name (#) | Location | Material Category | Material & Description | Homogeneous Sample Group (HSG) / Sample # | Sample I.D. | Quantity <sup>(1)</sup> | Friable | Condition | Accessibility | % Asbestos and Type | Asbestos Abatement Category | Lead Concentration (mg/kg) | Representative Photograph |
|---|---|---|---|---|---|---|---|---|---|---|---|---|---|
| 325 - 10 Street NW (HIL2, formerly HU2) | Boiler/Generator Room | Mercury | Fluorescent Light Tubes Containing Mercury-Vapour | N/A | N/A | 11 Each | N/A | N/A | N/A | N/A | N/A | N/A | |

that at the time of removal, the capsules and tubes be kept separate from all other waste to prevent damage. These materials should be recycled or disposed of in accordance with regulations specified by AEP.

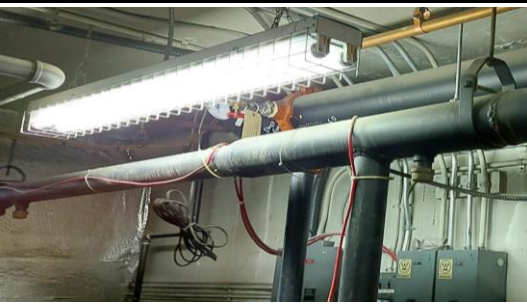
| Building / Component Name (#) | Location | Material Category | Material & Description | Homogeneous Sample Group (HSG) / Sample # | Sample I.D. | Quantity <sup>(1)</sup> | Friable | Condition | Accessibility | % Asbestos and Type | Asbestos Abatement Category | Lead Concentration (mg/kg) | Representative Photograph |
|---|---|---|---|---|---|---|---|---|---|---|---|---|---|
| 325 - 10 Street NW (HIL2, formerly HU2) | Boiler/Generator Room | Polychlorinated Biphenyls (PCBs) | PCBs in Fluorescent Light Ballasts | N/A | N/A | 6 Each | N/A | N/A | N/A | N/A | N/A | N/A | |

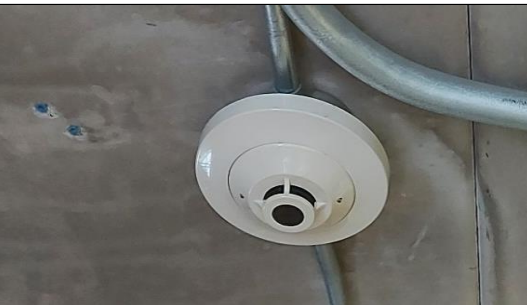
| Building / Component Name (#) | Location | Material Category | Material & Description | Homogeneous Sample Group (HSG) / Sample # | Sample I.D. | Quantity <sup>(1)</sup> | Friable | Condition | Accessibility | % Asbestos and Type | Asbestos Abatement Category | Lead Concentration (mg/kg) | Representative Photograph |
|---|---|---|---|---|---|---|---|---|---|---|---|---|---|
| 325 - 10 Street NW (HIL2, formerly HU2) | Boiler/Generator Room | Radioactive Materials | Smoke Detectors | N/A | N/A | 2 Each | N/A | N/A | N/A | N/A | N/A | N/A | |

Smoke detectors suspected of containing radioactive materials were observed during the assessment. Radioactive materials within the smoke detectors pose no risk to workers or occupants provided the materials remain intact and undisturbed. It is recommended that at the time of renovation or demolition, all smoke detectors should be kept separate from all other waste to prevent damage. These materials may be recycled by qualified personnel or may be disposed of in accordance with regulations specified by Alberta Environment and Parks.

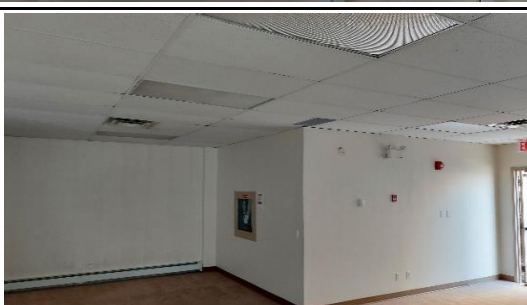
| Building / Component Name (#) | Location | Material Category | Material & Description | Homogeneous Sample Group (HSG) / Sample # | Sample I.D. | Quantity <sup>(1)</sup> | Friable | Condition | Accessibility | % Asbestos and Type | Asbestos Abatement Category | Lead Concentration (mg/kg) | Representative Photograph |
|---|---|---|---|---|---|---|---|---|---|---|---|---|---|
| 325 - 10 Street NW (HIL2, formerly HU2) | Common Areas (Former Daycare) | Asbestos | Drywall Joint Compound on Walls | HIL2-A-05 | Reference | 3,200 Square Feet | Moderate | Good | High | 2% Chrysotile | Moderate-Risk | N/A | |

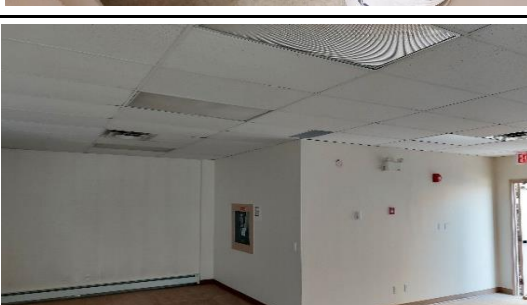
| Building / Component Name (#) | Location | Material Category | Material & Description | Homogeneous Sample Group (HSG) / Sample # | Sample I.D. | Quantity <sup>(1)</sup> | Friable | Condition | Accessibility | % Asbestos and Type | Asbestos Abatement Category | Lead Concentration (mg/kg) | Representative Photograph |
|---|---|---|---|---|---|---|---|---|---|---|---|---|---|
| 325 - 10 Street NW (HIL2, formerly HU2) | Common Areas (Former Daycare) | Lead-Paint | Beige Paint on Drywall | HIL2-L-07 | Reference | 3,200 Square Feet | N/A | Good | N/A | N/A | N/A | 120 (Considered to be lead-containing) | |

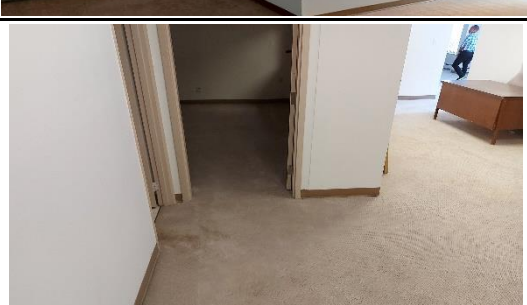
| Building / Component Name (#) | Location | Material Category | Material & Description | Homogeneous Sample Group (HSG) / Sample # | Sample I.D. | Quantity <sup>(1)</sup> | Friable | Condition | Accessibility | % Asbestos and Type | Asbestos Abatement Category | Lead Concentration (mg/kg) | Representative Photograph |
|---|---|---|---|---|---|---|---|---|---|---|---|---|---|
| 325 - 10 Street NW (HIL2, formerly HU2) | Common Areas (Former Daycare) | Lead-Paint | Light Grey Paint on Metal | HIL2-L-08 | Reference | 320 Square Feet | N/A | Good | N/A | N/A | N/A | 717 (Considered to be lead-containing) | |

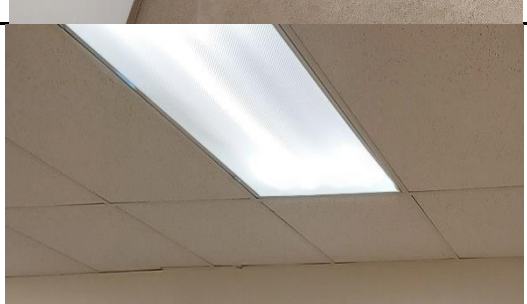
| Building / Component Name (#) | Location | Material Category | Material & Description | Homogeneous Sample Group (HSG) / Sample # | Sample I.D. | Quantity <sup>(1)</sup> | Friable | Condition | Accessibility | % Asbestos and Type | Asbestos Abatement Category | Lead Concentration (mg/kg) | Representative Photograph |
|---|---|---|---|---|---|---|---|---|---|---|---|---|---|
| 325 - 10 Street NW (HIL2, formerly HU2) | Common Areas (Former Daycare) | Mercury | Fluorescent Light Tubes Containing Mercury-Vapour | N/A | N/A | 88 Each | N/A | N/A | N/A | N/A | N/A | N/A | |

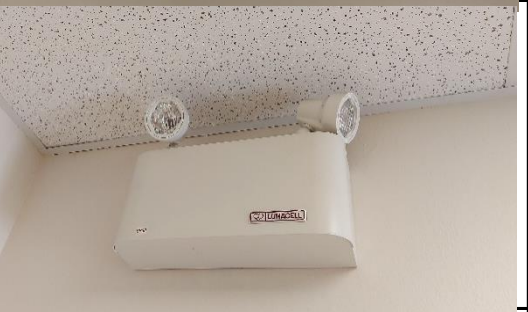
| Building / Component Name (#) | Location | Material Category | Material & Description | Homogeneous Sample Group (HSG) / Sample # | Sample I.D. | Quantity <sup>(1)</sup> | Friable | Condition | Accessibility | % Asbestos and Type | Asbestos Abatement Category | Lead Concentration (mg/kg) | Representative Photograph |
|---|---|---|---|---|---|---|---|---|---|---|---|---|---|
| 325 - 10 Street NW (HIL2, formerly HU2) | Common Areas (Former Daycare) | Lead Batteries | Emergency Lights | N/A | N/A | 2 Each | N/A | N/A | N/A | N/A | N/A | N/A | |

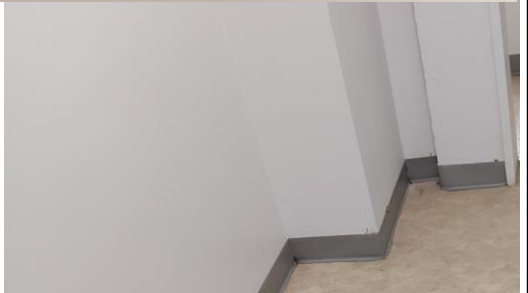
| Building / Component Name (#) | Location | Material Category | Material & Description | Homogeneous Sample Group (HSG) / Sample # | Sample I.D. | Quantity <sup>(1)</sup> | Friable | Condition | Accessibility | % Asbestos and Type | Asbestos Abatement Category | Lead Concentration (mg/kg) | Representative Photograph |
|---|---|---|---|---|---|---|---|---|---|---|---|---|---|
| 325 - 10 Street NW (HIL2, formerly HU2) | Common Areas (Main Floor) | Asbestos | Drywall Joint Compound on Walls | HIL2-A-05 | G | 2,300 Square Feet | Low | Good | High | 2% Chrysotile | Moderate-Risk | N/A | |

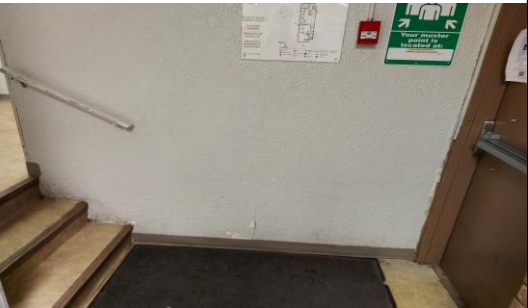
| Building / Component Name (#) | Location | Material Category | Material & Description | Homogeneous Sample Group (HSG) / Sample # | Sample I.D. | Quantity <sup>(1)</sup> | Friable | Condition | Accessibility | % Asbestos and Type | Asbestos Abatement Category | Lead Concentration (mg/kg) | Representative Photograph |
|---|---|---|---|---|---|---|---|---|---|---|---|---|---|
| 325 - 10 Street NW (HIL2, formerly HU2) | Common Areas (Main Floor) | Asbestos | Wall Texture Coat | HIL2-A-14 | A to C | 80 Square Feet | High | Good | High | None Detected | N/A | N/A | |

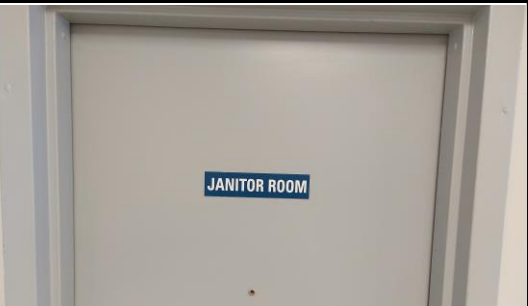
| Building / Component Name (#) | Location | Material Category | Material & Description | Homogeneous Sample Group (HSG) / Sample # | Sample I.D. | Quantity <sup>(1)</sup> | Friable | Condition | Accessibility | % Asbestos and Type | Asbestos Abatement Category | Lead Concentration (mg/kg) | Representative Photograph |
|---|---|---|---|---|---|---|---|---|---|---|---|---|---|
| 325 - 10 Street NW (HIL2, formerly HU2) | Common Areas (Main Floor) | Lead-Paint | Light Grey Paint on Metal | HIL2-L-08 | Reference | 10 Doors and Frames | N/A | Good | N/A | N/A | N/A | 717 (Considered to be lead-containing) | |

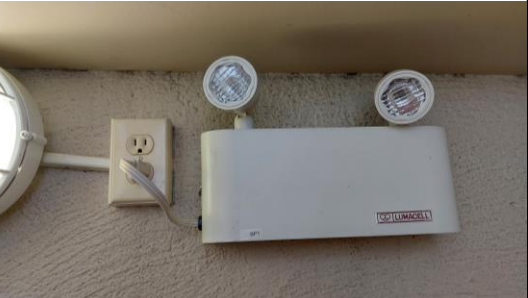
| Building / Component Name (#) | Location | Material Category | Material & Description | Homogeneous Sample Group (HSG) / Sample # | Sample I.D. | Quantity <sup>(1)</sup> | Friable | Condition | Accessibility | % Asbestos and Type | Asbestos Abatement Category | Lead Concentration (mg/kg) | Representative Photograph |
|---|---|---|---|---|---|---|---|---|---|---|---|---|---|
| 325 - 10 Street NW (HIL2, formerly HU2) | Common Areas (Main Floor) | Lead Batteries | Emergency Lights | N/A | N/A | 3 Each | N/A | N/A | N/A | N/A | N/A | N/A | |

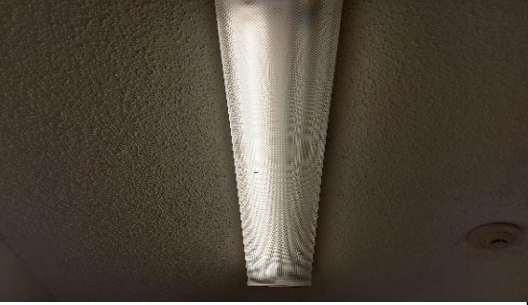
| Building / Component Name (#) | Location | Material Category | Material & Description | Homogeneous Sample Group (HSG) / Sample # | Sample I.D. | Quantity <sup>(1)</sup> | Friable | Condition | Accessibility | % Asbestos and Type | Asbestos Abatement Category | Lead Concentration (mg/kg) | Representative Photograph |
|---|---|---|---|---|---|---|---|---|---|---|---|---|---|
| 325 - 10 Street NW (HIL2, formerly HU2) | Common Areas (Main Floor) | Mercury | Fluorescent Light Tubes Containing Mercury-Vapour | N/A | N/A | 32 Each | N/A | N/A | N/A | N/A | N/A | N/A | |

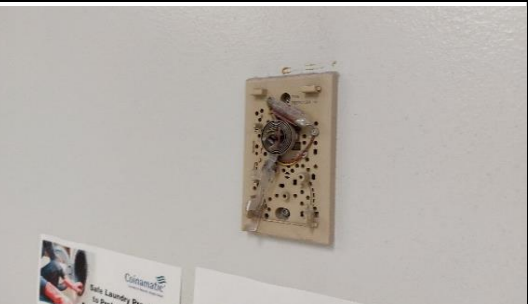
| Building / Component Name (#) | Location | Material Category | Material & Description | Homogeneous Sample Group (HSG) / Sample # | Sample I.D. | Quantity <sup>(1)</sup> | Friable | Condition | Accessibility | % Asbestos and Type | Asbestos Abatement Category | Lead Concentration (mg/kg) | Representative Photograph |
|---|---|---|---|---|---|---|---|---|---|---|---|---|---|
| 325 - 10 Street NW (HIL2, formerly HU2) | Common Areas (Main Floor) | Mercury | Mercury Capsules in Thermostats | N/A | N/A | 1 Each | N/A | N/A | N/A | N/A | N/A | N/A | |

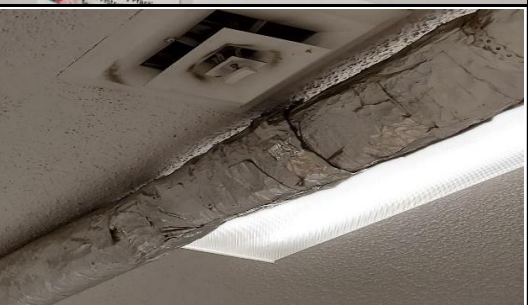
| Building / Component Name (#) | Location | Material Category | Material & Description | Homogeneous Sample Group (HSG) / Sample # | Sample I.D. | Quantity <sup>(1)</sup> | Friable | Condition | Accessibility | % Asbestos and Type | Asbestos Abatement Category | Lead Concentration (mg/kg) | Representative Photograph |
|---|---|---|---|---|---|---|---|---|---|---|---|---|---|
| 325 - 10 Street NW (HIL2, formerly HU2) | Common Areas (Main Floor) | Polychlorinated Biphenyls (PCBs) | PCBs in Fluorescent Light Ballasts | N/A | N/A | 1 Each | N/A | N/A | N/A | N/A | N/A | N/A | |

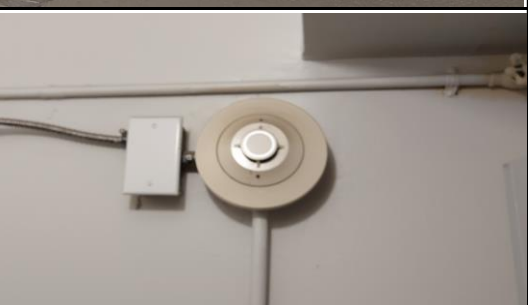
| Building / Component Name (#) | Location | Material Category | Material & Description | Homogeneous Sample Group (HSG) / Sample # | Sample I.D. | Quantity <sup>(1)</sup> | Friable | Condition | Accessibility | % Asbestos and Type | Asbestos Abatement Category | Lead Concentration (mg/kg) | Representative Photograph |
|---|---|---|---|---|---|---|---|---|---|---|---|---|---|
| 325 - 10 Street NW (HIL2, formerly HU2) | Common Areas (Main Floor) | Radioactive Materials | Smoke Detectors | N/A | N/A | 4 Each | N/A | N/A | N/A | N/A | N/A | N/A | |

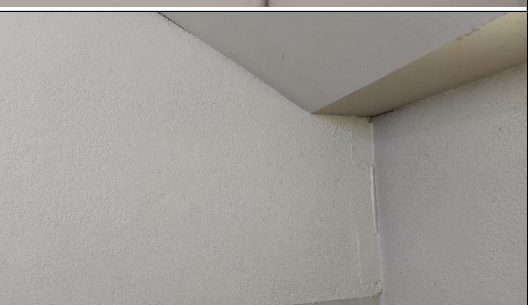
| Building / Component Name (#) | Location | Material Category | Material & Description | Homogeneous Sample Group (HSG) / Sample # | Sample I.D. | Quantity <sup>(1)</sup> | Friable | Condition | Accessibility | % Asbestos and Type | Asbestos Abatement Category | Lead Concentration (mg/kg) | Representative Photograph |
|---|---|---|---|---|---|---|---|---|---|---|---|---|---|
| 325 - 10 Street NW (HIL2, formerly HU2) | Common Areas (Corridors and Stairwells) | Asbestos | Concrete Texture Coat | HIL2-A-03 | Reference | 6,400 Square Feet | High | Good | Low | None Detected | N/A | N/A | |

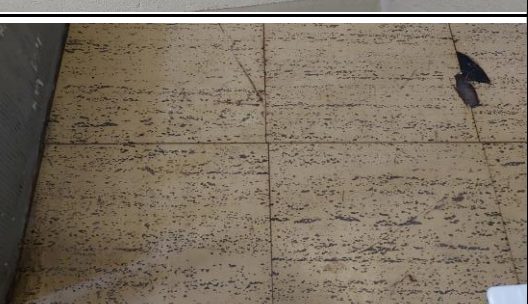
| Building / Component Name (#) | Location | Material Category | Material & Description | Homogeneous Sample Group (HSG) / Sample # | Sample I.D. | Quantity <sup>(1)</sup> | Friable | Condition | Accessibility | % Asbestos and Type | Asbestos Abatement Category | Lead Concentration (mg/kg) | Representative Photograph |
|---|---|---|---|---|---|---|---|---|---|---|---|---|---|
| 325 - 10 Street NW (HIL2, formerly HU2) | Common Areas (Corridors and Stairwells) | Asbestos | Vinyl Floor Tile, 12" x 12" Off-White with Black Splotches | HIL2-A-04 | A to C | 640 Square Feet | Low | Good | High | 4% Chrysotile | Low-Risk | N/A | |

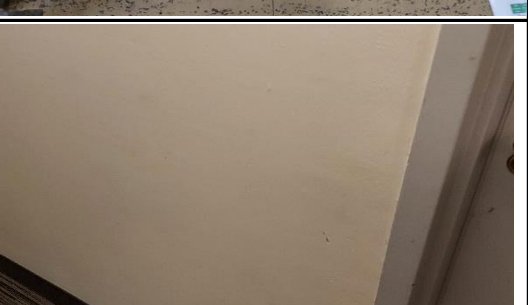
| Building / Component Name (#) | Location | Material Category | Material & Description | Homogeneous Sample Group (HSG) / Sample # | Sample I.D. | Quantity <sup>(1)</sup> | Friable | Condition | Accessibility | % Asbestos and Type | Asbestos Abatement Category | Lead Concentration (mg/kg) | Representative Photograph |
|---|---|---|---|---|---|---|---|---|---|---|---|---|---|
| 325 - 10 Street NW (HIL2, formerly HU2) | Common Areas (Corridors and Stairwells) | Asbestos | Drywall Joint Compound on Walls | HIL2-A-05 | A, B, and F | 15,100 Square Feet | Moderate | Good | High | 2% Chrysotile | Moderate-Risk | N/A | |

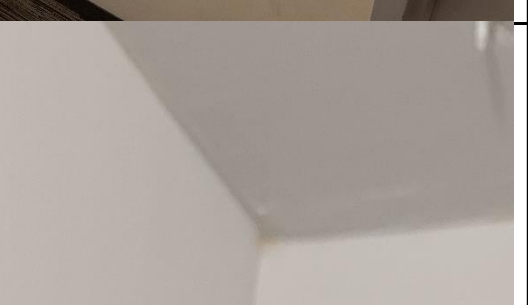
| Building / Component Name (#) | Location | Material Category | Material & Description | Homogeneous Sample Group (HSG) / Sample # | Sample I.D. | Quantity <sup>(1)</sup> | Friable | Condition | Accessibility | % Asbestos and Type | Asbestos Abatement Category | Lead Concentration (mg/kg) | Representative Photograph |
|---|---|---|---|---|---|---|---|---|---|---|---|---|---|
| 325 - 10 Street NW (HIL2, formerly HU2) | Common Areas (Corridors and Stairwells) | Asbestos | Ceiling Stipple | HIL2-A-06 | B, D, and G | 3,360 Square Feet | High | Good | High | 10% Chrysotile | High-Risk | N/A | |

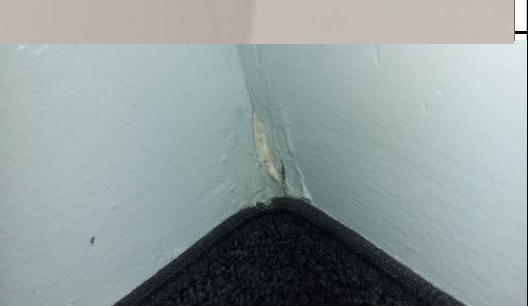
| Building / Component Name (#) | Location | Material Category | Material & Description | Homogeneous Sample Group (HSG) / Sample # | Sample I.D. | Quantity <sup>(1)</sup> | Friable | Condition | Accessibility | % Asbestos and Type | Asbestos Abatement Category | Lead Concentration (mg/kg) | Representative Photograph |
|---|---|---|---|---|---|---|---|---|---|---|---|---|---|
| 325 - 10 Street NW (HIL2, formerly HU2) | Common Areas (Corridors and Stairwells) | Asbestos | White Cornerbead Caulking | HIL2-A-12 | A | 20 Linear Feet | Low | Good | Moderate | None Detected | N/A | N/A | |

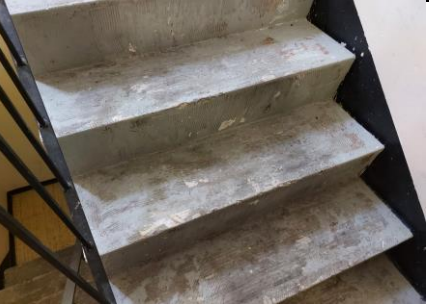
| Building / Component Name (#) | Location | Material Category | Material & Description | Homogeneous Sample Group (HSG) / Sample # | Sample I.D. | Quantity <sup>(1)</sup> | Friable | Condition | Accessibility | % Asbestos and Type | Asbestos Abatement Category | Lead Concentration (mg/kg) | Representative Photograph |
|---|---|---|---|---|---|---|---|---|---|---|---|---|---|
| 325 - 10 Street NW (HIL2, formerly HU2) | Common Areas (Corridors and Stairwells) | Lead-Paint | Grey Paint on Concrete Steps | HIL2-L-06 | HIL2-L-06 | 1,600 Square Feet | N/A | Good | N/A | N/A | N/A | 9 (Not considered to be lead-containing) | |

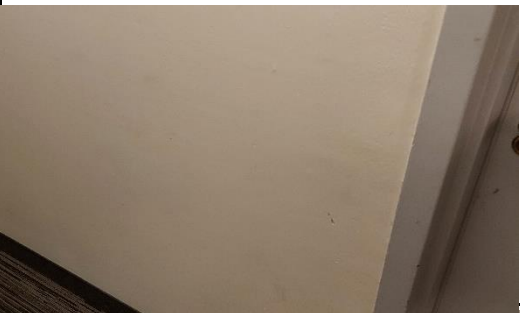
| Building / Component Name (#) | Location | Material Category | Material & Description | Homogeneous Sample Group (HSG) / Sample # | Sample I.D. | Quantity <sup>(1)</sup> | Friable | Condition | Accessibility | % Asbestos and Type | Asbestos Abatement Category | Lead Concentration (mg/kg) | Representative Photograph |
|---|---|---|---|---|---|---|---|---|---|---|---|---|---|
| 325 - 10 Street NW (HIL2, formerly HU2) | Common Areas (Corridors and Stairwells) | Lead-Paint | Beige Paint on Drywall | HIL2-L-07 | HIL2-L-07 | 15,100 Square Feet | N/A | Good | N/A | N/A | N/A | 120 (Considered to be lead-containing) | |

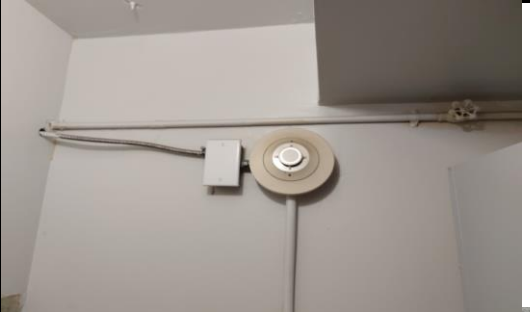
| Building / Component Name (#) | Location | Material Category | Material & Description | Homogeneous Sample Group (HSG) / Sample # | Sample I.D. | Quantity <sup>(1)</sup> | Friable | Condition | Accessibility | % Asbestos and Type | Asbestos Abatement Category | Lead Concentration (mg/kg) | Representative Photograph |
|---|---|---|---|---|---|---|---|---|---|---|---|---|---|
| 325 - 10 Street NW (HIL2, formerly HU2) | Common Areas (Corridors and Stairwells) | Radioactive Materials | Smoke Detectors | N/A | N/A | 24 Each | N/A | N/A | N/A | N/A | N/A | N/A | |

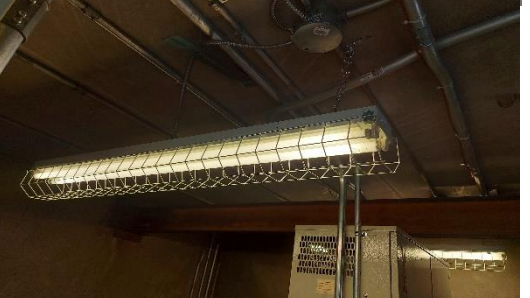
| Building / Component Name (#) | Location | Material Category | Material & Description | Homogeneous Sample Group (HSG) / Sample # | Sample I.D. | Quantity <sup>(1)</sup> | Friable | Condition | Accessibility | % Asbestos and Type | Asbestos Abatement Category | Lead Concentration (mg/kg) | Representative Photograph |
|---|---|---|---|---|---|---|---|---|---|---|---|---|---|
| 325 - 10 Street NW (HIL2, formerly HU2) | Rooftop Elevator Room | Polychlorinated Biphenyls (PCBs) | Fluorescent Light Fixtures with PCB-containing Ballasts | N/A | N/A | 2 Each | N/A | N/A | N/A | N/A | N/A | N/A | |

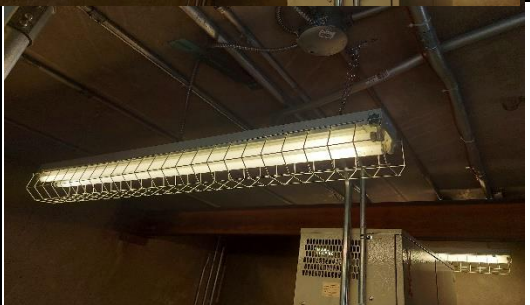
| Building / Component Name (#) | Location | Material Category | Material & Description | Homogeneous Sample Group (HSG) / Sample # | Sample I.D. | Quantity <sup>(1)</sup> | Friable | Condition | Accessibility | % Asbestos and Type | Asbestos Abatement Category | Lead Concentration (mg/kg) | Representative Photograph |
|---|---|---|---|---|---|---|---|---|---|---|---|---|---|
| 325 - 10 Street NW (HIL2, formerly HU2) | Rooftop Elevator Room | Mercury | Fluorescent Light Tubes Containing Mercury-Vapour | N/A | N/A | 6 Each | N/A | N/A | N/A | N/A | N/A | N/A | |

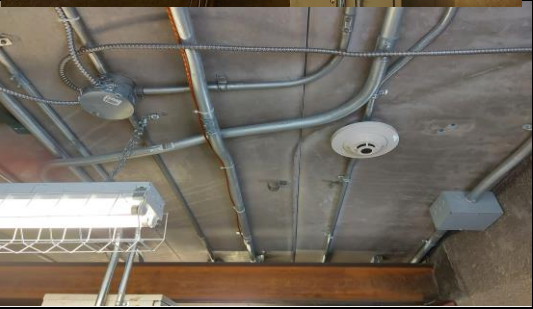
| Building / Component Name (#) | Location | Material Category | Material & Description | Homogeneous Sample Group (HSG) / Sample # | Sample I.D. | Quantity <sup>(1)</sup> | Friable | Condition | Accessibility | % Asbestos and Type | Asbestos Abatement Category | Lead Concentration (mg/kg) | Representative Photograph |
|---|---|---|---|---|---|---|---|---|---|---|---|---|---|
| 325 - 10 Street NW (HIL2, formerly HU2) | Rooftop Elevator Room | Radioactive Materials | Smoke Detectors | N/A | N/A | 1 Each | N/A | N/A | N/A | N/A | N/A | N/A | |

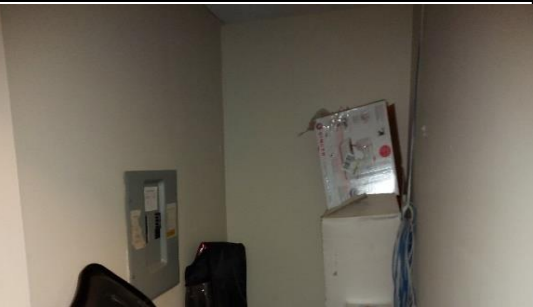
| Building / Component Name (#) | Location | Material Category | Material & Description | Homogeneous Sample Group (HSG) / Sample # | Sample I.D. | Quantity <sup>(1)</sup> | Friable | Condition | Accessibility | % Asbestos and Type | Asbestos Abatement Category | Lead Concentration (mg/kg) | Representative Photograph |
|---|---|---|---|---|---|---|---|---|---|---|---|---|---|
| 325 - 10 Street NW (HIL2, formerly HU2) | Unit 208 | Asbestos | Drywall Joint Compound on Walls | HIL2-A-05 | Reference | 1,600 Square Feet | Moderate | Good | High | 2% Chrysotile | Moderate-Risk | N/A | |

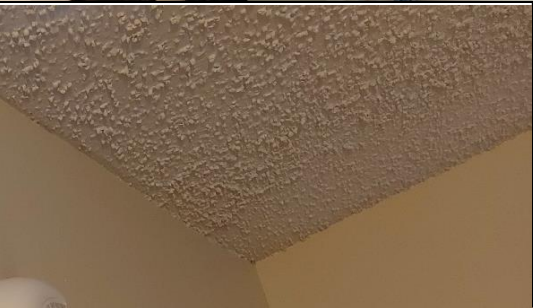
| Building / Component Name (#) | Location | Material Category | Material & Description | Homogeneous Sample Group (HSG) / Sample # | Sample I.D. | Quantity <sup>(1)</sup> | Friable | Condition | Accessibility | % Asbestos and Type | Asbestos Abatement Category | Lead Concentration (mg/kg) | Representative Photograph |
|---|---|---|---|---|---|---|---|---|---|---|---|---|---|
| 325 - 10 Street NW (HIL2, formerly HU2) | Unit 208 | Asbestos | Ceiling Stipple | HIL2-A-06 | Reference | 500 Square Feet | High | Good | High | 10% Chrysotile | High-Risk | N/A | |

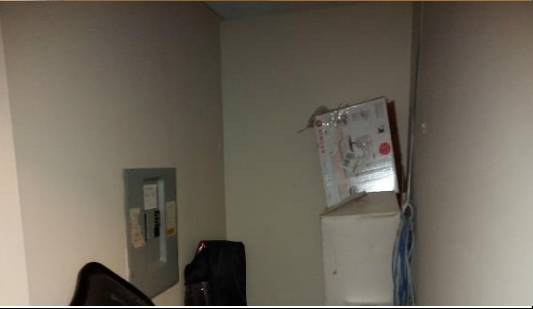
| Building / Component Name (#) | Location | Material Category | Material & Description | Homogeneous Sample Group (HSG) / Sample # | Sample I.D. | Quantity <sup>(1)</sup> | Friable | Condition | Accessibility | % Asbestos and Type | Asbestos Abatement Category | Lead Concentration (mg/kg) | Representative Photograph |
|---|---|---|---|---|---|---|---|---|---|---|---|---|---|
| 325 - 10 Street NW (HIL2, formerly HU2) | Unit 208 | Lead-Paint | Beige Paint on Drywall | HIL2-L-07 | Reference | 1,600 Square Feet | N/A | Good | N/A | N/A | N/A | 120 (Considered to be lead-containing) | |

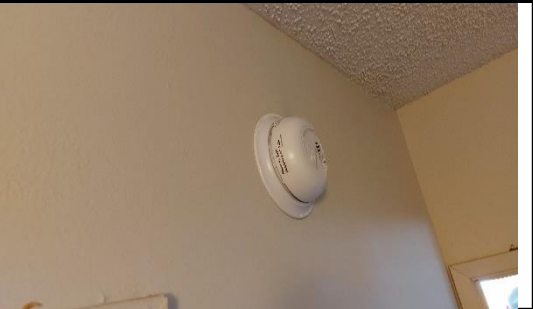
| Building / Component Name (#) | Location | Material Category | Material & Description | Homogeneous Sample Group (HSG) / Sample # | Sample I.D. | Quantity <sup>(1)</sup> | Friable | Condition | Accessibility | % Asbestos and Type | Asbestos Abatement Category | Lead Concentration (mg/kg) | Representative Photograph |
|---|---|---|---|---|---|---|---|---|---|---|---|---|---|
| 325 - 10 Street NW (HIL2, formerly HU2) | Unit 208 | Radioactive Materials | Smoke Detectors | N/A | N/A | 1 Each | N/A | N/A | N/A | N/A | N/A | N/A | |

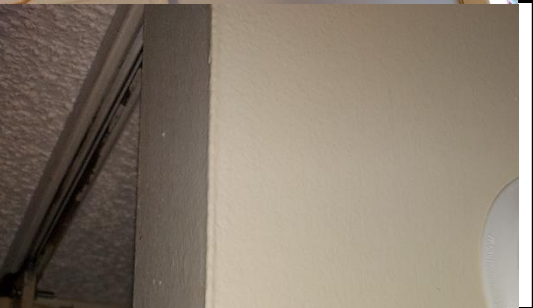
| Building / Component Name (#) | Location | Material Category | Material & Description | Homogeneous Sample Group (HSG) / Sample # | Sample I.D. | Quantity <sup>(1)</sup> | Friable | Condition | Accessibility | % Asbestos and Type | Asbestos Abatement Category | Lead Concentration (mg/kg) | Representative Photograph |
|---|---|---|---|---|---|---|---|---|---|---|---|---|---|
| 325 - 10 Street NW (HIL2, formerly HU2) | Unit 302 | Asbestos | Drywall Joint Compound on Walls | HIL2-A-05 | Reference | 1,600 Square Feet | Moderate | Good | High | 2% Chrysotile | Moderate-Risk | N/A | |

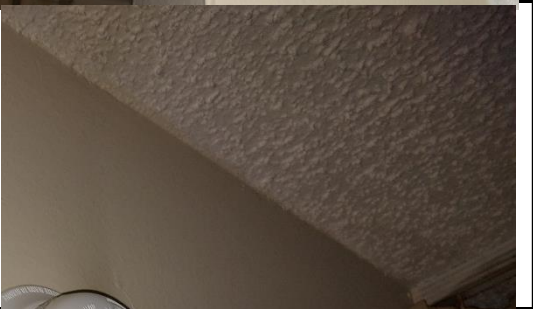
| Building / Component Name (#) | Location | Material Category | Material & Description | Homogeneous Sample Group (HSG) / Sample # | Sample I.D. | Quantity <sup>(1)</sup> | Friable | Condition | Accessibility | % Asbestos and Type | Asbestos Abatement Category | Lead Concentration (mg/kg) | Representative Photograph |
|---|---|---|---|---|---|---|---|---|---|---|---|---|---|
| 325 - 10 Street NW (HIL2, formerly HU2) | Unit 302 | Asbestos | Ceiling Stipple | HIL2-A-06 | Reference | 500 Square Feet | High | Good | High | 10% Chrysotile | High-Risk | N/A | |

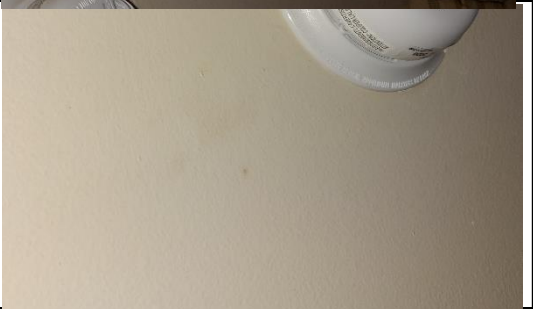
| Building / Component Name (#) | Location | Material Category | Material & Description | Homogeneous Sample Group (HSG) / Sample # | Sample I.D. | Quantity <sup>(1)</sup> | Friable | Condition | Accessibility | % Asbestos and Type | Asbestos Abatement Category | Lead Concentration (mg/kg) | Representative Photograph |
|---|---|---|---|---|---|---|---|---|---|---|---|---|---|
| 325 - 10 Street NW (HIL2, formerly HU2) | Unit 302 | Lead-Paint | Beige Paint on Drywall | HIL2-L-07 | Reference | 1,600 Square Feet | N/A | Good | N/A | N/A | N/A | 120 (Considered to be lead-containing) | |

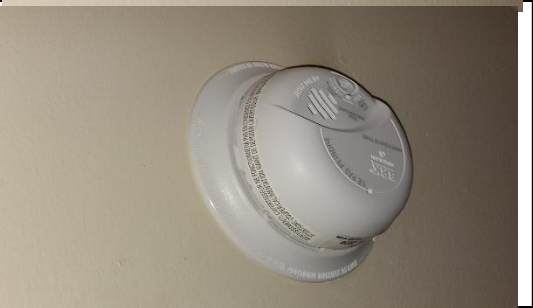
| Building / Component Name (#) | Location | Material Category | Material & Description | Homogeneous Sample Group (HSG) / Sample # | Sample I.D. | Quantity <sup>(1)</sup> | Friable | Condition | Accessibility | % Asbestos and Type | Asbestos Abatement Category | Lead Concentration (mg/kg) | Representative Photograph |
|---|---|---|---|---|---|---|---|---|---|---|---|---|---|
| 325 - 10 Street NW (HIL2, formerly HU2) | Unit 302 | Radioactive Materials | Smoke Detectors | N/A | N/A | 1 Each | N/A | N/A | N/A | N/A | N/A | N/A | |

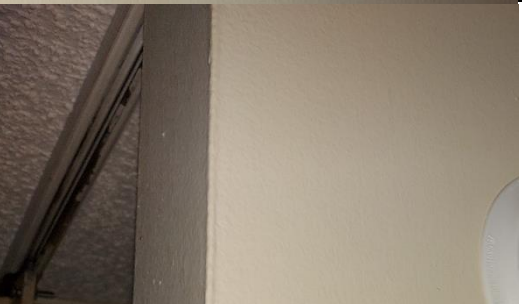
| Building / Component Name (#) | Location | Material Category | Material & Description | Homogeneous Sample Group (HSG) / Sample # | Sample I.D. | Quantity <sup>(1)</sup> | Friable | Condition | Accessibility | % Asbestos and Type | Asbestos Abatement Category | Lead Concentration (mg/kg) | Representative Photograph |
|---|---|---|---|---|---|---|---|---|---|---|---|---|---|
| 325 - 10 Street NW (HIL2, formerly HU2) | Unit 404 | Asbestos | Drywall Joint Compound on Walls | HIL2-A-05 | E | 1,600 Square Feet | Moderate | Good | High | 2% Chrysotile | Moderate-Risk | N/A | |

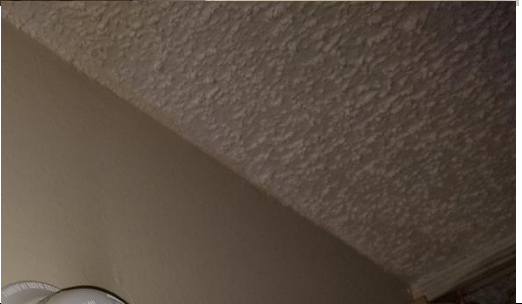
| Building / Component Name (#) | Location | Material Category | Material & Description | Homogeneous Sample Group (HSG) / Sample # | Sample I.D. | Quantity <sup>(1)</sup> | Friable | Condition | Accessibility | % Asbestos and Type | Asbestos Abatement Category | Lead Concentration (mg/kg) | Representative Photograph |
|---|---|---|---|---|---|---|---|---|---|---|---|---|---|
| 325 - 10 Street NW (HIL2, formerly HU2) | Unit 404 | Asbestos | Ceiling Stipple | HIL2-A-06 | F | 500 Square Feet | High | Good | High | 10% Chrysotile | High-Risk | N/A | |

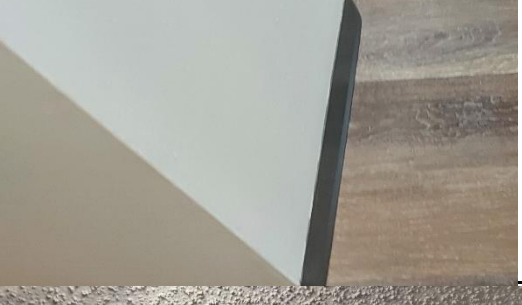
| Building / Component Name (#) | Location | Material Category | Material & Description | Homogeneous Sample Group (HSG) / Sample # | Sample I.D. | Quantity <sup>(1)</sup> | Friable | Condition | Accessibility | % Asbestos and Type | Asbestos Abatement Category | Lead Concentration (mg/kg) | Representative Photograph |
|---|---|---|---|---|---|---|---|---|---|---|---|---|---|
| 325 - 10 Street NW (HIL2, formerly HU2) | Unit 705 | Asbestos | Drywall Joint Compound on Walls | HIL2-A-05 | D | 1,600 Square Feet | Moderate | Good | High | 2% Chrysotile | Moderate-Risk | N/A | |

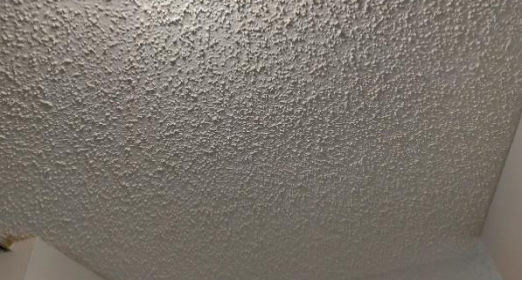
| Building / Component Name (#) | Location | Material Category | Material & Description | Homogeneous Sample Group (HSG) / Sample # | Sample I.D. | Quantity <sup>(1)</sup> | Friable | Condition | Accessibility | % Asbestos and Type | Asbestos Abatement Category | Lead Concentration (mg/kg) | Representative Photograph |
|---|---|---|---|---|---|---|---|---|---|---|---|---|---|
| 325 - 10 Street NW (HIL2, formerly HU2) | Unit 705 | Asbestos | Ceiling Stipple | HIL2-A-06 | E | 500 Square Feet | High | Good | High | 10% Chrysotile | High-Risk | N/A | |

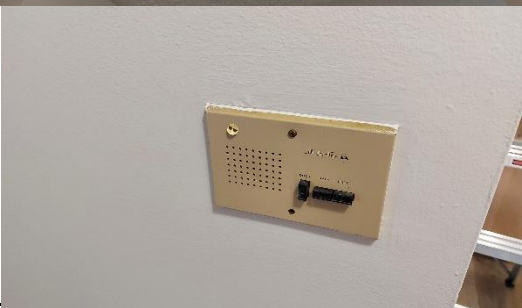
| Building / Component Name (#) | Location | Material Category | Material & Description | Homogeneous Sample Group (HSG) / Sample # | Sample I.D. | Quantity <sup>(1)</sup> | Friable | Condition | Accessibility | % Asbestos and Type | Asbestos Abatement Category | Lead Concentration (mg/kg) | Representative Photograph |
|---|---|---|---|---|---|---|---|---|---|---|---|---|---|
| 325 - 10 Street NW (HIL2, formerly HU2) | Unit 705 | Lead-Paint | Beige Paint on Drywall | HIL2-L-07 | Reference | 1,600 Square Feet | N/A | Good | N/A | N/A | N/A | 120 (Considered to be lead-containing) | |

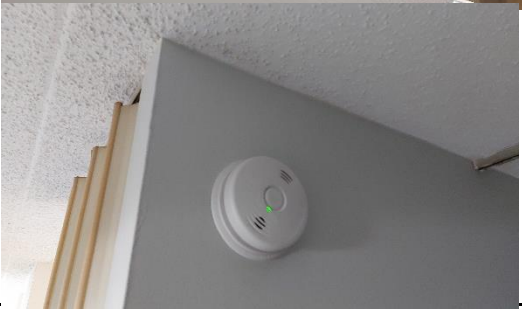
| Building / Component Name (#) | Location | Material Category | Material & Description | Homogeneous Sample Group (HSG) / Sample # | Sample I.D. | Quantity <sup>(1)</sup> | Friable | Condition | Accessibility | % Asbestos and Type | Asbestos Abatement Category | Lead Concentration (mg/kg) | Representative Photograph |
|---|---|---|---|---|---|---|---|---|---|---|---|---|---|
| 325 - 10 Street NW (HIL2, formerly HU2) | Unit 705 | Radioactive Materials | Smoke Detectors | N/A | N/A | 1 Each | N/A | N/A | N/A | N/A | N/A | N/A | |

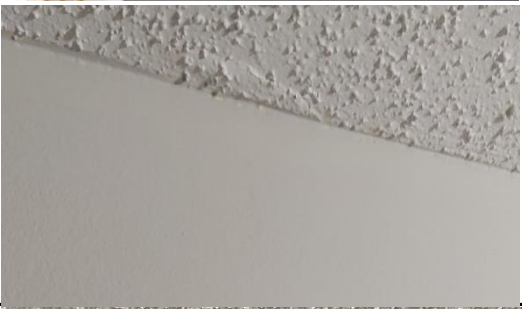
| Building / Component Name (#) | Location | Material Category | Material & Description | Homogeneous Sample Group (HSG) / Sample # | Sample I.D. | Quantity <sup>(1)</sup> | Friable | Condition | Accessibility | % Asbestos and Type | Asbestos Abatement Category | Lead Concentration (mg/kg) | Representative Photograph |
|---|---|---|---|---|---|---|---|---|---|---|---|---|---|
| 325 - 10 Street NW (HIL2, formerly HU2) | Unit 806 | Asbestos | Drywall Joint Compound on Walls | HIL2-A-05 | C | 1,600 Square Feet | Moderate | Good | High | 2% Chrysotile | Moderate-Risk | N/A | |

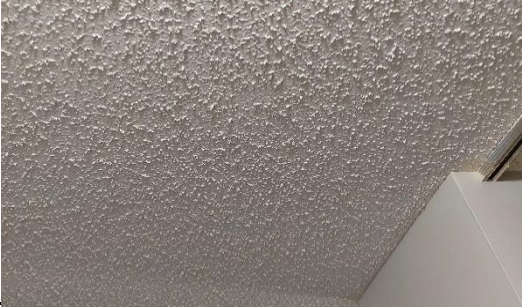
| Building / Component Name (#) | Location | Material Category | Material & Description | Homogeneous Sample Group (HSG) / Sample # | Sample I.D. | Quantity <sup>(1)</sup> | Friable | Condition | Accessibility | % Asbestos and Type | Asbestos Abatement Category | Lead Concentration (mg/kg) | Representative Photograph |
|---|---|---|---|---|---|---|---|---|---|---|---|---|---|
| 325 - 10 Street NW (HIL2, formerly HU2) | Unit 806 | Asbestos | Ceiling Stipple | HIL2-A-06 | C | 500 Square Feet | High | Good | High | 10% Chrysotile | High-Risk | N/A | |

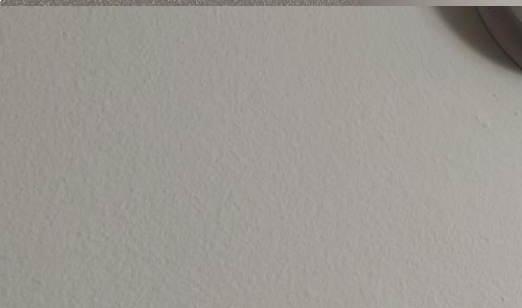
| Building / Component Name (#) | Location | Material Category | Material & Description | Homogeneous Sample Group (HSG) / Sample # | Sample I.D. | Quantity <sup>(1)</sup> | Friable | Condition | Accessibility | % Asbestos and Type | Asbestos Abatement Category | Lead Concentration (mg/kg) | Representative Photograph |
|---|---|---|---|---|---|---|---|---|---|---|---|---|---|
| 325 - 10 Street NW (HIL2, formerly HU2) | Unit 806 | Lead-Paint | Beige Paint on Drywall | HIL2-L-07 | Reference | 1,600 Square Feet | N/A | Good | N/A | N/A | N/A | 120 (Considered to be lead-containing) | |

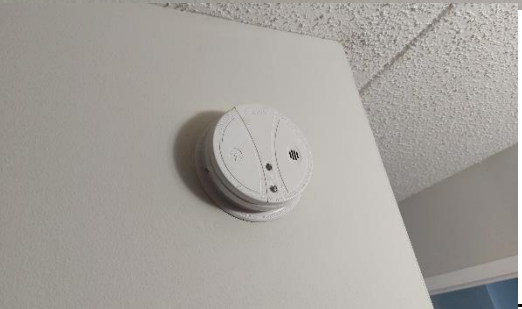
| Building / Component Name (#) | Location | Material Category | Material & Description | Homogeneous Sample Group (HSG) / Sample # | Sample I.D. | Quantity <sup>(1)</sup> | Friable | Condition | Accessibility | % Asbestos and Type | Asbestos Abatement Category | Lead Concentration (mg/kg) | Representative Photograph |
|---|---|---|---|---|---|---|---|---|---|---|---|---|---|
| 325 - 10 Street NW (HIL2, formerly HU2) | Unit 806 | Radioactive Materials | Smoke Detectors | N/A | N/A | 1 Each | N/A | N/A | N/A | N/A | N/A | N/A | |

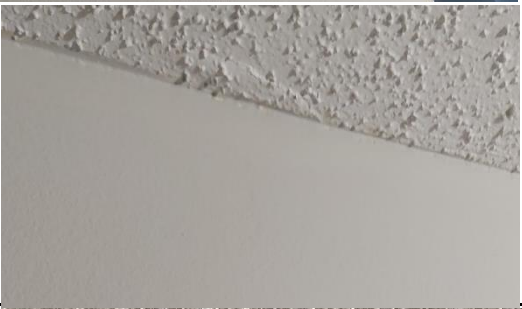
| Building / Component Name (#) | Location | Material Category | Material & Description | Homogeneous Sample Group (HSG) / Sample # | Sample I.D. | Quantity <sup>(1)</sup> | Friable | Condition | Accessibility | % Asbestos and Type | Asbestos Abatement Category | Lead Concentration (mg/kg) | Representative Photograph |
|---|---|---|---|---|---|---|---|---|---|---|---|---|---|
| 325 - 10 Street NW (HIL2, formerly HU2) | Unit 905 | Asbestos | Drywall Joint Compound on Walls | HIL2-A-05 | Reference | 1,600 Square Feet | Moderate | Good | High | 2% Chrysotile | Moderate-Risk | N/A | |

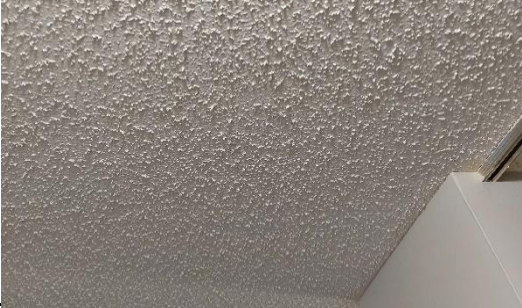
| Building / Component Name (#) | Location | Material Category | Material & Description | Homogeneous Sample Group (HSG) / Sample # | Sample I.D. | Quantity <sup>(1)</sup> | Friable | Condition | Accessibility | % Asbestos and Type | Asbestos Abatement Category | Lead Concentration (mg/kg) | Representative Photograph |
|---|---|---|---|---|---|---|---|---|---|---|---|---|---|
| 325 - 10 Street NW (HIL2, formerly HU2) | Unit 905 | Asbestos | Ceiling Stipple | HIL2-A-06 | A | 500 Square Feet | High | Good | High | 10% Chrysotile | High-Risk | N/A | |

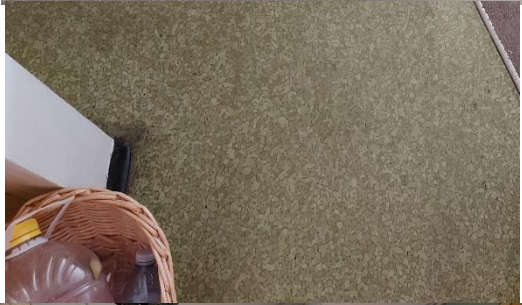
| Building / Component Name (#) | Location | Material Category | Material & Description | Homogeneous Sample Group (HSG) / Sample # | Sample I.D. | Quantity <sup>(1)</sup> | Friable | Condition | Accessibility | % Asbestos and Type | Asbestos Abatement Category | Lead Concentration (mg/kg) | Representative Photograph |
|---|---|---|---|---|---|---|---|---|---|---|---|---|---|
| 325 - 10 Street NW (HIL2, formerly HU2) | Unit 905 | Asbestos | Vinyl Sheet Floor, Green and Brown Mosaic Pattern | HIL2-A-07 | A to C | 320 Square Feet | Low | Good | High | 20% Chrysotile | High-Risk (>100 ft <sup>2</sup> )<br>Moderate-Risk (<100 ft <sup>2</sup> ) | N/A | |

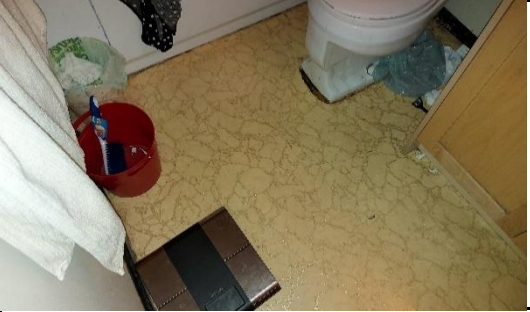
| Building / Component Name (#) | Location | Material Category | Material & Description | Homogeneous Sample Group (HSG) / Sample # | Sample I.D. | Quantity <sup>(1)</sup> | Friable | Condition | Accessibility | % Asbestos and Type | Asbestos Abatement Category | Lead Concentration (mg/kg) | Representative Photograph |
|---|---|---|---|---|---|---|---|---|---|---|---|---|---|
| 325 - 10 Street NW (HIL2, formerly HU2) | Unit 905 | Asbestos | Vinyl Sheet Floor, Beige Stone Pattern | HIL2-A-08 | A to C | 80 Square Feet | Low | Good | High | 20% Chrysotile | Moderate-Risk | N/A | |

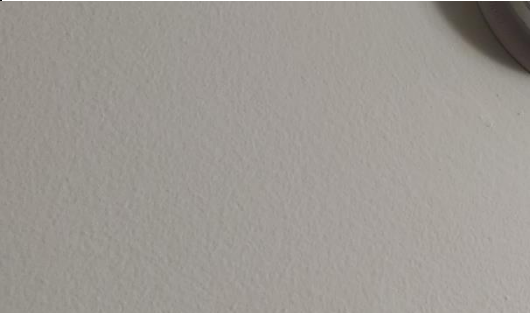
| Building / Component Name (#) | Location | Material Category | Material & Description | Homogeneous Sample Group (HSG) / Sample # | Sample I.D. | Quantity <sup>(1)</sup> | Friable | Condition | Accessibility | % Asbestos and Type | Asbestos Abatement Category | Lead Concentration (mg/kg) | Representative Photograph |
|---|---|---|---|---|---|---|---|---|---|---|---|---|---|
| 325 - 10 Street NW (HIL2, formerly HU2) | Unit 905 | Lead-Paint | Beige Paint on Drywall | HIL2-L-07 | Reference | 1,600 Square Feet | N/A | Good | N/A | N/A | N/A | 120 (Considered to be lead-containing) | |

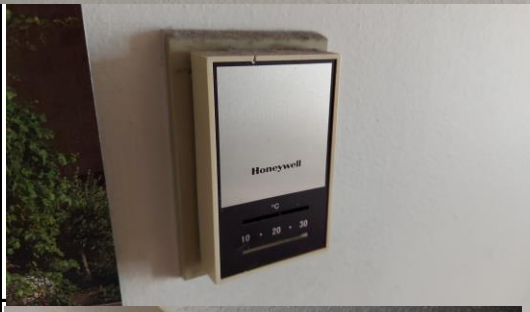
| Building / Component Name (#) | Location | Material Category | Material & Description | Homogeneous Sample Group (HSG) / Sample # | Sample I.D. | Quantity <sup>(1)</sup> | Friable | Condition | Accessibility | % Asbestos and Type | Asbestos Abatement Category | Lead Concentration (mg/kg) | Representative Photograph |
|---|---|---|---|---|---|---|---|---|---|---|---|---|---|
| 325 - 10 Street NW (HIL2, formerly HU2) | Unit 905 | Mercury | Mercury Capsules in Thermostats | N/A | N/A | 1 Each | N/A | N/A | N/A | N/A | N/A | N/A | |

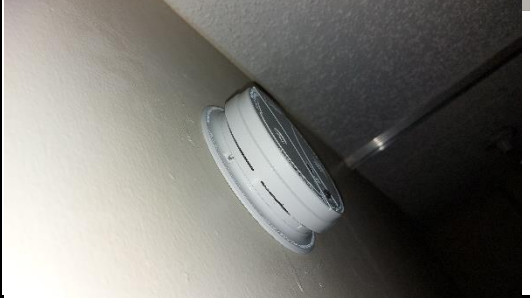
| Building / Component Name (#) | Location | Material Category | Material & Description | Homogeneous Sample Group (HSG) / Sample # | Sample I.D. | Quantity <sup>(1)</sup> | Friable | Condition | Accessibility | % Asbestos and Type | Asbestos Abatement Category | Lead Concentration (mg/kg) | Representative Photograph |
|---|---|---|---|---|---|---|---|---|---|---|---|---|---|
| 325 - 10 Street NW (HIL2, formerly HU2) | Unit 905 | Radioactive Materials | Smoke Detectors | N/A | N/A | 1 Each | N/A | N/A | N/A | N/A | N/A | N/A | |
