# Hazardous Building Materials Assessment, Property DNE1 formerly EV1, Calgary Housing Company

750 5 Street NE, Calgary, Alberta

*Assessment Completed: August 18 and September 13, 2021*

4 February 2022

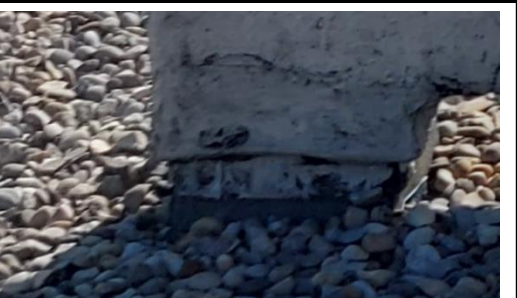
| Building / Component Name (#) | Location | Material Category | Material & Description | Homogeneous Sample Group (HSG) / Sample # | Sample I.D. | Quantity <sup>(1)</sup> | Friable | Condition | Accessibility | % Asbestos and Type | Asbestos Abatement Category | Lead Concentration (mg/kg) | Representative Photograph |
|---|---|---|---|---|---|---|---|---|---|---|---|---|---|
| 750 - 5 Street SE (DNE1, formerly EV1) | Exterior | Asbestos | Black Tar Mastic | DNE1-A-06 | A to C | 120 Square Feet | Low | Good | Low | 5% Chrysotile | Low-Risk | N/A | |

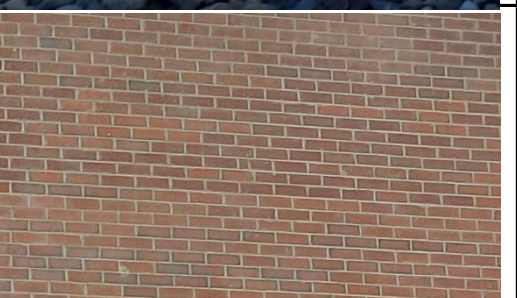
| Building / Component Name (#) | Location | Material Category | Material & Description | Homogeneous Sample Group (HSG) / Sample # | Sample I.D. | Quantity <sup>(1)</sup> | Friable | Condition | Accessibility | % Asbestos and Type | Asbestos Abatement Category | Lead Concentration (mg/kg) | Representative Photograph |
|---|---|---|---|---|---|---|---|---|---|---|---|---|---|
| 750 - 5 Street SE (DNE1, formerly EV1) | Exterior | Asbestos | Brick Mortar | DNE1-A-23 | A to C | 23,000 Squarer Feet | Moderate | Good | High | None Detected | N/A | N/A | |

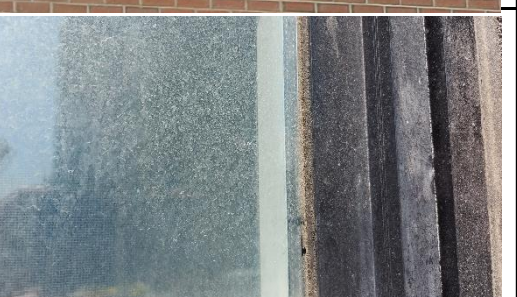
| Building / Component Name (#) | Location | Material Category | Material & Description | Homogeneous Sample Group (HSG) / Sample # | Sample I.D. | Quantity <sup>(1)</sup> | Friable | Condition | Accessibility | % Asbestos and Type | Asbestos Abatement Category | Lead Concentration (mg/kg) | Representative Photograph |
|---|---|---|---|---|---|---|---|---|---|---|---|---|---|
| 750 - 5 Street SE (DNE1, formerly EV1) | Exterior | Asbestos | Black Window Glazing | DNE1-A-16 | A to C | 250 Linear Feet | Low | Good | High | None Detected | N/A | N/A | |

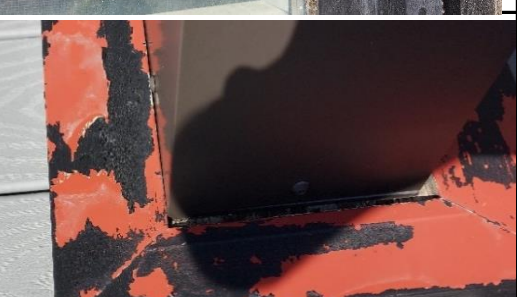
| Building / Component Name (#) | Location | Material Category | Material & Description | Homogeneous Sample Group (HSG) / Sample # | Sample I.D. | Quantity <sup>(1)</sup> | Friable | Condition | Accessibility | % Asbestos and Type | Asbestos Abatement Category | Lead Concentration (mg/kg) | Representative Photograph |
|---|---|---|---|---|---|---|---|---|---|---|---|---|---|
| 750 - 5 Street SE (DNE1, formerly EV1) | Exterior | Lead Paint | Black Paint on Metal | DNE1-L-05 | DNE1-L-05 | 400 Square Feet | N/A | Good | N/A | N/A | N/A | <5 (Not considered to be lead-containing) | |

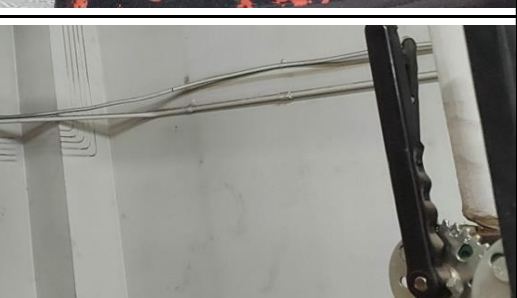
| Building / Component Name (#) | Location | Material Category | Material & Description | Homogeneous Sample Group (HSG) / Sample # | Sample I.D. | Quantity <sup>(1)</sup> | Friable | Condition | Accessibility | % Asbestos and Type | Asbestos Abatement Category | Lead Concentration (mg/kg) | Representative Photograph |
|---|---|---|---|---|---|---|---|---|---|---|---|---|---|
| 750 - 5 Street SE (DNE1, formerly EV1) | Boiler Room / Elevator Motor Room | Asbestos | Drywall Joint Compound on Walls | DNE1-A-01 | A | 1,300 Square Feet | Moderate | Good | Moderate | None Detected | N/A | N/A | |

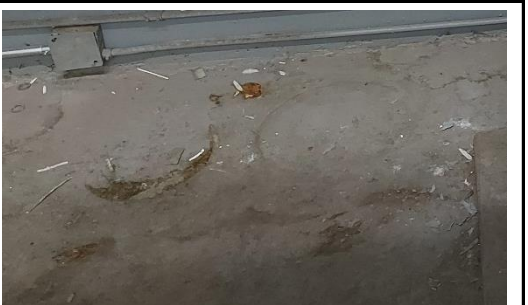
| Building / Component Name (#) | Location | Material Category | Material & Description | Homogeneous Sample Group (HSG) / Sample # | Sample I.D. | Quantity <sup>(1)</sup> | Friable | Condition | Accessibility | % Asbestos and Type | Asbestos Abatement Category | Lead Concentration (mg/kg) | Representative Photograph |
|---|---|---|---|---|---|---|---|---|---|---|---|---|---|
| 750 - 5 Street SE (DNE1, formerly EV1) | Boiler Room/ Elevator Motor Room | Lead Paint | Grey Paint on Concrete | DNE1-L-02 | DNE1-L-02 | 450 Square Feet | N/A | Good | N/A | N/A | N/A | 888 (Considered to be lead-containing) | |

The lead-containing paint was observed to be in good condition, at the time of the assessment. If the condition of the paints degrades, they should be abated following methods and requirements outlined in the Alberta OHS *Lead at the Work Site* bulletin. The lead-containing paint waste generated from the abatement activities should be analyzed for lead leachability by toxicity characteristic leaching procedure (TCLP) prior to disposal to ensure transportation and disposal of lead-containing waste materials is conducted in accordance with the requirements of AEP and the Federal *Transportation of Dangerous Goods Act* and Regulations, current to the date of the work. The AEP Waste Control Regulation prescribes the disposal pathways for lead-containing waste. Non-metal building materials (bricks, wood, concrete, cinderblock etc.) coated with lead-containing paint should not be recycled for re-use.

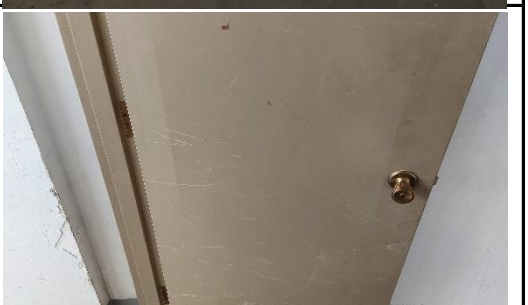
| Building / Component Name (#) | Location | Material Category | Material & Description | Homogeneous Sample Group (HSG) / Sample # | Sample I.D. | Quantity <sup>(1)</sup> | Friable | Condition | Accessibility | % Asbestos and Type | Asbestos Abatement Category | Lead Concentration (mg/kg) | Representative Photograph |
|---|---|---|---|---|---|---|---|---|---|---|---|---|---|
| 750 - 5 Street SE (DNE1, formerly EV1) | Boiler Room/ Elevator Motor Room | Lead Paint | Taupe Paint on Metal | DNE1-L-03 | DNE1-L-03 | 320 Square Feet | N/A | Good | N/A | N/A | N/A | 1,360 (Considered to be lead-containing) | |

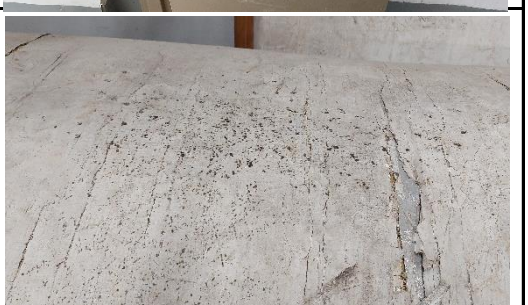
| Building / Component Name (#) | Location | Material Category | Material & Description | Homogeneous Sample Group (HSG) / Sample # | Sample I.D. | Quantity <sup>(1)</sup> | Friable | Condition | Accessibility | % Asbestos and Type | Asbestos Abatement Category | Lead Concentration (mg/kg) | Representative Photograph |
|---|---|---|---|---|---|---|---|---|---|---|---|---|---|
| 750 - 5 Street SE (DNE1, formerly EV1) | Boiler Room Insulation | Fungal Contamination | Fungal Contamination | DNE1-F-01 | DNE1-F-01 | 30 Square Feet | N/A | N/A | N/A | N/A | N/A | N/A | |

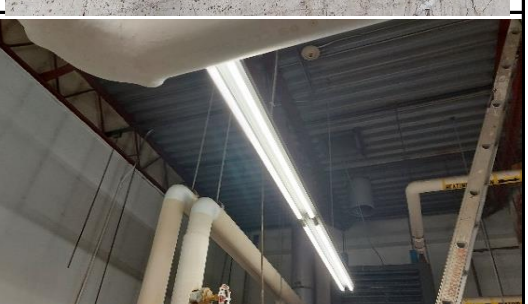
| Building / Component Name (#) | Location | Material Category | Material & Description | Homogeneous Sample Group (HSG) / Sample # | Sample I.D. | Quantity <sup>(1)</sup> | Friable | Condition | Accessibility | % Asbestos and Type | Asbestos Abatement Category | Lead Concentration (mg/kg) | Representative Photograph |
|---|---|---|---|---|---|---|---|---|---|---|---|---|---|
| 750 - 5 Street SE (DNE1, formerly EV1) | Boiler Room/ Elevator Motor Room | Mercury | Fluorescent Light Tubes Containing Mercury-Vapour | N/A | N/A | 32 Each | N/A | N/A | N/A | N/A | N/A | N/A | |

pose no risk to workers or occupants provided the capsules and tubes remain intact and undisturbed. It is recommended that at the time of removal, the capsules and tubes be kept separate from all other waste to prevent damage. These materials should be recycled or disposed of in accordance with regulations specified by AEP.

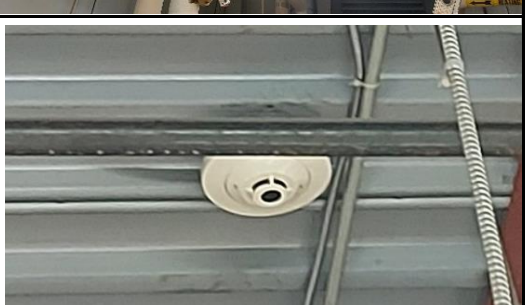
| Building / Component Name (#) | Location | Material Category | Material & Description | Homogeneous Sample Group (HSG) / Sample # | Sample I.D. | Quantity <sup>(1)</sup> | Friable | Condition | Accessibility | % Asbestos and Type | Asbestos Abatement Category | Lead Concentration (mg/kg) | Representative Photograph |
|---|---|---|---|---|---|---|---|---|---|---|---|---|---|
| 750 - 5 Street SE (DNE1, formerly EV1) | Boiler Room/ Elevator Motor Room | Radioactive Materials | Radioactive Material in Smoke Detectors | N/A | N/A | 4 Each | N/A | N/A | N/A | N/A | N/A | N/A | |

Smoke detectors suspected of containing radioactive materials were observed during the assessment. Radioactive materials within the smoke detectors pose no risk to workers or occupants provided the materials remain intact and undisturbed. It is recommended that at the time of renovation or demolition, all smoke detectors should be kept separate from all other waste to prevent damage. These materials may be recycled by qualified personnel or may be disposed of in accordance with regulations specified by Alberta Environment and Parks.

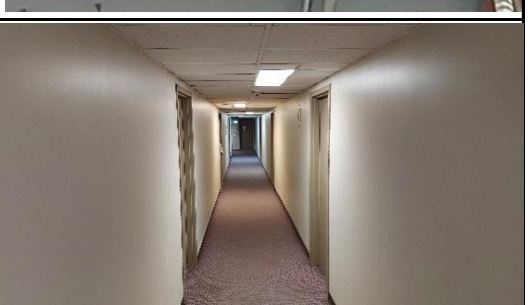
| Building / Component Name (#) | Location | Material Category | Material & Description | Homogeneous Sample Group (HSG) / Sample # | Sample I.D. | Quantity <sup>(1)</sup> | Friable | Condition | Accessibility | % Asbestos and Type | Asbestos Abatement Category | Lead Concentration (mg/kg) | Representative Photograph |
|---|---|---|---|---|---|---|---|---|---|---|---|---|---|
| 750 - 5 Street SE (DNE1, formerly EV1) | Common Areas (Corridors, Garbage Rooms, and Electrical Rooms 4 - 16th Floors) | Asbestos | Drywall Joint Compound on Walls | DNE1-A-01 | B | 14,000 Square Feet | Moderate | Good | High | None Detected | N/A | N/A | |

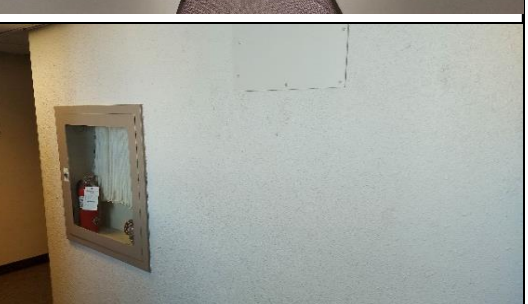
| Building / Component Name (#) | Location | Material Category | Material & Description | Homogeneous Sample Group (HSG) / Sample # | Sample I.D. | Quantity <sup>(1)</sup> | Friable | Condition | Accessibility | % Asbestos and Type | Asbestos Abatement Category | Lead Concentration (mg/kg) | Representative Photograph |
|---|---|---|---|---|---|---|---|---|---|---|---|---|---|
| 750 - 5 Street SE (DNE1, formerly EV1) | Common Areas (Corridors, Garbage Rooms, and Electrical Rooms 4 - 16th Floors) | Asbestos | Texture Coat on Wall | DNE1-A-07 | A-C | 3000 Square Feet | Moderate | Good | High | None Detected | N/A | N/A | |

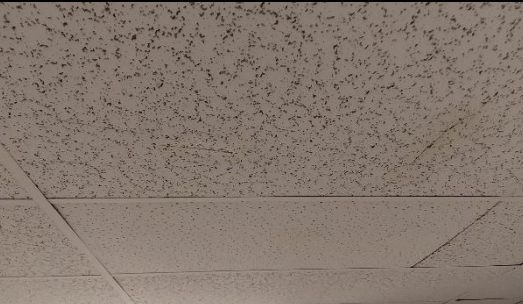
| Building / Component Name (#) | Location | Material Category | Material & Description | Homogeneous Sample Group (HSG) / Sample # | Sample I.D. | Quantity <sup>(1)</sup> | Friable | Condition | Accessibility | % Asbestos and Type | Asbestos Abatement Category | Lead Concentration (mg/kg) | Representative Photograph |
|---|---|---|---|---|---|---|---|---|---|---|---|---|---|
| 750 - 5 Street SE (DNE1, formerly EV1) | Common Areas (Corridors, Garbage Rooms, and Electrical Rooms 4 - 16th Floors) | Asbestos | 2' x 4' Multi-Directional Fissures with Pinholes Patterned Ceiling Tiles | DNE1-A-08 | A | 80 Square Feet | High | Good | Moderate | None Detected | N/A | N/A | |

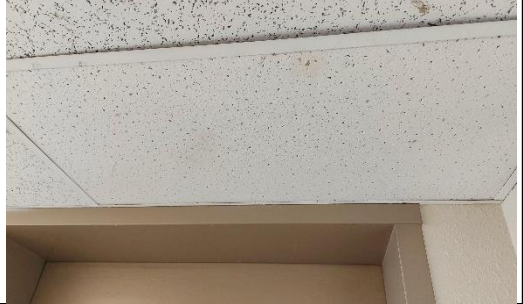
| Building / Component Name (#) | Location | Material Category | Material & Description | Homogeneous Sample Group (HSG) / Sample # | Sample I.D. | Quantity <sup>(1)</sup> | Friable | Condition | Accessibility | % Asbestos and Type | Asbestos Abatement Category | Lead Concentration (mg/kg) | Representative Photograph |
|---|---|---|---|---|---|---|---|---|---|---|---|---|---|
| 750 - 5 Street SE (DNE1, formerly EV1) | Common Areas (Corridors, Garbage Rooms, and Electrical Rooms 4 - 16th Floors) | Asbestos | 2' x 4' Sparse Multi-Directional Fissures with Pinholes Patterned Ceiling Tiles | DNE1-A-09 | A | 60 Square Feet | High | Good | Moderate | None Detected | N/A | N/A | |

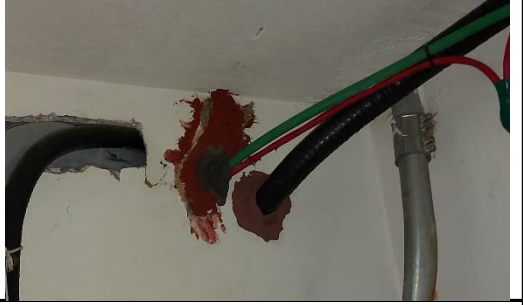
| Building / Component Name (#) | Location | Material Category | Material & Description | Homogeneous Sample Group (HSG) / Sample # | Sample I.D. | Quantity <sup>(1)</sup> | Friable | Condition | Accessibility | % Asbestos and Type | Asbestos Abatement Category | Lead Concentration (mg/kg) | Representative Photograph |
|---|---|---|---|---|---|---|---|---|---|---|---|---|---|
| 750 - 5 Street SE (DNE1, formerly EV1) | Common Areas (Corridors, Garbage Rooms, and Electrical Rooms 4 - 16th Floors) | Asbestos | Red/Brown Firestop | DNE1-A-09 | A | 20 Square Feet | Low | Good | Low | None Detected | N/A | N/A | |

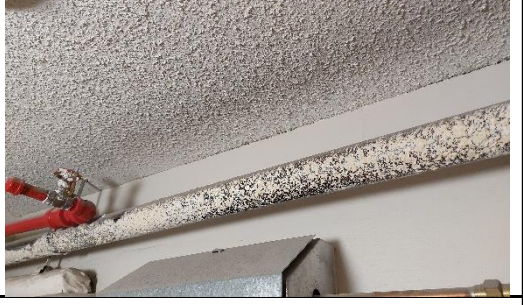
| Building / Component Name (#) | Location | Material Category | Material & Description | Homogeneous Sample Group (HSG) / Sample # | Sample I.D. | Quantity <sup>(1)</sup> | Friable | Condition | Accessibility | % Asbestos and Type | Asbestos Abatement Category | Lead Concentration (mg/kg) | Representative Photograph |
|---|---|---|---|---|---|---|---|---|---|---|---|---|---|
| 750 - 5 Street SE (DNE1, formerly EV1) | Common Areas (Corridors, Garbage Rooms, and Electrical Rooms 4 - 16th Floors) | Asbestos | Ceiling Stipple Coat | DNE1-A-11 | A, D, and E | 720 Square Feet | High | Good | Moderate | None Detected | N/A | N/A | |

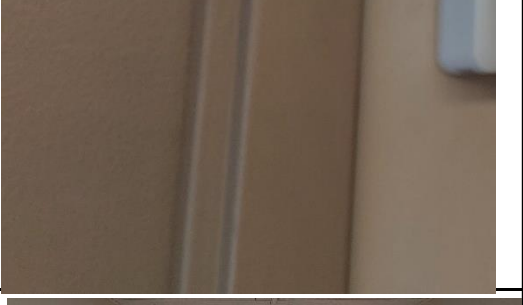
| Building / Component Name (#) | Location | Material Category | Material & Description | Homogeneous Sample Group (HSG) / Sample # | Sample I.D. | Quantity <sup>(1)</sup> | Friable | Condition | Accessibility | % Asbestos and Type | Asbestos Abatement Category | Lead Concentration (mg/kg) | Representative Photograph |
|---|---|---|---|---|---|---|---|---|---|---|---|---|---|
| 750 - 5 Street SE (DNE1, formerly EV1) | Common Areas (Corridors, Garbage Rooms, and Electrical Rooms 4 - 16th Floors) | Lead Paint | Taupe Paint on Metal | DNE1-L-03 | Reference | 11,200 Square Feet | N/A | Good | N/A | N/A | N/A | 1,360 (Considered to be lead-containing) | |

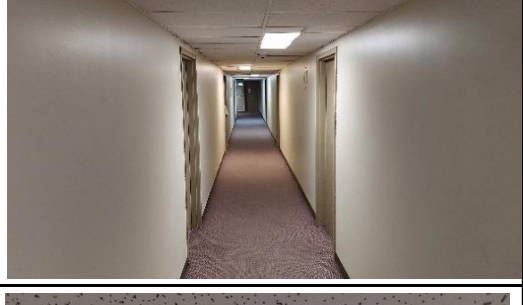
| Building / Component Name (#) | Location | Material Category | Material & Description | Homogeneous Sample Group (HSG) / Sample # | Sample I.D. | Quantity <sup>(1)</sup> | Friable | Condition | Accessibility | % Asbestos and Type | Asbestos Abatement Category | Lead Concentration (mg/kg) | Representative Photograph |
|---|---|---|---|---|---|---|---|---|---|---|---|---|---|
| 750 - 5 Street SE (DNE1, formerly EV1) | Common Areas (Corridors, Garbage Rooms, and Electrical Rooms 4 - 16th Floors) | Lead Paint | Beige Paint on Drywall | DNE1-L-04 | DNE1-L-04 | 14,000 Square Feet | N/A | Good | N/A | N/A | N/A | <5 (Not considered to be lead-containing) | |

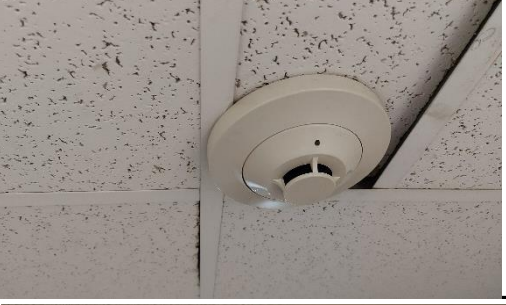
| Building / Component Name (#) | Location | Material Category | Material & Description | Homogeneous Sample Group (HSG) / Sample # | Sample I.D. | Quantity <sup>(1)</sup> | Friable | Condition | Accessibility | % Asbestos and Type | Asbestos Abatement Category | Lead Concentration (mg/kg) | Representative Photograph |
|---|---|---|---|---|---|---|---|---|---|---|---|---|---|
| 750 - 5 Street SE (DNE1, formerly EV1) | Common Areas (Corridors, Garbage Rooms, and Electrical Rooms 4 - 16th Floors) | Radioactive Materials | Radioactive Material in Smoke Detectors | N/A | N/A | 75 Each | N/A | N/A | N/A | N/A | N/A | N/A | |

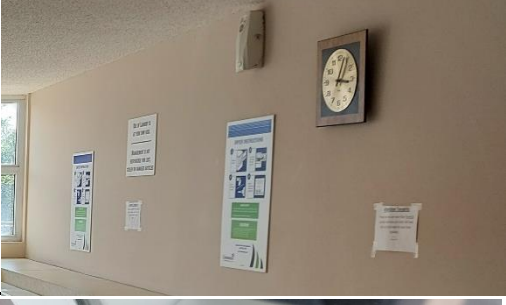
| Building / Component Name (#) | Location | Material Category | Material & Description | Homogeneous Sample Group (HSG) / Sample # | Sample I.D. | Quantity <sup>(1)</sup> | Friable | Condition | Accessibility | % Asbestos and Type | Asbestos Abatement Category | Lead Concentration (mg/kg) | Representative Photograph |
|---|---|---|---|---|---|---|---|---|---|---|---|---|---|
| 750 - 5 Street SE (DNE1, formerly EV1) | Common Areas (Corridor, Laundryroom, Community Room, Meeting Room - 3rd Floor) | Asbestos | Drywall Joint Compound on Walls | DNE1-A-01 | F and G | 3,600 Square Feet | Moderate | Good | High | None Detected | N/A | N/A | |

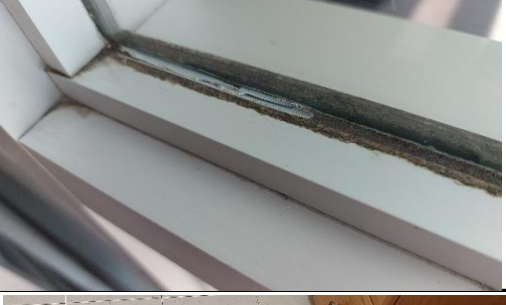
| Building / Component Name (#) | Location | Material Category | Material & Description | Homogeneous Sample Group (HSG) / Sample # | Sample I.D. | Quantity <sup>(1)</sup> | Friable | Condition | Accessibility | % Asbestos and Type | Asbestos Abatement Category | Lead Concentration (mg/kg) | Representative Photograph |
|---|---|---|---|---|---|---|---|---|---|---|---|---|---|
| 750 - 5 Street SE (DNE1, formerly EV1) | Common Areas (Corridor, Laundryroom, Community Room, Meeting Room - 3rd Floor) | Asbestos | Grey Window Glazing | DNE1-A-17 | A to C | 220 Square Feet | Low | Good | Moderate | None Detected | N/A | N/A | |

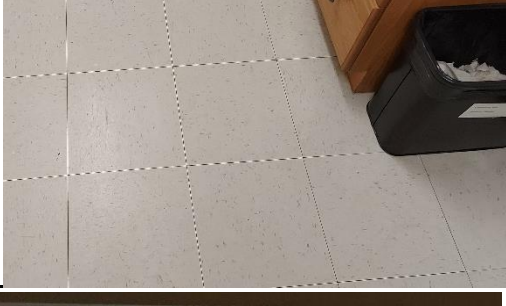
| Building / Component Name (#) | Location | Material Category | Material & Description | Homogeneous Sample Group (HSG) / Sample # | Sample I.D. | Quantity <sup>(1)</sup> | Friable | Condition | Accessibility | % Asbestos and Type | Asbestos Abatement Category | Lead Concentration (mg/kg) | Representative Photograph |
|---|---|---|---|---|---|---|---|---|---|---|---|---|---|
| 750 - 5 Street SE (DNE1, formerly EV1) | Common Areas (Corridor, Laundryroom, Community Room, Meeting Room - 3rd Floor) | Asbestos | 12" x 12" White wih Beige Flecks Patterned Vinyl Floor Tile<br>Mastic | DNE1-A-18 | A to C | 80 Square Feet | Low | Good | High | None Detected<br>None Detected | N/A | N/A | |

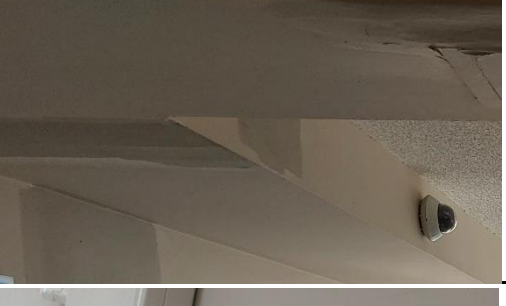
| Building / Component Name (#) | Location | Material Category | Material & Description | Homogeneous Sample Group (HSG) / Sample # | Sample I.D. | Quantity <sup>(1)</sup> | Friable | Condition | Accessibility | % Asbestos and Type | Asbestos Abatement Category | Lead Concentration (mg/kg) | Representative Photograph |
|---|---|---|---|---|---|---|---|---|---|---|---|---|---|
| 750 - 5 Street SE (DNE1, formerly EV1) | Common Areas (Corridor, Laundryroom, Community Room, Meeting Room - 3rd Floor) | Asbestos | Ceiling Stipple Coat | DNE1-A-11 | G | 160 Square Feet | High | Good | Moderate | None Detected | N/A | N/A | |

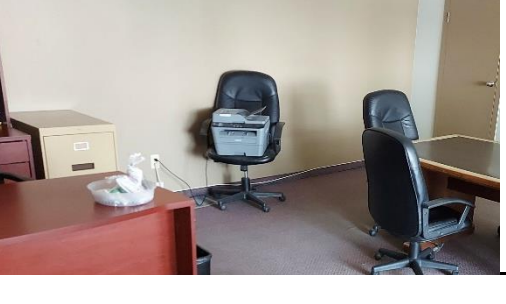
| Building / Component Name (#) | Location | Material Category | Material & Description | Homogeneous Sample Group (HSG) / Sample # | Sample I.D. | Quantity <sup>(1)</sup> | Friable | Condition | Accessibility | % Asbestos and Type | Asbestos Abatement Category | Lead Concentration (mg/kg) | Representative Photograph |
|---|---|---|---|---|---|---|---|---|---|---|---|---|---|
| 750 - 5 Street SE (DNE1, formerly EV1) | Common Areas (Corridor, Laundryroom, Community Room, Meeting Room - 3rd Floor) | Lead Paint | Beige Paint on Drywall | DNE1-L-04 | DNE1-L-04 | 14,000 Square Feet | N/A | Good | N/A | N/A | N/A | <5 (Not considered to be lead-containing) | |

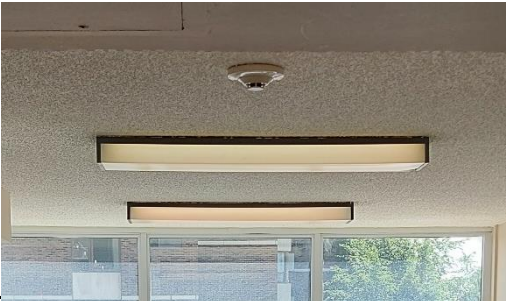
Approximately 185 fluorescent light fixtures (with T-12 style light tubes) suspected to house PCB-containing ballasts were observed in the mechanical rooms and common areas at the time of the assessment. As the lights were in operation, Golder was not able to safely inspect the light fixtures to assess the ballast code information. Additionally, fluorescent light fixtures using the newer style T-8 fluorescent light tubes were observed throughout the building. Fluorescent light fixtures using the newer T-8 style light tubes are not suspected of housing PCB-containing light ballasts.

| Building / Component Name (#) | Location | Material Category | Material & Description | Homogeneous Sample Group (HSG) / Sample # | Sample I.D. | Quantity <sup>(1)</sup> | Friable | Condition | Accessibility | % Asbestos and Type | Asbestos Abatement Category | Lead Concentration (mg/kg) | Representative Photograph |
|---|---|---|---|---|---|---|---|---|---|---|---|---|---|
| 750 - 5 Street SE (DNE1, formerly EV1) | Common Areas (Corridor, Laundryroom, Community Room, Meeting Room - 3rd Floor) | PCB | PCB-Containing Ballasts in Fluorescent Light Fixtures | N/A | N/A | 13 Each | N/A | N/A | N/A | N/A | N/A | N/A | |

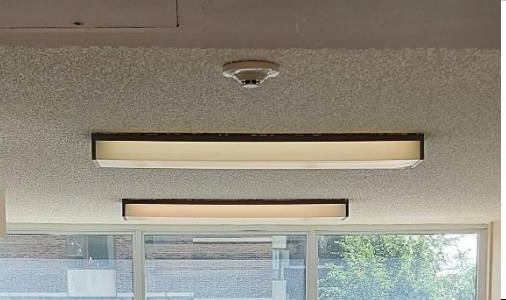
| Building / Component Name (#) | Location | Material Category | Material & Description | Homogeneous Sample Group (HSG) / Sample # | Sample I.D. | Quantity <sup>(1)</sup> | Friable | Condition | Accessibility | % Asbestos and Type | Asbestos Abatement Category | Lead Concentration (mg/kg) | Representative Photograph |
|---|---|---|---|---|---|---|---|---|---|---|---|---|---|
| 750 - 5 Street SE (DNE1, formerly EV1) | Common Areas (Corridor, Laundryroom, Community Room, Meeting Room - 3rd Floor) | Mercury | Fluorescent Light Tubes Containing Mercury-Vapour | N/A | N/A | 23 Each | N/A | N/A | N/A | N/A | N/A | N/A | |

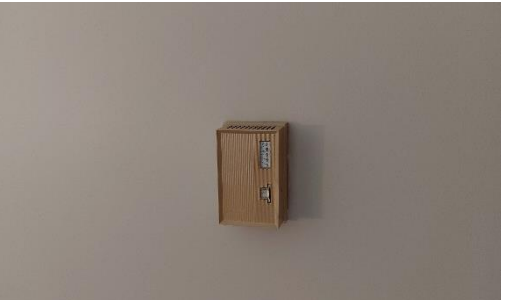
| Building / Component Name (#) | Location | Material Category | Material & Description | Homogeneous Sample Group (HSG) / Sample # | Sample I.D. | Quantity <sup>(1)</sup> | Friable | Condition | Accessibility | % Asbestos and Type | Asbestos Abatement Category | Lead Concentration (mg/kg) | Representative Photograph |
|---|---|---|---|---|---|---|---|---|---|---|---|---|---|
| 750 - 5 Street SE (DNE1, formerly EV1) | Common Areas (Corridor, Laundryroom, Community Room, Meeting Room - 3rd Floor) | Mercury | Mercury Capsules in Thermostat | N/A | N/A | 3 Each | N/A | N/A | N/A | N/A | N/A | N/A | |

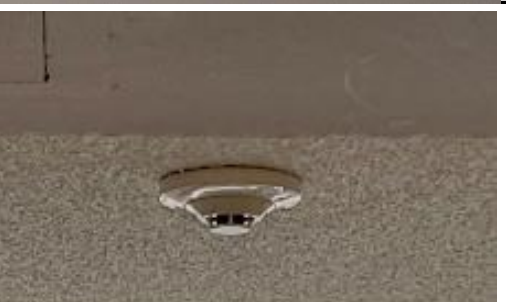
| Building / Component Name (#) | Location | Material Category | Material & Description | Homogeneous Sample Group (HSG) / Sample # | Sample I.D. | Quantity <sup>(1)</sup> | Friable | Condition | Accessibility | % Asbestos and Type | Asbestos Abatement Category | Lead Concentration (mg/kg) | Representative Photograph |
|---|---|---|---|---|---|---|---|---|---|---|---|---|---|
| 750 - 5 Street SE (DNE1, formerly EV1) | Common Areas (Corridor, Laundryroom, Community Room, Meeting Room - 3rd Floor) | Radioactive Materials | Radioactive Material in Smoke Detectors | N/A | N/A | 20 Each | N/A | N/A | N/A | N/A | N/A | N/A | |

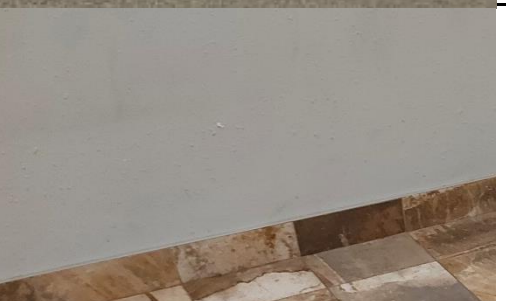
| Building / Component Name (#) | Location | Material Category | Material & Description | Homogeneous Sample Group (HSG) / Sample # | Sample I.D. | Quantity <sup>(1)</sup> | Friable | Condition | Accessibility | % Asbestos and Type | Asbestos Abatement Category | Lead Concentration (mg/kg) | Representative Photograph |
|---|---|---|---|---|---|---|---|---|---|---|---|---|---|
| 750 - 5 Street SE (DNE1, formerly EV1) | Common Areas (Lobby, Service Areas - Main Floor) | Asbestos | Drywall Joint Compound on Walls | DNE1-A-01 | Reference | 5,200 Square Feet | Moderate | Good | High | None Detected | N/A | N/A | |

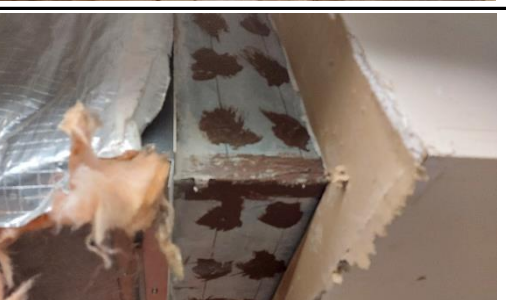
| Building / Component Name (#) | Location | Material Category | Material & Description | Homogeneous Sample Group (HSG) / Sample # | Sample I.D. | Quantity <sup>(1)</sup> | Friable | Condition | Accessibility | % Asbestos and Type | Asbestos Abatement Category | Lead Concentration (mg/kg) | Representative Photograph |
|---|---|---|---|---|---|---|---|---|---|---|---|---|---|
| 750 - 5 Street SE (DNE1, formerly EV1) | Common Areas (Lobby, Service Areas - Main Floor) | Asbestos | Brown Duct Joint Mastic | DNE1-A-20 | A | 20 Linear Feet | Low | Good | Low | None Detected | N/A | N/A | |

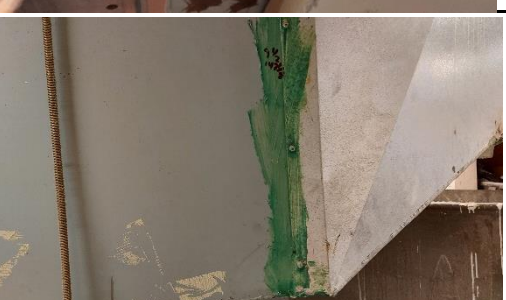
| Building / Component Name (#) | Location | Material Category | Material & Description | Homogeneous Sample Group (HSG) / Sample # | Sample I.D. | Quantity <sup>(1)</sup> | Friable | Condition | Accessibility | % Asbestos and Type | Asbestos Abatement Category | Lead Concentration (mg/kg) | Representative Photograph |
|---|---|---|---|---|---|---|---|---|---|---|---|---|---|
| 750 - 5 Street SE (DNE1, formerly EV1) | Common Areas (Lobby, Service Areas - Main Floor) | Asbestos | Green Duct Joint Mastic | DNE1-A-21 | A | 40 Linear Feet | Low | Good | Low | None Detected | N/A | N/A | |

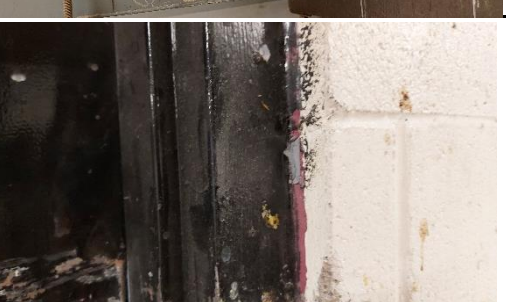
| Building / Component Name (#) | Location | Material Category | Material & Description | Homogeneous Sample Group (HSG) / Sample # | Sample I.D. | Quantity <sup>(1)</sup> | Friable | Condition | Accessibility | % Asbestos and Type | Asbestos Abatement Category | Lead Concentration (mg/kg) | Representative Photograph |
|---|---|---|---|---|---|---|---|---|---|---|---|---|---|
| 750 - 5 Street SE (DNE1, formerly EV1) | Common Areas (Lobby, Service Areas - Main Floor) | Asbestos | Grey Caulking | DNE1-A-22 | A | 30 Linear Feet | Low | Good | High | None Detected | N/A | N/A | |

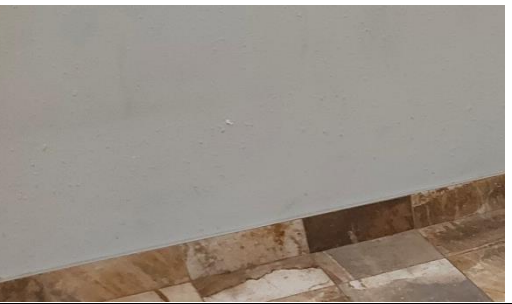
| Building / Component Name (#) | Location | Material Category | Material & Description | Homogeneous Sample Group (HSG) / Sample # | Sample I.D. | Quantity <sup>(1)</sup> | Friable | Condition | Accessibility | % Asbestos and Type | Asbestos Abatement Category | Lead Concentration (mg/kg) | Representative Photograph |
|---|---|---|---|---|---|---|---|---|---|---|---|---|---|
| 750 - 5 Street SE (DNE1, formerly EV1) | Common Areas (Lobby, Service Areas - Main Floor) | Lead Paint | Beige Paint on Drywall | DNE1-L-04 | Reference | 5,200 Square Feet | N/A | Good | N/A | N/A | N/A | <5 (Not considered to be lead-containing) | |

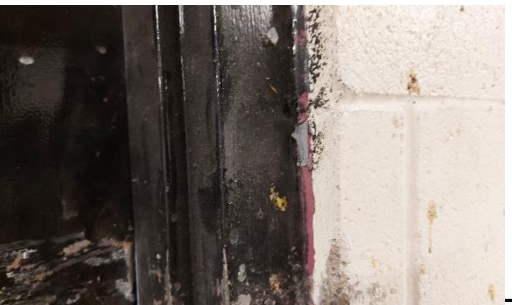
| Building / Component Name (#) | Location | Material Category | Material & Description | Homogeneous Sample Group (HSG) / Sample # | Sample I.D. | Quantity <sup>(1)</sup> | Friable | Condition | Accessibility | % Asbestos and Type | Asbestos Abatement Category | Lead Concentration (mg/kg) | Representative Photograph |
|---|---|---|---|---|---|---|---|---|---|---|---|---|---|
| 750 - 5 Street SE (DNE1, formerly EV1) | Common Areas (Lobby, Service Areas - Main Floor) | Lead Paint | lack on Metal | DNE1-L-05 | Reference | 230 Square Feet | N/A | Good | N/A | N/A | N/A | <5 (Not considered to be lead-containing) | |

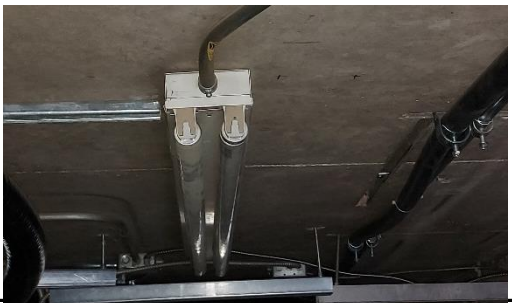
| Building / Component Name (#) | Location | Material Category | Material & Description | Homogeneous Sample Group (HSG) / Sample # | Sample I.D. | Quantity <sup>(1)</sup> | Friable | Condition | Accessibility | % Asbestos and Type | Asbestos Abatement Category | Lead Concentration (mg/kg) | Representative Photograph |
|---|---|---|---|---|---|---|---|---|---|---|---|---|---|
| 750 - 5 Street SE (DNE1, formerly EV1) | Common Areas (Lobby, Service Areas - Main Floor) | PCB | PCB-Containing Ballasts in Fluorescent Light Fixtures | N/A | N/A | 14 Each | N/A | N/A | N/A | N/A | N/A | N/A | |

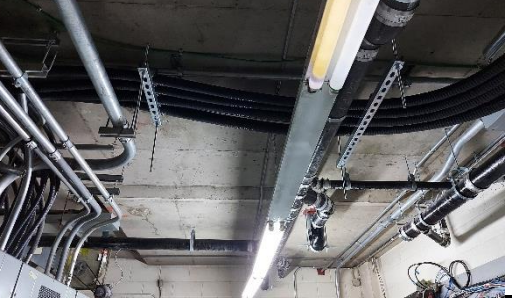
| Building / Component Name (#) | Location | Material Category | Material & Description | Homogeneous Sample Group (HSG) / Sample # | Sample I.D. | Quantity <sup>(1)</sup> | Friable | Condition | Accessibility | % Asbestos and Type | Asbestos Abatement Category | Lead Concentration (mg/kg) | Representative Photograph |
|---|---|---|---|---|---|---|---|---|---|---|---|---|---|
| 750 - 5 Street SE (DNE1, formerly EV1) | Common Areas (Lobby, Service Areas - Main Floor) | Mercury | Fluorescent Light Tubes Containing Mercury-Vapour | N/A | N/A | 80 Each | N/A | N/A | N/A | N/A | N/A | N/A | |

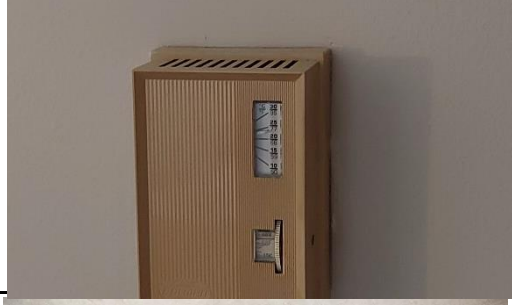
| Building / Component Name (#) | Location | Material Category | Material & Description | Homogeneous Sample Group (HSG) / Sample # | Sample I.D. | Quantity <sup>(1)</sup> | Friable | Condition | Accessibility | % Asbestos and Type | Asbestos Abatement Category | Lead Concentration (mg/kg) | Representative Photograph |
|---|---|---|---|---|---|---|---|---|---|---|---|---|---|
| 750 - 5 Street SE (DNE1, formerly EV1) | Common Areas (Lobby, Service Areas - Main Floor) | Mercury | Mercury Capsules in Thermostat | N/A | N/A | 3 Each | N/A | N/A | N/A | N/A | N/A | N/A | |

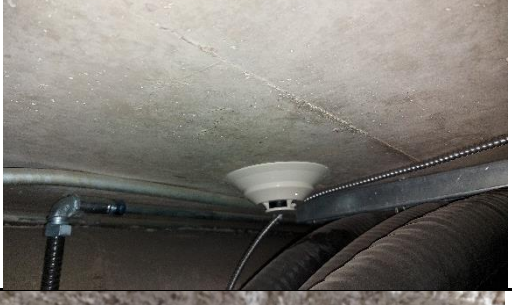
| Building / Component Name (#) | Location | Material Category | Material & Description | Homogeneous Sample Group (HSG) / Sample # | Sample I.D. | Quantity <sup>(1)</sup> | Friable | Condition | Accessibility | % Asbestos and Type | Asbestos Abatement Category | Lead Concentration (mg/kg) | Representative Photograph |
|---|---|---|---|---|---|---|---|---|---|---|---|---|---|
| 750 - 5 Street SE (DNE1, formerly EV1) | Common Areas (Lobby, Service Areas - Main Floor) | Radioactive Materials | Radioactive Material in Smoke Detectors | N/A | N/A | 9 Each | N/A | N/A | N/A | N/A | N/A | N/A | |

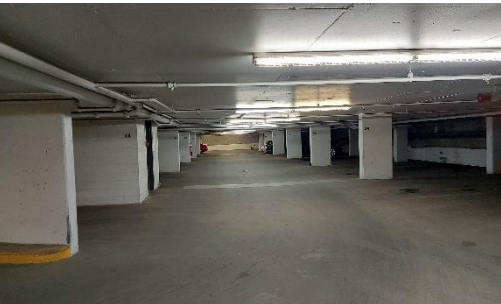
| Building / Component Name (#) | Location | Material Category | Material & Description | Homogeneous Sample Group (HSG) / Sample # | Sample I.D. | Quantity <sup>(1)</sup> | Friable | Condition | Accessibility | % Asbestos and Type | Asbestos Abatement Category | Lead Concentration (mg/kg) | Representative Photograph |
|---|---|---|---|---|---|---|---|---|---|---|---|---|---|
| 750 - 5 Street SE (DNE1, formerly EV1) | Common Area (Parkade) | Lead Paint | White Paint on Concrete | DNE1-L-06 | DNE1-L-06 | 10,900 Square Feet | N/A | Good | N/A | N/A | N/A | 14 (Not considered to be lead-containing) | |

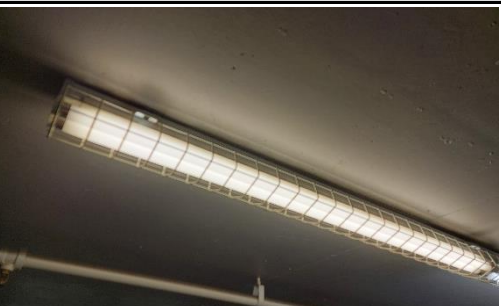
| Building / Component Name (#) | Location | Material Category | Material & Description | Homogeneous Sample Group (HSG) / Sample # | Sample I.D. | Quantity <sup>(1)</sup> | Friable | Condition | Accessibility | % Asbestos and Type | Asbestos Abatement Category | Lead Concentration (mg/kg) | Representative Photograph |
|---|---|---|---|---|---|---|---|---|---|---|---|---|---|
| 750 - 5 Street SE (DNE1, formerly EV1) | Common Area (Parkade) | Mercury | Fluorescent Light Tubes Containing Mercury-Vapour | N/A | N/A | 200 Each | N/A | N/A | N/A | N/A | N/A | N/A | |

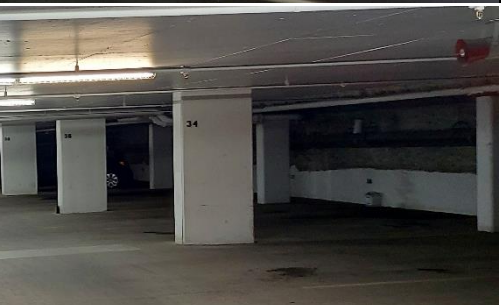
| Building / Component Name (#) | Location | Material Category | Material & Description | Homogeneous Sample Group (HSG) / Sample # | Sample I.D. | Quantity <sup>(1)</sup> | Friable | Condition | Accessibility | % Asbestos and Type | Asbestos Abatement Category | Lead Concentration (mg/kg) | Representative Photograph |
|---|---|---|---|---|---|---|---|---|---|---|---|---|---|
| 750 - 5 Street SE (DNE1, formerly EV1) | Common Area (Parkade) | Radioactive Materials | Radioactive Material in Smoke Detectors | N/A | N/A | 20 Each | N/A | N/A | N/A | N/A | N/A | N/A | |

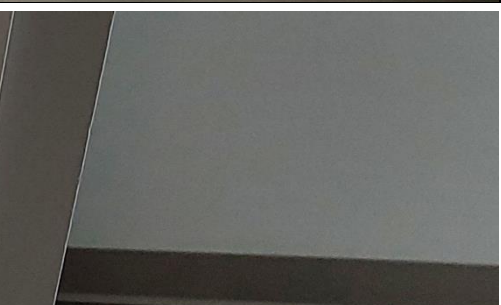
| Building / Component Name (#) | Location | Material Category | Material & Description | Homogeneous Sample Group (HSG) / Sample # | Sample I.D. | Quantity <sup>(1)</sup> | Friable | Condition | Accessibility | % Asbestos and Type | Asbestos Abatement Category | Lead Concentration (mg/kg) | Representative Photograph |
|---|---|---|---|---|---|---|---|---|---|---|---|---|---|
| 750 - 5 Street SE (DNE1, formerly EV1) | Unit 1608 | Asbestos | Drywall Joint Compound on Walls | DNE1-A-01 | C | 2,100 Square Feet | Moderate | Good | High | None Detected | N/A | N/A | |

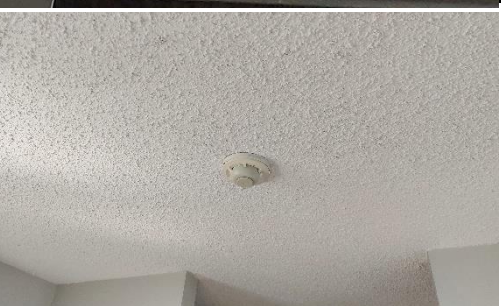
| Building / Component Name (#) | Location | Material Category | Material & Description | Homogeneous Sample Group (HSG) / Sample # | Sample I.D. | Quantity <sup>(1)</sup> | Friable | Condition | Accessibility | % Asbestos and Type | Asbestos Abatement Category | Lead Concentration (mg/kg) | Representative Photograph |
|---|---|---|---|---|---|---|---|---|---|---|---|---|---|
| 750 - 5 Street SE (DNE1, formerly EV1) | Unit 1608 | Asbestos | Ceiling Stipple Coat | DNE1-A-11 | B | 650 Square Feet | High | Good | Low | None Detected | N/A | N/A | |

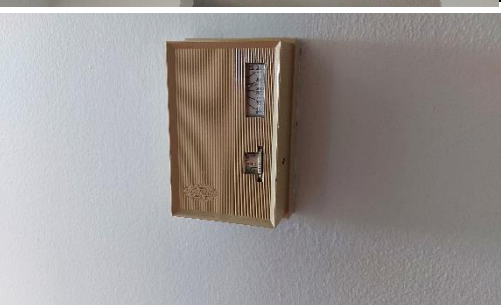
| Building / Component Name (#) | Location | Material Category | Material & Description | Homogeneous Sample Group (HSG) / Sample # | Sample I.D. | Quantity <sup>(1)</sup> | Friable | Condition | Accessibility | % Asbestos and Type | Asbestos Abatement Category | Lead Concentration (mg/kg) | Representative Photograph |
|---|---|---|---|---|---|---|---|---|---|---|---|---|---|
| 750 - 5 Street SE (DNE1, formerly EV1) | Unit 1608 | Mercury | Mercury Capsules in Thermostat | N/A | N/A | 1 Each | N/A | N/A | N/A | N/A | N/A | N/A | |

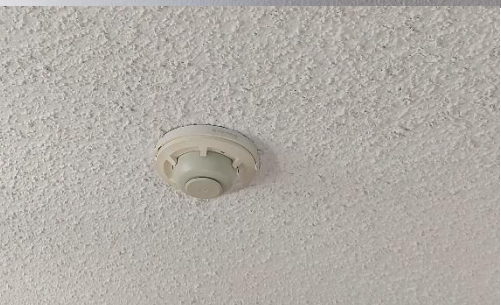
| Building / Component Name (#) | Location | Material Category | Material & Description | Homogeneous Sample Group (HSG) / Sample # | Sample I.D. | Quantity <sup>(1)</sup> | Friable | Condition | Accessibility | % Asbestos and Type | Asbestos Abatement Category | Lead Concentration (mg/kg) | Representative Photograph |
|---|---|---|---|---|---|---|---|---|---|---|---|---|---|
| 750 - 5 Street SE (DNE1, formerly EV1) | Unit 1608 | Radioactive Materials | Radioactive Material in Smoke Detectors | N/A | N/A | 1 Each | N/A | N/A | N/A | N/A | N/A | N/A | |

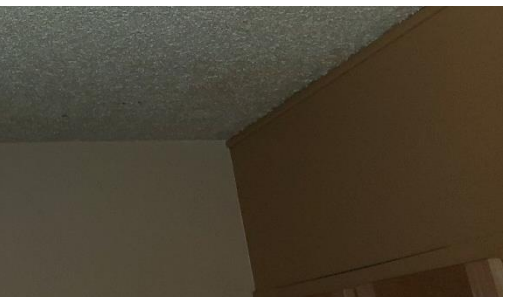
| Building / Component Name (#) | Location | Material Category | Material & Description | Homogeneous Sample Group (HSG) / Sample # | Sample I.D. | Quantity <sup>(1)</sup> | Friable | Condition | Accessibility | % Asbestos and Type | Asbestos Abatement Category | Lead Concentration (mg/kg) | Representative Photograph |
|---|---|---|---|---|---|---|---|---|---|---|---|---|---|
| 750 - 5 Street SE (DNE1, formerly EV1) | Unit 1603 | Asbestos | Drywall Joint Compound on Walls | DNE1-A-01 | Reference | 2,100 Square Feet | Moderate | Good | High | None Detected | N/A | N/A | |

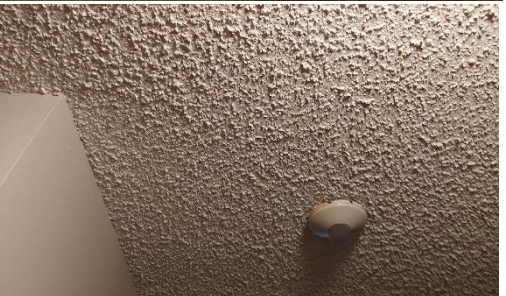
| Building / Component Name (#) | Location | Material Category | Material & Description | Homogeneous Sample Group (HSG) / Sample # | Sample I.D. | Quantity <sup>(1)</sup> | Friable | Condition | Accessibility | % Asbestos and Type | Asbestos Abatement Category | Lead Concentration (mg/kg) | Representative Photograph |
|---|---|---|---|---|---|---|---|---|---|---|---|---|---|
| 750 - 5 Street SE (DNE1, formerly EV1) | Unit 1603 | Asbestos | Ceiling Stipple Coat | DNE1-A-11 | C | 650 Square Feet | High | Good | Low | None Detected | N/A | N/A | |

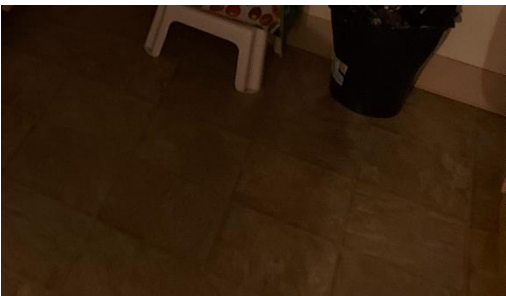
| Building / Component Name (#) | Location | Material Category | Material & Description | Homogeneous Sample Group (HSG) / Sample # | Sample I.D. | Quantity <sup>(1)</sup> | Friable | Condition | Accessibility | % Asbestos and Type | Asbestos Abatement Category | Lead Concentration (mg/kg) | Representative Photograph |
|---|---|---|---|---|---|---|---|---|---|---|---|---|---|
| 750 - 5 Street SE (DNE1, formerly EV1) | Unit 1603 | Asbestos | 9" x 9" Beige Tile Patterned Vinyl Sheet Floor | DNE1-A-12 | A | 140 Square Feet | High | Good | High | None Detected | N/A | N/A | |

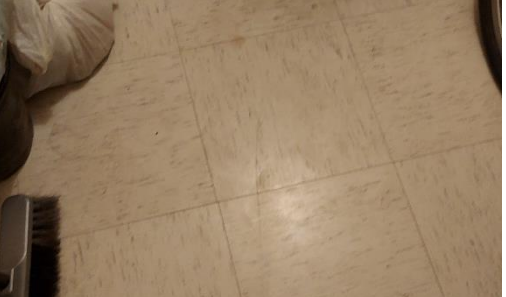
| Building / Component Name (#) | Location | Material Category | Material & Description | Homogeneous Sample Group (HSG) / Sample # | Sample I.D. | Quantity <sup>(1)</sup> | Friable | Condition | Accessibility | % Asbestos and Type | Asbestos Abatement Category | Lead Concentration (mg/kg) | Representative Photograph |
|---|---|---|---|---|---|---|---|---|---|---|---|---|---|
| 750 - 5 Street SE (DNE1, formerly EV1) | Unit 1603 | Asbestos | 12" x 12" White with Blue Streaks Patterned Vinyl Floor Tile<br>Mastic | DNE1-A-13 | A | 60 Square Feet | Low | Good | High | 5% Chrysotile<br>None Detected | Low-Risk | N/A | |

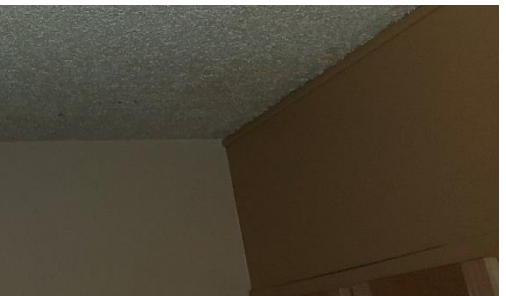
| Building / Component Name (#) | Location | Material Category | Material & Description | Homogeneous Sample Group (HSG) / Sample # | Sample I.D. | Quantity <sup>(1)</sup> | Friable | Condition | Accessibility | % Asbestos and Type | Asbestos Abatement Category | Lead Concentration (mg/kg) | Representative Photograph |
|---|---|---|---|---|---|---|---|---|---|---|---|---|---|
| 750 - 5 Street SE (DNE1, formerly EV1) | Unit 1603 | Lead Paint | Beige Paint on Drywall | DNE1-L-04 | Reference | 2,100 Square Feet | N/A | Good | N/A | N/A | N/A | <5 (Not considered to be lead-containing) | |

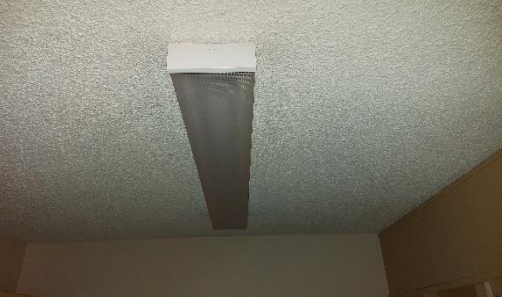
| Building / Component Name (#) | Location | Material Category | Material & Description | Homogeneous Sample Group (HSG) / Sample # | Sample I.D. | Quantity <sup>(1)</sup> | Friable | Condition | Accessibility | % Asbestos and Type | Asbestos Abatement Category | Lead Concentration (mg/kg) | Representative Photograph |
|---|---|---|---|---|---|---|---|---|---|---|---|---|---|
| 750 - 5 Street SE (DNE1, formerly EV1) | Unit 1603 | PCB | PCB-Containing Ballasts in Fluorescent Light Fixtures | N/A | N/A | 1 Each | N/A | N/A | N/A | N/A | N/A | N/A | |

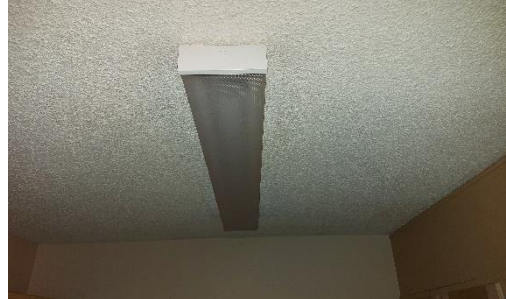
| Building / Component Name (#) | Location | Material Category | Material & Description | Homogeneous Sample Group (HSG) / Sample # | Sample I.D. | Quantity <sup>(1)</sup> | Friable | Condition | Accessibility | % Asbestos and Type | Asbestos Abatement Category | Lead Concentration (mg/kg) | Representative Photograph |
|---|---|---|---|---|---|---|---|---|---|---|---|---|---|
| 750 - 5 Street SE (DNE1, formerly EV1) | Unit 1603 | Mercury | Fluorescent Light Tubes Containing Mercury-Vapour | N/A | N/A | 2 Each | N/A | N/A | N/A | N/A | N/A | N/A | |

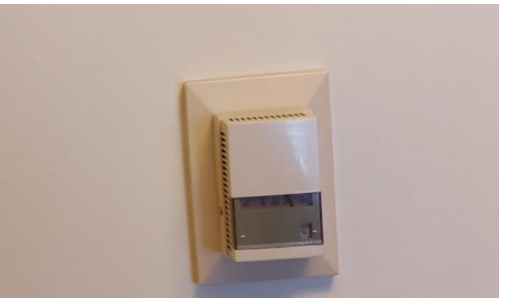
| Building / Component Name (#) | Location | Material Category | Material & Description | Homogeneous Sample Group (HSG) / Sample # | Sample I.D. | Quantity <sup>(1)</sup> | Friable | Condition | Accessibility | % Asbestos and Type | Asbestos Abatement Category | Lead Concentration (mg/kg) | Representative Photograph |
|---|---|---|---|---|---|---|---|---|---|---|---|---|---|
| 750 - 5 Street SE (DNE1, formerly EV1) | Unit 1603 | Mercury | Mercury Capsules in Thermostat | N/A | N/A | 1 Each | N/A | N/A | N/A | N/A | N/A | N/A | |

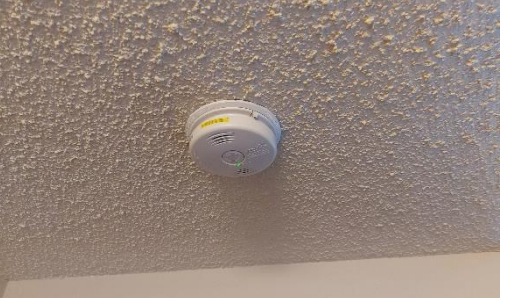
| Building / Component Name (#) | Location | Material Category | Material & Description | Homogeneous Sample Group (HSG) / Sample # | Sample I.D. | Quantity <sup>(1)</sup> | Friable | Condition | Accessibility | % Asbestos and Type | Asbestos Abatement Category | Lead Concentration (mg/kg) | Representative Photograph |
|---|---|---|---|---|---|---|---|---|---|---|---|---|---|
| 750 - 5 Street SE (DNE1, formerly EV1) | Unit 1603 | Radioactive Materials | Radioactive Material in Smoke Detectors | N/A | N/A | 1 Each | N/A | N/A | N/A | N/A | N/A | N/A | |

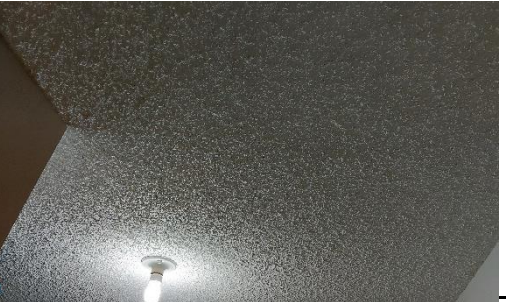
| Building / Component Name (#) | Location | Material Category | Material & Description | Homogeneous Sample Group (HSG) / Sample # | Sample I.D. | Quantity <sup>(1)</sup> | Friable | Condition | Accessibility | % Asbestos and Type | Asbestos Abatement Category | Lead Concentration (mg/kg) | Representative Photograph |
|---|---|---|---|---|---|---|---|---|---|---|---|---|---|
| 750 - 5 Street SE (DNE1, formerly EV1) | Unit 1511 | Asbestos | Ceiling Stipple Coat | DNE1-A-11 | Reference | 650 Square Feet | High | Good | Low | None Detected | N/A | N/A | |

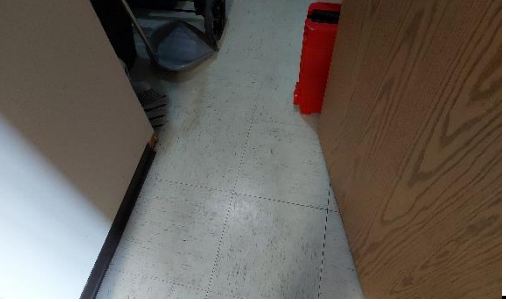
| Building / Component Name (#) | Location | Material Category | Material & Description | Homogeneous Sample Group (HSG) / Sample # | Sample I.D. | Quantity <sup>(1)</sup> | Friable | Condition | Accessibility | % Asbestos and Type | Asbestos Abatement Category | Lead Concentration (mg/kg) | Representative Photograph |
|---|---|---|---|---|---|---|---|---|---|---|---|---|---|
| 750 - 5 Street SE (DNE1, formerly EV1) | Unit 1511 | Asbestos | 12" x 12" White with Blue Streaks Patterned Vinyl Floor Tile | DNE1-A-13 | B | 60 Square Feet | Low | Good | High | 5% Chrysotile | Low-Risk | N/A | |

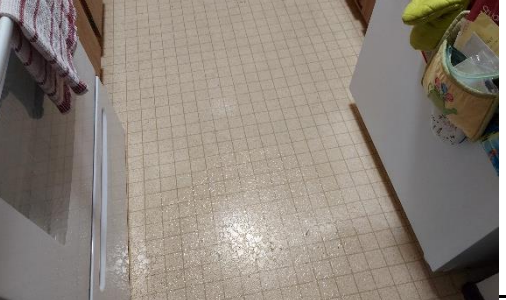
| Building / Component Name (#) | Location | Material Category | Material & Description | Homogeneous Sample Group (HSG) / Sample # | Sample I.D. | Quantity <sup>(1)</sup> | Friable | Condition | Accessibility | % Asbestos and Type | Asbestos Abatement Category | Lead Concentration (mg/kg) | Representative Photograph |
|---|---|---|---|---|---|---|---|---|---|---|---|---|---|
| 750 - 5 Street SE (DNE1, formerly EV1) | Unit 1511 | Asbestos | 2" x 2" Tile Patterned Vinyl Sheet Floor | DNE1-A-14 | A | 60 Square Feet | High | Good | High | 20% Chrysotile | Moderate-Risk | N/A | |

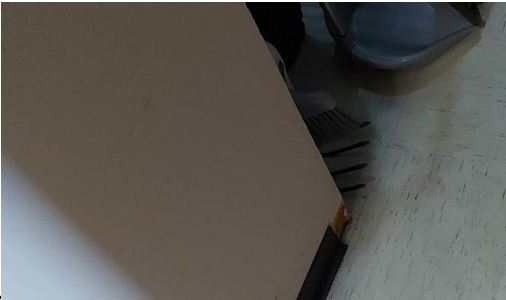
| Building / Component Name (#) | Location | Material Category | Material & Description | Homogeneous Sample Group (HSG) / Sample # | Sample I.D. | Quantity <sup>(1)</sup> | Friable | Condition | Accessibility | % Asbestos and Type | Asbestos Abatement Category | Lead Concentration (mg/kg) | Representative Photograph |
|---|---|---|---|---|---|---|---|---|---|---|---|---|---|
| 750 - 5 Street SE (DNE1, formerly EV1) | Unit 1511 | Lead Paint | Beige Paint on Drywall | DNE1-L-04 | Reference | 2,100 Square Feet | N/A | Good | N/A | N/A | N/A | <5 (Not considered to be lead-containing) | |

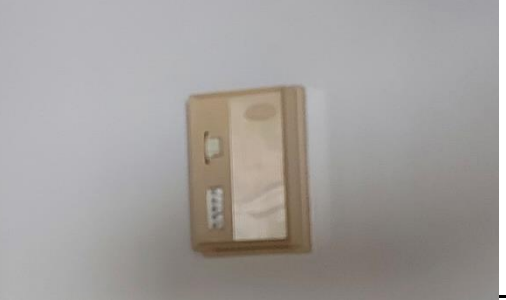
| Building / Component Name (#) | Location | Material Category | Material & Description | Homogeneous Sample Group (HSG) / Sample # | Sample I.D. | Quantity <sup>(1)</sup> | Friable | Condition | Accessibility | % Asbestos and Type | Asbestos Abatement Category | Lead Concentration (mg/kg) | Representative Photograph |
|---|---|---|---|---|---|---|---|---|---|---|---|---|---|
| 750 - 5 Street SE (DNE1, formerly EV1) | Unit 1511 | Mercury | Mercury Capsules in Thermostat | N/A | N/A | 1 Each | N/A | N/A | N/A | N/A | N/A | N/A | |

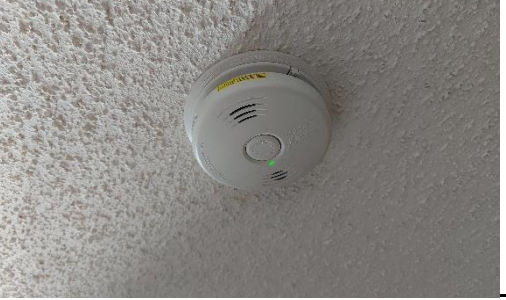
| Building / Component Name (#) | Location | Material Category | Material & Description | Homogeneous Sample Group (HSG) / Sample # | Sample I.D. | Quantity <sup>(1)</sup> | Friable | Condition | Accessibility | % Asbestos and Type | Asbestos Abatement Category | Lead Concentration (mg/kg) | Representative Photograph |
|---|---|---|---|---|---|---|---|---|---|---|---|---|---|
| 750 - 5 Street SE (DNE1, formerly EV1) | Unit 1511 | Radioactive Materials | Radioactive Material in Smoke Detectors | N/A | N/A | 1 Each | N/A | N/A | N/A | N/A | N/A | N/A | |

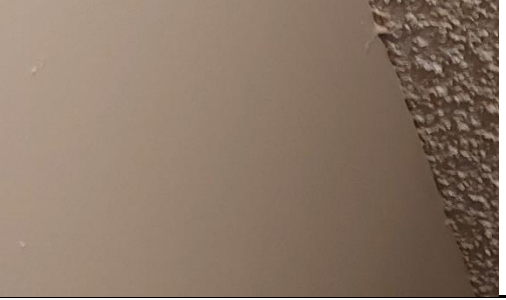
| Building / Component Name (#) | Location | Material Category | Material & Description | Homogeneous Sample Group (HSG) / Sample # | Sample I.D. | Quantity <sup>(1)</sup> | Friable | Condition | Accessibility | % Asbestos and Type | Asbestos Abatement Category | Lead Concentration (mg/kg) | Representative Photograph |
|---|---|---|---|---|---|---|---|---|---|---|---|---|---|
| 750 - 5 Street SE (DNE1, formerly EV1) | Unit 1405 | Asbestos | Drywall Joint Compound on Walls | DNE1-A-01 | Reference | 2,100 Square Feet | Moderate | Good | High | None Detected | N/A | N/A | |

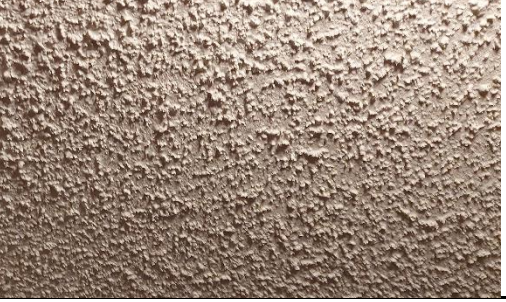
| Building / Component Name (#) | Location | Material Category | Material & Description | Homogeneous Sample Group (HSG) / Sample # | Sample I.D. | Quantity <sup>(1)</sup> | Friable | Condition | Accessibility | % Asbestos and Type | Asbestos Abatement Category | Lead Concentration (mg/kg) | Representative Photograph |
|---|---|---|---|---|---|---|---|---|---|---|---|---|---|
| 750 - 5 Street SE (DNE1, formerly EV1) | Unit 1405 | Asbestos | Ceiling Stipple Coat | DNE1-A-11 | Reference | 650 Square Feet | High | Good | Low | None Detected | N/A | N/A | |

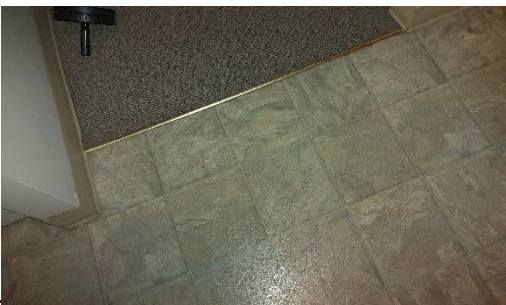
| Building / Component Name (#) | Location | Material Category | Material & Description | Homogeneous Sample Group (HSG) / Sample # | Sample I.D. | Quantity <sup>(1)</sup> | Friable | Condition | Accessibility | % Asbestos and Type | Asbestos Abatement Category | Lead Concentration (mg/kg) | Representative Photograph |
|---|---|---|---|---|---|---|---|---|---|---|---|---|---|
| 750 - 5 Street SE (DNE1, formerly EV1) | Unit 1405 | Asbestos | 9" x 9" Beige Tile Patterned Vinyl Sheet Floor | DNE1-A-12 | Reference | 140 Square Feet | High | Good | High | None Detected | N/A | N/A | |

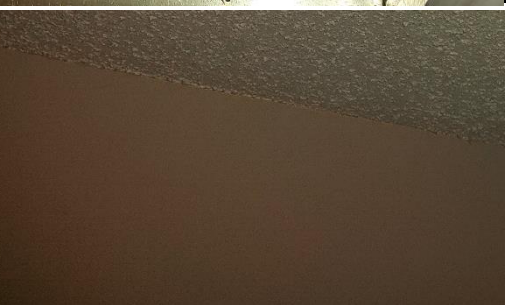
| Building / Component Name (#) | Location | Material Category | Material & Description | Homogeneous Sample Group (HSG) / Sample # | Sample I.D. | Quantity <sup>(1)</sup> | Friable | Condition | Accessibility | % Asbestos and Type | Asbestos Abatement Category | Lead Concentration (mg/kg) | Representative Photograph |
|---|---|---|---|---|---|---|---|---|---|---|---|---|---|
| 750 - 5 Street SE (DNE1, formerly EV1) | Unit 1405 | Lead Paint | Beige Paint on Drywall | DNE1-L-04 | Reference | 2,100 Square Feet | N/A | Good | N/A | N/A | N/A | <5 (Not considered to be lead-containing) | |

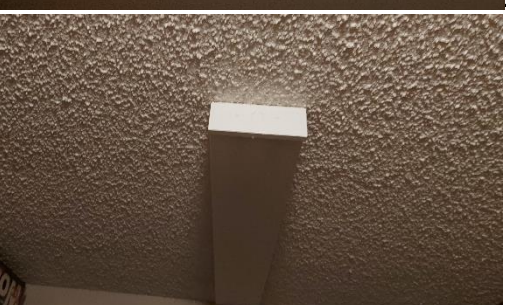
| Building / Component Name (#) | Location | Material Category | Material & Description | Homogeneous Sample Group (HSG) / Sample # | Sample I.D. | Quantity <sup>(1)</sup> | Friable | Condition | Accessibility | % Asbestos and Type | Asbestos Abatement Category | Lead Concentration (mg/kg) | Representative Photograph |
|---|---|---|---|---|---|---|---|---|---|---|---|---|---|
| 750 - 5 Street SE (DNE1, formerly EV1) | Unit 1405 | PCB | PCB-Containing Ballasts in Fluorescent Light Fixtures | N/A | N/A | 1 Each | N/A | N/A | N/A | N/A | N/A | N/A | |

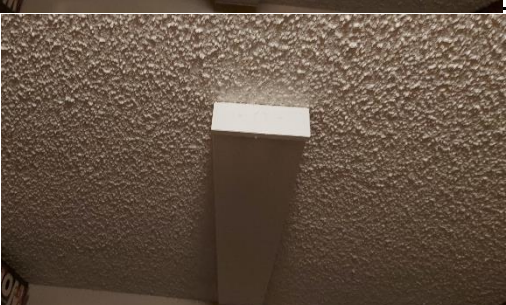
| Building / Component Name (#) | Location | Material Category | Material & Description | Homogeneous Sample Group (HSG) / Sample # | Sample I.D. | Quantity <sup>(1)</sup> | Friable | Condition | Accessibility | % Asbestos and Type | Asbestos Abatement Category | Lead Concentration (mg/kg) | Representative Photograph |
|---|---|---|---|---|---|---|---|---|---|---|---|---|---|
| 750 - 5 Street SE (DNE1, formerly EV1) | Unit 1405 | Mercury | Fluorescent Light Tubes Containing Mercury-Vapour | N/A | N/A | 2 Each | N/A | N/A | N/A | N/A | N/A | N/A | |
