# Hazardous Building Materials Assessment, Property DNE1 formerly EV1, Calgary Housing Company

750 5 Street NE, Calgary, Alberta

*Assessment Completed: August 18 and September 13, 2021*

4 February 2022

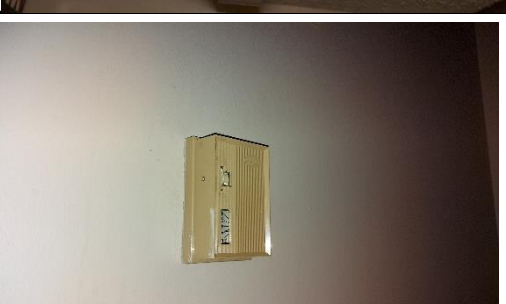
| Building / Component Name (#) | Location | Material Category | Material & Description | Homogeneous Sample Group (HSG) / Sample # | Sample I.D. | Quantity <sup>(1)</sup> | Friable | Condition | Accessibility | % Asbestos and Type | Asbestos Abatement Category | Lead Concentration (mg/kg) | Representative Photograph |
|---|---|---|---|---|---|---|---|---|---|---|---|---|---|
| 750 - 5 Street SE (DNE1, formerly EV1) | Unit 1405 | Mercury | Mercury Capsules in Thermostat | N/A | N/A | 1 Each | N/A | N/A | N/A | N/A | N/A | N/A | |

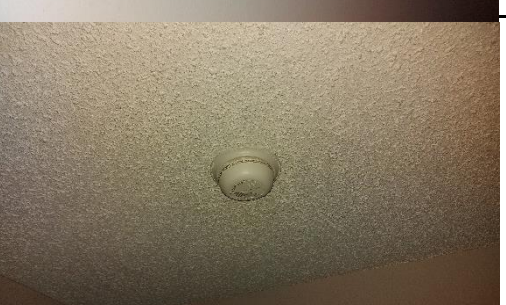
| Building / Component Name (#) | Location | Material Category | Material & Description | Homogeneous Sample Group (HSG) / Sample # | Sample I.D. | Quantity <sup>(1)</sup> | Friable | Condition | Accessibility | % Asbestos and Type | Asbestos Abatement Category | Lead Concentration (mg/kg) | Representative Photograph |
|---|---|---|---|---|---|---|---|---|---|---|---|---|---|
| 750 - 5 Street SE (DNE1, formerly EV1) | Unit 1405 | Radioactive Materials | Radioactive Material in Smoke Detectors | N/A | N/A | 1 Each | N/A | N/A | N/A | N/A | N/A | N/A | |

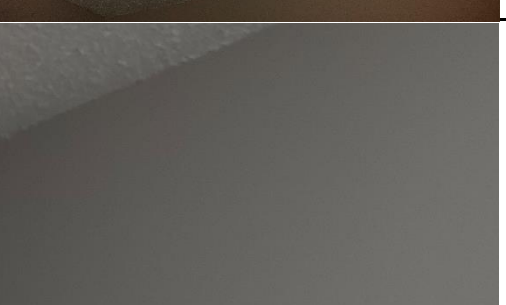
| Building / Component Name (#) | Location | Material Category | Material & Description | Homogeneous Sample Group (HSG) / Sample # | Sample I.D. | Quantity <sup>(1)</sup> | Friable | Condition | Accessibility | % Asbestos and Type | Asbestos Abatement Category | Lead Concentration (mg/kg) | Representative Photograph |
|---|---|---|---|---|---|---|---|---|---|---|---|---|---|
| 750 - 5 Street SE (DNE1, formerly EV1) | Unit 1214 | Asbestos | Drywall Joint Compound on Walls | DNE1-A-01 | E | 2,100 Square Feet | Moderate | Good | High | None Detected | N/A | N/A | |

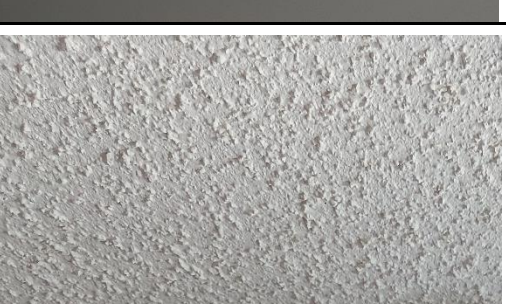
| Building / Component Name (#) | Location | Material Category | Material & Description | Homogeneous Sample Group (HSG) / Sample # | Sample I.D. | Quantity <sup>(1)</sup> | Friable | Condition | Accessibility | % Asbestos and Type | Asbestos Abatement Category | Lead Concentration (mg/kg) | Representative Photograph |
|---|---|---|---|---|---|---|---|---|---|---|---|---|---|
| 750 - 5 Street SE (DNE1, formerly EV1) | Unit 1214 | Asbestos | Ceiling Stipple Coat | DNE1-A-11 | F | 650 Square Feet | High | Good | Low | None Detected | N/A | N/A | |

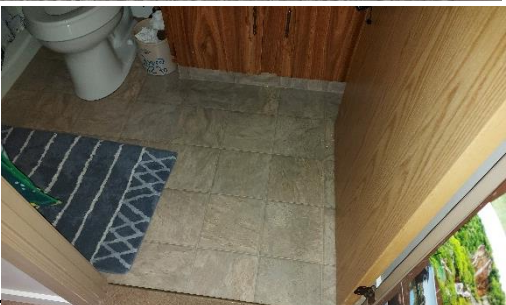
| Building / Component Name (#) | Location | Material Category | Material & Description | Homogeneous Sample Group (HSG) / Sample # | Sample I.D. | Quantity <sup>(1)</sup> | Friable | Condition | Accessibility | % Asbestos and Type | Asbestos Abatement Category | Lead Concentration (mg/kg) | Representative Photograph |
|---|---|---|---|---|---|---|---|---|---|---|---|---|---|
| 750 - 5 Street SE (DNE1, formerly EV1) | Unit 1214 | Asbestos | 9" x 9" Beige Tile Patterned Vinyl Sheet Floor | DNE1-A-12 | B | 140 Square Feet | High | Good | High | None Detected | N/A | N/A | |

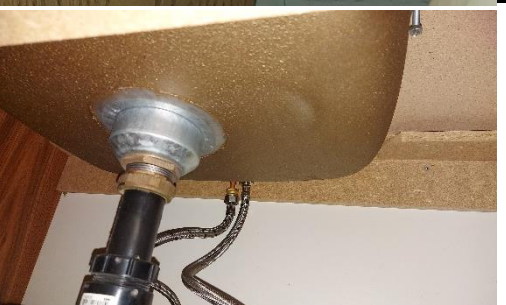
| Building / Component Name (#) | Location | Material Category | Material & Description | Homogeneous Sample Group (HSG) / Sample # | Sample I.D. | Quantity <sup>(1)</sup> | Friable | Condition | Accessibility | % Asbestos and Type | Asbestos Abatement Category | Lead Concentration (mg/kg) | Representative Photograph |
|---|---|---|---|---|---|---|---|---|---|---|---|---|---|
| 750 - 5 Street SE (DNE1, formerly EV1) | Unit 1214 | Asbestos | Brown Acoustic Sink Insulation | DNE1-A-24 | A | 1 Each | Low | Good | High | 5% Chrysotile | Low-Risk | N/A | |

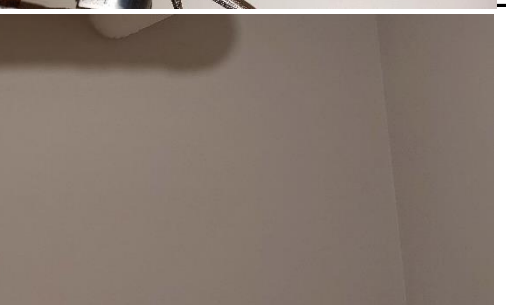
| Building / Component Name (#) | Location | Material Category | Material & Description | Homogeneous Sample Group (HSG) / Sample # | Sample I.D. | Quantity <sup>(1)</sup> | Friable | Condition | Accessibility | % Asbestos and Type | Asbestos Abatement Category | Lead Concentration (mg/kg) | Representative Photograph |
|---|---|---|---|---|---|---|---|---|---|---|---|---|---|
| 750 - 5 Street SE (DNE1, formerly EV1) | Unit 1214 | Lead Paint | Beige Paint on Drywall | DNE1-L-04 | Reference | 2,100 Square Feet | N/A | Good | N/A | N/A | N/A | <5 (Not considered to be lead-containing) | |

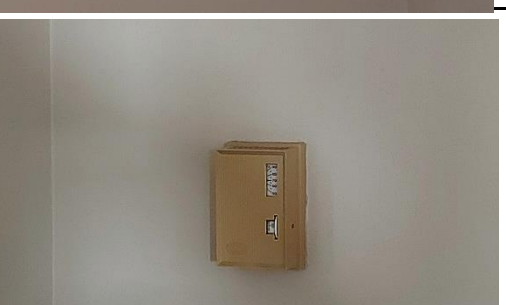
| Building / Component Name (#) | Location | Material Category | Material & Description | Homogeneous Sample Group (HSG) / Sample # | Sample I.D. | Quantity <sup>(1)</sup> | Friable | Condition | Accessibility | % Asbestos and Type | Asbestos Abatement Category | Lead Concentration (mg/kg) | Representative Photograph |
|---|---|---|---|---|---|---|---|---|---|---|---|---|---|
| 750 - 5 Street SE (DNE1, formerly EV1) | Unit 1214 | Mercury | Mercury Capsules in Thermostat | N/A | N/A | 1 Each | N/A | N/A | N/A | N/A | N/A | N/A | |

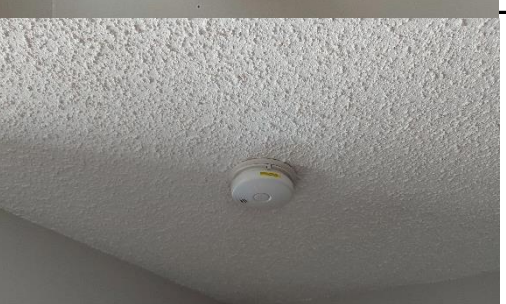
| Building / Component Name (#) | Location | Material Category | Material & Description | Homogeneous Sample Group (HSG) / Sample # | Sample I.D. | Quantity <sup>(1)</sup> | Friable | Condition | Accessibility | % Asbestos and Type | Asbestos Abatement Category | Lead Concentration (mg/kg) | Representative Photograph |
|---|---|---|---|---|---|---|---|---|---|---|---|---|---|
| 750 - 5 Street SE (DNE1, formerly EV1) | Unit 1214 | Radioactive Materials | Radioactive Material in Smoke Detectors | N/A | N/A | 1 Each | N/A | N/A | N/A | N/A | N/A | N/A | |

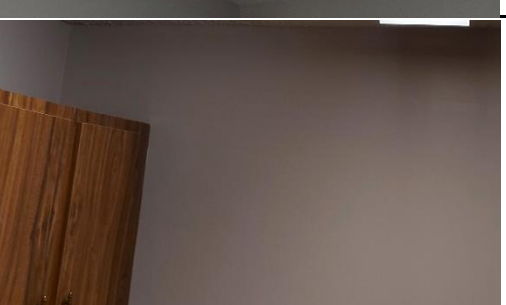
| Building / Component Name (#) | Location | Material Category | Material & Description | Homogeneous Sample Group (HSG) / Sample # | Sample I.D. | Quantity <sup>(1)</sup> | Friable | Condition | Accessibility | % Asbestos and Type | Asbestos Abatement Category | Lead Concentration (mg/kg) | Representative Photograph |
|---|---|---|---|---|---|---|---|---|---|---|---|---|---|
| 750 - 5 Street SE (DNE1, formerly EV1) | Unit 1102 | Asbestos | Drywall Joint Compound on Walls | DNE1-A-01 | Reference | 2,100 Square Feet | Moderate | Good | High | None Detected | N/A | N/A | |

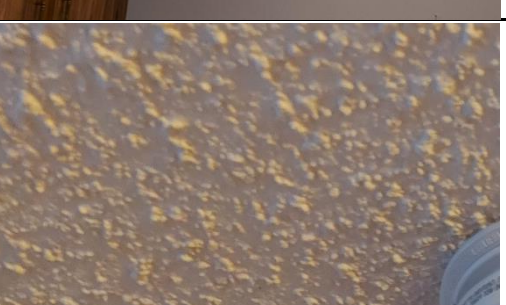
| Building / Component Name (#) | Location | Material Category | Material & Description | Homogeneous Sample Group (HSG) / Sample # | Sample I.D. | Quantity <sup>(1)</sup> | Friable | Condition | Accessibility | % Asbestos and Type | Asbestos Abatement Category | Lead Concentration (mg/kg) | Representative Photograph |
|---|---|---|---|---|---|---|---|---|---|---|---|---|---|
| 750 - 5 Street SE (DNE1, formerly EV1) | Unit 1102 | Asbestos | Ceiling Stipple Coat | DNE1-A-11 | Reference | 650 Square Feet | High | Good | Low | None Detected | N/A | N/A | |

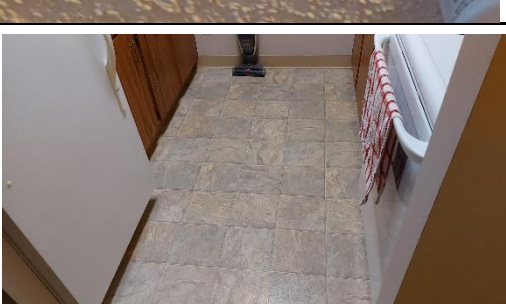
| Building / Component Name (#) | Location | Material Category | Material & Description | Homogeneous Sample Group (HSG) / Sample # | Sample I.D. | Quantity <sup>(1)</sup> | Friable | Condition | Accessibility | % Asbestos and Type | Asbestos Abatement Category | Lead Concentration (mg/kg) | Representative Photograph |
|---|---|---|---|---|---|---|---|---|---|---|---|---|---|
| 750 - 5 Street SE (DNE1, formerly EV1) | Unit 1102 | Asbestos | 9" x 9" Beige Tile Patterned Vinyl Sheet Floor | DNE1-A-12 | Reference | 140 Square Feet | High | Good | High | None Detected | N/A | N/A | |

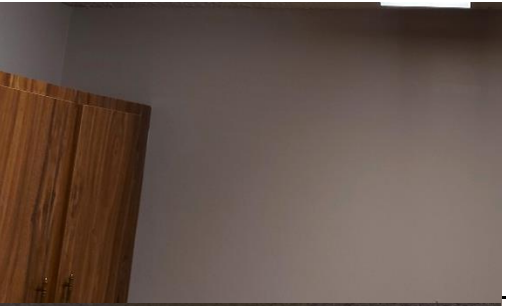
| Building / Component Name (#) | Location | Material Category | Material & Description | Homogeneous Sample Group (HSG) / Sample # | Sample I.D. | Quantity <sup>(1)</sup> | Friable | Condition | Accessibility | % Asbestos and Type | Asbestos Abatement Category | Lead Concentration (mg/kg) | Representative Photograph |
|---|---|---|---|---|---|---|---|---|---|---|---|---|---|
| 750 - 5 Street SE (DNE1, formerly EV1) | Unit 1102 | Lead Paint | Beige Paint on Drywall | DNE1-L-04 | Reference | 2,100 Square Feet | N/A | Good | N/A | N/A | N/A | <5 (Not considered to be lead-containing) | |

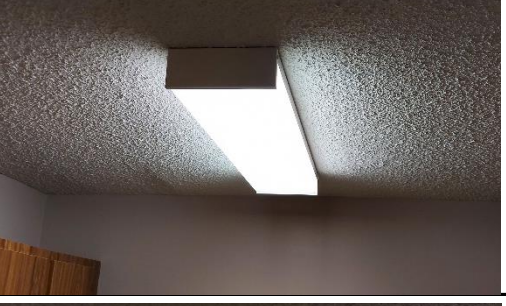
| Building / Component Name (#) | Location | Material Category | Material & Description | Homogeneous Sample Group (HSG) / Sample # | Sample I.D. | Quantity <sup>(1)</sup> | Friable | Condition | Accessibility | % Asbestos and Type | Asbestos Abatement Category | Lead Concentration (mg/kg) | Representative Photograph |
|---|---|---|---|---|---|---|---|---|---|---|---|---|---|
| 750 - 5 Street SE (DNE1, formerly EV1) | Unit 1102 | PCB | PCB-Containing Ballasts in Fluorescent Light Fixtures | N/A | N/A | 1 Each | N/A | N/A | N/A | N/A | N/A | N/A | |

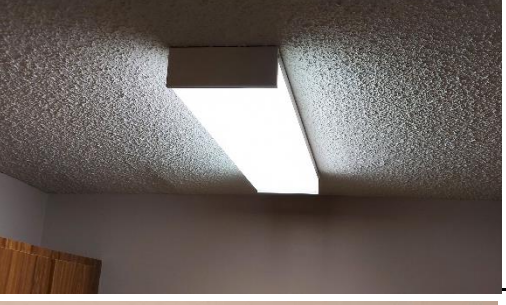
| Building / Component Name (#) | Location | Material Category | Material & Description | Homogeneous Sample Group (HSG) / Sample # | Sample I.D. | Quantity <sup>(1)</sup> | Friable | Condition | Accessibility | % Asbestos and Type | Asbestos Abatement Category | Lead Concentration (mg/kg) | Representative Photograph |
|---|---|---|---|---|---|---|---|---|---|---|---|---|---|
| 750 - 5 Street SE (DNE1, formerly EV1) | Unit 1102 | Mercury | Fluorescent Light Tubes Containing Mercury-Vapour | N/A | N/A | 2 Each | N/A | N/A | N/A | N/A | N/A | N/A | |

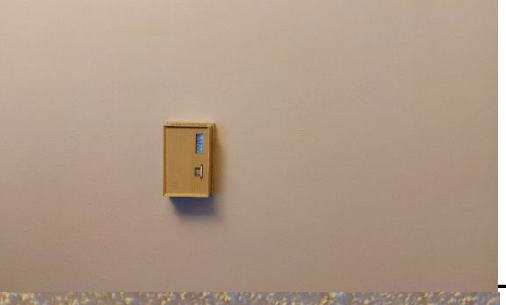
| Building / Component Name (#) | Location | Material Category | Material & Description | Homogeneous Sample Group (HSG) / Sample # | Sample I.D. | Quantity <sup>(1)</sup> | Friable | Condition | Accessibility | % Asbestos and Type | Asbestos Abatement Category | Lead Concentration (mg/kg) | Representative Photograph |
|---|---|---|---|---|---|---|---|---|---|---|---|---|---|
| 750 - 5 Street SE (DNE1, formerly EV1) | Unit 1102 | Mercury | Mercury Capsules in Thermostat | N/A | N/A | 1 Each | N/A | N/A | N/A | N/A | N/A | N/A | |

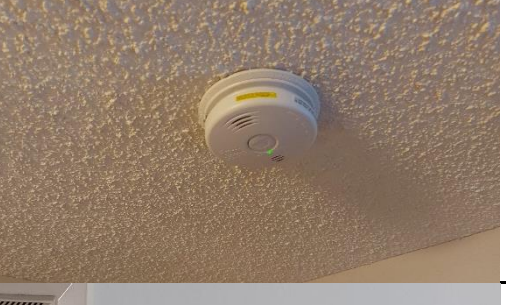
| Building / Component Name (#) | Location | Material Category | Material & Description | Homogeneous Sample Group (HSG) / Sample # | Sample I.D. | Quantity <sup>(1)</sup> | Friable | Condition | Accessibility | % Asbestos and Type | Asbestos Abatement Category | Lead Concentration (mg/kg) | Representative Photograph |
|---|---|---|---|---|---|---|---|---|---|---|---|---|---|
| 750 - 5 Street SE (DNE1, formerly EV1) | Unit 1102 | Radioactive Materials | Radioactive Material in Smoke Detectors | N/A | N/A | 1 Each | N/A | N/A | N/A | N/A | N/A | N/A | |

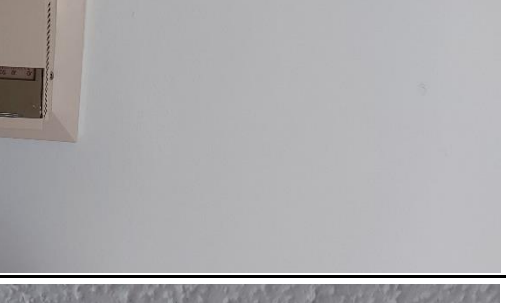
| Building / Component Name (#) | Location | Material Category | Material & Description | Homogeneous Sample Group (HSG) / Sample # | Sample I.D. | Quantity <sup>(1)</sup> | Friable | Condition | Accessibility | % Asbestos and Type | Asbestos Abatement Category | Lead Concentration (mg/kg) | Representative Photograph |
|---|---|---|---|---|---|---|---|---|---|---|---|---|---|
| 750 - 5 Street SE (DNE1, formerly EV1) | Unit 1004 | Asbestos | Drywall Joint Compound on Walls | DNE1-A-01 | Reference | 2,100 Square Feet | Moderate | Good | High | None Detected | N/A | N/A | |

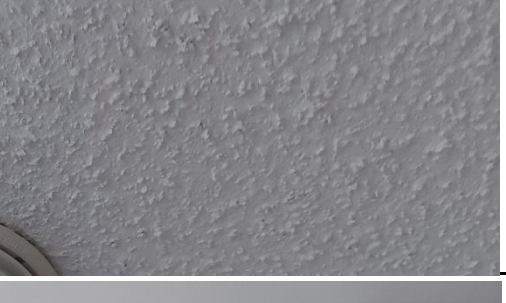
| Building / Component Name (#) | Location | Material Category | Material & Description | Homogeneous Sample Group (HSG) / Sample # | Sample I.D. | Quantity <sup>(1)</sup> | Friable | Condition | Accessibility | % Asbestos and Type | Asbestos Abatement Category | Lead Concentration (mg/kg) | Representative Photograph |
|---|---|---|---|---|---|---|---|---|---|---|---|---|---|
| 750 - 5 Street SE (DNE1, formerly EV1) | Unit 1004 | Asbestos | Ceiling Stipple Coat | DNE1-A-11 | Reference | 650 Square Feet | High | Good | Low | None Detected | N/A | N/A | |

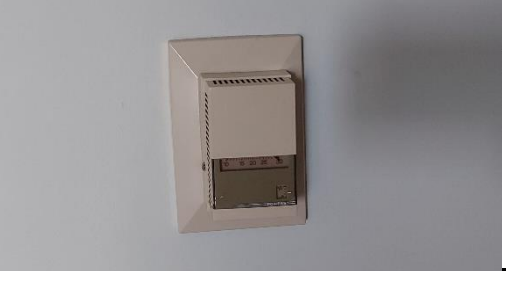
| Building / Component Name (#) | Location | Material Category | Material & Description | Homogeneous Sample Group (HSG) / Sample # | Sample I.D. | Quantity <sup>(1)</sup> | Friable | Condition | Accessibility | % Asbestos and Type | Asbestos Abatement Category | Lead Concentration (mg/kg) | Representative Photograph |
|---|---|---|---|---|---|---|---|---|---|---|---|---|---|
| 750 - 5 Street SE (DNE1, formerly EV1) | Unit 1004 | Mercury | Mercury Capsules in Thermostat | N/A | N/A | 1 Each | N/A | N/A | N/A | N/A | N/A | N/A | |

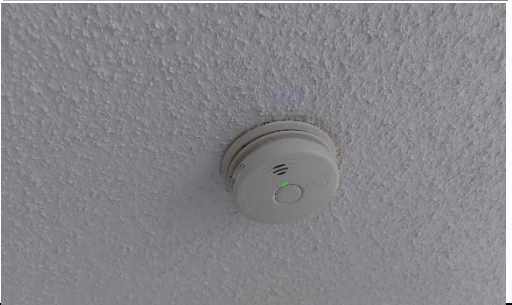
| Building / Component Name (#) | Location | Material Category | Material & Description | Homogeneous Sample Group (HSG) / Sample # | Sample I.D. | Quantity <sup>(1)</sup> | Friable | Condition | Accessibility | % Asbestos and Type | Asbestos Abatement Category | Lead Concentration (mg/kg) | Representative Photograph |
|---|---|---|---|---|---|---|---|---|---|---|---|---|---|
| 750 - 5 Street SE (DNE1, formerly EV1) | Unit 1004 | Radioactive Materials | Radioactive Material in Smoke Detectors | N/A | N/A | 1 Each | N/A | N/A | N/A | N/A | N/A | N/A | |

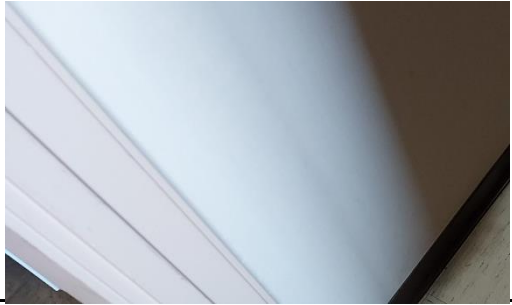
| Building / Component Name (#) | Location | Material Category | Material & Description | Homogeneous Sample Group (HSG) / Sample # | Sample I.D. | Quantity <sup>(1)</sup> | Friable | Condition | Accessibility | % Asbestos and Type | Asbestos Abatement Category | Lead Concentration (mg/kg) | Representative Photograph |
|---|---|---|---|---|---|---|---|---|---|---|---|---|---|
| 750 - 5 Street SE (DNE1, formerly EV1) | Unit 910 | Asbestos | Drywall Joint Compound on Walls | DNE1-A-01 | Reference | 2,100 Square Feet | Moderate | Good | High | None Detected | N/A | N/A | |

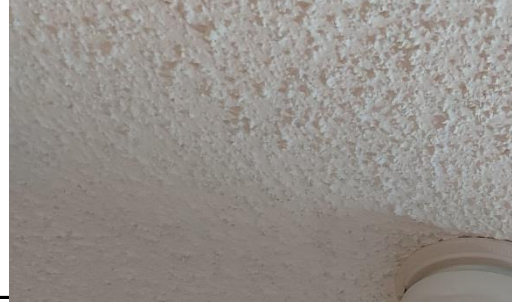
| Building / Component Name (#) | Location | Material Category | Material & Description | Homogeneous Sample Group (HSG) / Sample # | Sample I.D. | Quantity <sup>(1)</sup> | Friable | Condition | Accessibility | % Asbestos and Type | Asbestos Abatement Category | Lead Concentration (mg/kg) | Representative Photograph |
|---|---|---|---|---|---|---|---|---|---|---|---|---|---|
| 750 - 5 Street SE (DNE1, formerly EV1) | Unit 910 | Asbestos | Ceiling Stipple Coat | DNE1-A-11 | Reference | 650 Square Feet | High | Good | Low | None Detected | N/A | N/A | |

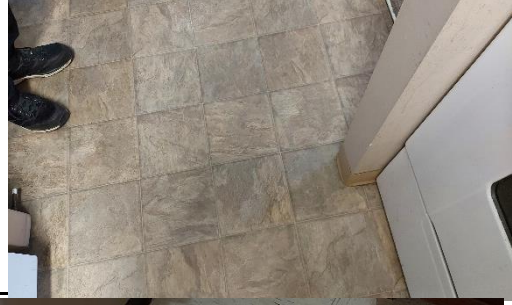
| Building / Component Name (#) | Location | Material Category | Material & Description | Homogeneous Sample Group (HSG) / Sample # | Sample I.D. | Quantity <sup>(1)</sup> | Friable | Condition | Accessibility | % Asbestos and Type | Asbestos Abatement Category | Lead Concentration (mg/kg) | Representative Photograph |
|---|---|---|---|---|---|---|---|---|---|---|---|---|---|
| 750 - 5 Street SE (DNE1, formerly EV1) | Unit 910 | Asbestos | 9" x 9" Beige Tile Patterned Vinyl Sheet Floor | DNE1-A-12 | Reference | 70 Square Feet | High | Good | High | None Detected | N/A | N/A | |

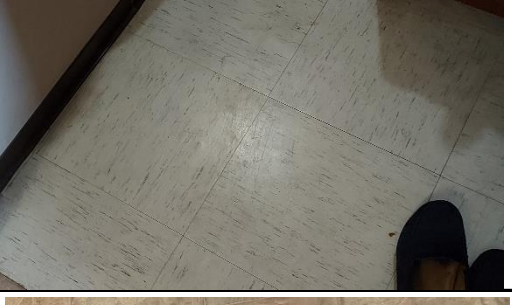
| Building / Component Name (#) | Location | Material Category | Material & Description | Homogeneous Sample Group (HSG) / Sample # | Sample I.D. | Quantity <sup>(1)</sup> | Friable | Condition | Accessibility | % Asbestos and Type | Asbestos Abatement Category | Lead Concentration (mg/kg) | Representative Photograph |
|---|---|---|---|---|---|---|---|---|---|---|---|---|---|
| 750 - 5 Street SE (DNE1, formerly EV1) | Unit 910 | Asbestos | 12" x 12" White with Blue Streaks Patterned Vinyl Floor Tile<br>Mastic | DNE1-A-13 | Reference | 35 Square Feet | Low | Good | High | 5% Chrysotile<br>None Detected | Low-Risk | N/A | |

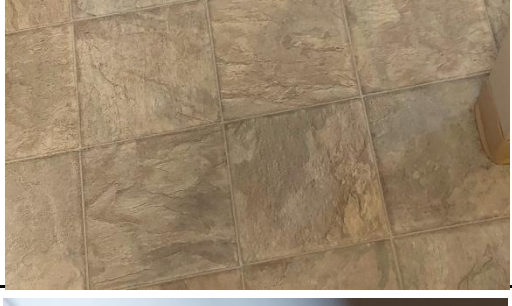
| Building / Component Name (#) | Location | Material Category | Material & Description | Homogeneous Sample Group (HSG) / Sample # | Sample I.D. | Quantity <sup>(1)</sup> | Friable | Condition | Accessibility | % Asbestos and Type | Asbestos Abatement Category | Lead Concentration (mg/kg) | Representative Photograph |
|---|---|---|---|---|---|---|---|---|---|---|---|---|---|
| 750 - 5 Street SE (DNE1, formerly EV1) | Unit 910 | Asbestos | 6" x 6" Tile Patterned Vinyl Sheet Floor | DNE1-A-15 | A | 40 Square Feet | Low | Good | High | None Detected | N/A | N/A | |

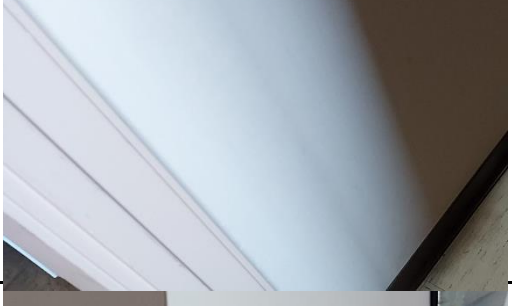
| Building / Component Name (#) | Location | Material Category | Material & Description | Homogeneous Sample Group (HSG) / Sample # | Sample I.D. | Quantity <sup>(1)</sup> | Friable | Condition | Accessibility | % Asbestos and Type | Asbestos Abatement Category | Lead Concentration (mg/kg) | Representative Photograph |
|---|---|---|---|---|---|---|---|---|---|---|---|---|---|
| 750 - 5 Street SE (DNE1, formerly EV1) | Unit 910 | Lead Paint | Beige Paint on Drywall | DNE1-L-04 | Reference | 2,100 Square Feet | N/A | Good | N/A | N/A | N/A | <5 (Not considered to be lead-containing) | |

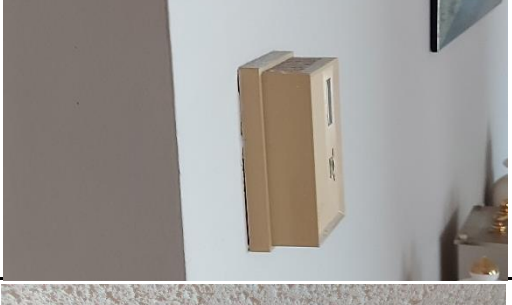
| Building / Component Name (#) | Location | Material Category | Material & Description | Homogeneous Sample Group (HSG) / Sample # | Sample I.D. | Quantity <sup>(1)</sup> | Friable | Condition | Accessibility | % Asbestos and Type | Asbestos Abatement Category | Lead Concentration (mg/kg) | Representative Photograph |
|---|---|---|---|---|---|---|---|---|---|---|---|---|---|
| 750 - 5 Street SE (DNE1, formerly EV1) | Unit 910 | Mercury | Mercury Capsules in Thermostat | N/A | N/A | 1 Each | N/A | N/A | N/A | N/A | N/A | N/A | |

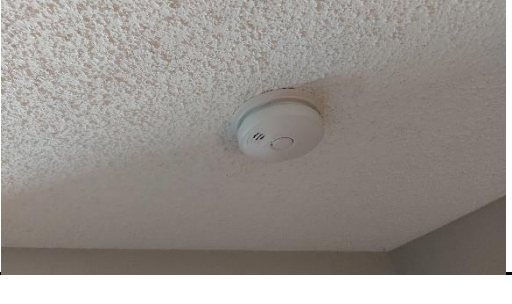
| Building / Component Name (#) | Location | Material Category | Material & Description | Homogeneous Sample Group (HSG) / Sample # | Sample I.D. | Quantity <sup>(1)</sup> | Friable | Condition | Accessibility | % Asbestos and Type | Asbestos Abatement Category | Lead Concentration (mg/kg) | Representative Photograph |
|---|---|---|---|---|---|---|---|---|---|---|---|---|---|
| 750 - 5 Street SE (DNE1, formerly EV1) | Unit 910 | Radioactive Materials | Radioactive Material in Smoke Detectors | N/A | N/A | 1 Each | N/A | N/A | N/A | N/A | N/A | N/A | |

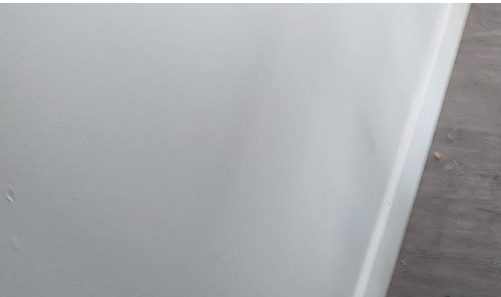
| Building / Component Name (#) | Location | Material Category | Material & Description | Homogeneous Sample Group (HSG) / Sample # | Sample I.D. | Quantity <sup>(1)</sup> | Friable | Condition | Accessibility | % Asbestos and Type | Asbestos Abatement Category | Lead Concentration (mg/kg) | Representative Photograph |
|---|---|---|---|---|---|---|---|---|---|---|---|---|---|
| 750 - 5 Street SE (DNE1, formerly EV1) | Unit 708 | Asbestos | Drywall Joint Compound on Walls | DNE1-A-01 | Reference | 2,100 Square Feet | Moderate | Good | High | None Detected | N/A | N/A | |

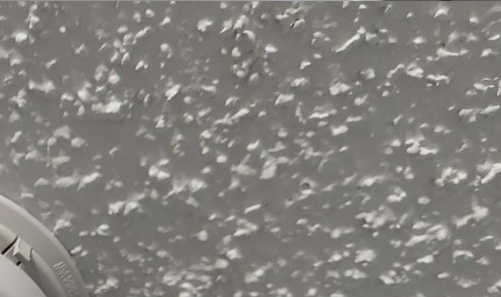
| Building / Component Name (#) | Location | Material Category | Material & Description | Homogeneous Sample Group (HSG) / Sample # | Sample I.D. | Quantity <sup>(1)</sup> | Friable | Condition | Accessibility | % Asbestos and Type | Asbestos Abatement Category | Lead Concentration (mg/kg) | Representative Photograph |
|---|---|---|---|---|---|---|---|---|---|---|---|---|---|
| 750 - 5 Street SE (DNE1, formerly EV1) | Unit 708 | Asbestos | Ceiling Stipple Coat | DNE1-A-11 | Reference | 650 Square Feet | High | Good | Low | None Detected | N/A | N/A | |

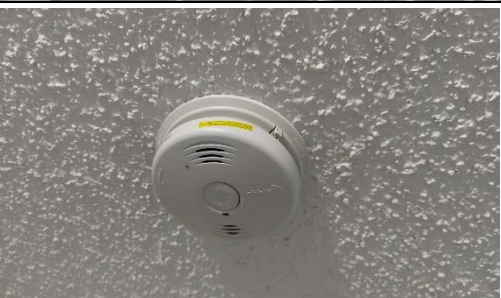
| Building / Component Name (#) | Location | Material Category | Material & Description | Homogeneous Sample Group (HSG) / Sample # | Sample I.D. | Quantity <sup>(1)</sup> | Friable | Condition | Accessibility | % Asbestos and Type | Asbestos Abatement Category | Lead Concentration (mg/kg) | Representative Photograph |
|---|---|---|---|---|---|---|---|---|---|---|---|---|---|
| 750 - 5 Street SE (DNE1, formerly EV1) | Unit 708 | Radioactive Materials | Radioactive Material in Smoke Detectors | N/A | N/A | 1 Each | N/A | N/A | N/A | N/A | N/A | N/A | |

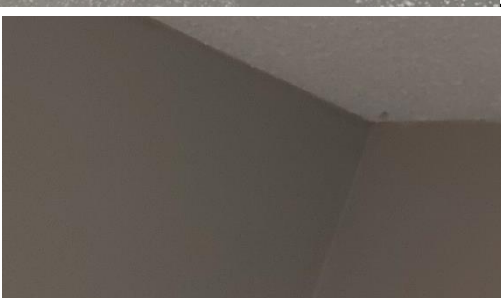
| Building / Component Name (#) | Location | Material Category | Material & Description | Homogeneous Sample Group (HSG) / Sample # | Sample I.D. | Quantity <sup>(1)</sup> | Friable | Condition | Accessibility | % Asbestos and Type | Asbestos Abatement Category | Lead Concentration (mg/kg) | Representative Photograph |
|---|---|---|---|---|---|---|---|---|---|---|---|---|---|
| 750 - 5 Street SE (DNE1, formerly EV1) | Unit 612 | Asbestos | Drywall Joint Compound on Walls | DNE1-A-01 | Reference | 2,100 Square Feet | Moderate | Good | High | None Detected | N/A | N/A | |

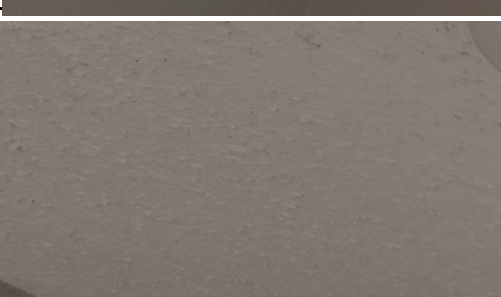
| Building / Component Name (#) | Location | Material Category | Material & Description | Homogeneous Sample Group (HSG) / Sample # | Sample I.D. | Quantity <sup>(1)</sup> | Friable | Condition | Accessibility | % Asbestos and Type | Asbestos Abatement Category | Lead Concentration (mg/kg) | Representative Photograph |
|---|---|---|---|---|---|---|---|---|---|---|---|---|---|
| 750 - 5 Street SE (DNE1, formerly EV1) | Unit 612 | Asbestos | Ceiling Stipple Coat | DNE1-A-11 | Reference | 650 Square Feet | High | Good | Low | None Detected | N/A | N/A | |

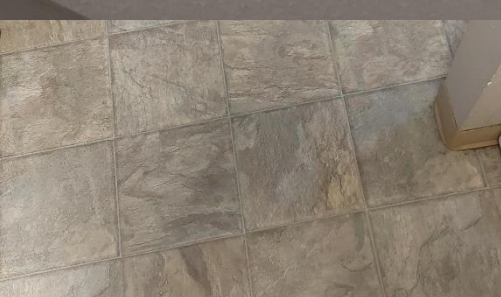
| Building / Component Name (#) | Location | Material Category | Material & Description | Homogeneous Sample Group (HSG) / Sample # | Sample I.D. | Quantity <sup>(1)</sup> | Friable | Condition | Accessibility | % Asbestos and Type | Asbestos Abatement Category | Lead Concentration (mg/kg) | Representative Photograph |
|---|---|---|---|---|---|---|---|---|---|---|---|---|---|
| 750 - 5 Street SE (DNE1, formerly EV1) | Unit 612 | Asbestos | 9" x 9" Beige Tile Patterned Vinyl Sheet Floor | DNE1-A-12 | Reference | 170 Square Feet | High | Good | High | None Detected | N/A | N/A | |

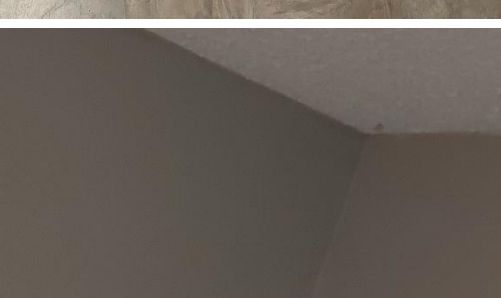
| Building / Component Name (#) | Location | Material Category | Material & Description | Homogeneous Sample Group (HSG) / Sample # | Sample I.D. | Quantity <sup>(1)</sup> | Friable | Condition | Accessibility | % Asbestos and Type | Asbestos Abatement Category | Lead Concentration (mg/kg) | Representative Photograph |
|---|---|---|---|---|---|---|---|---|---|---|---|---|---|
| 750 - 5 Street SE (DNE1, formerly EV1) | Unit 612 | Lead Paint | Beige Paint on Drywall | DNE1-L-04 | Reference | 2,100 Square Feet | N/A | Good | N/A | N/A | N/A | <5 (Not considered to be lead-containing) | |

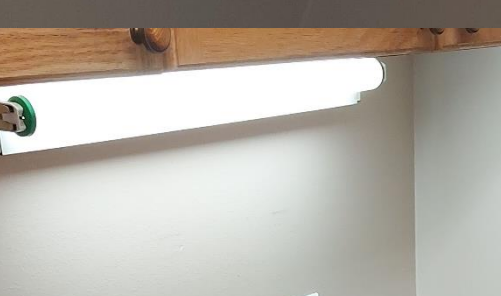
| Building / Component Name (#) | Location | Material Category | Material & Description | Homogeneous Sample Group (HSG) / Sample # | Sample I.D. | Quantity <sup>(1)</sup> | Friable | Condition | Accessibility | % Asbestos and Type | Asbestos Abatement Category | Lead Concentration (mg/kg) | Representative Photograph |
|---|---|---|---|---|---|---|---|---|---|---|---|---|---|
| 750 - 5 Street SE (DNE1, formerly EV1) | Unit 612 | PCB | PCB-Containing Ballasts in Fluorescent Light Fixtures | N/A | N/A | 2 Each | N/A | N/A | N/A | N/A | N/A | N/A | |

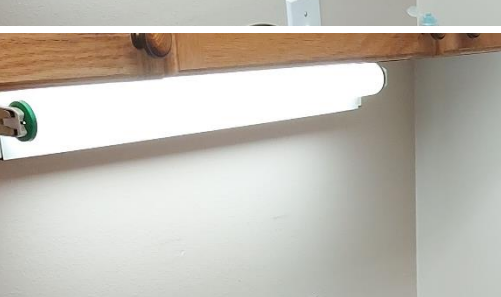
| Building / Component Name (#) | Location | Material Category | Material & Description | Homogeneous Sample Group (HSG) / Sample # | Sample I.D. | Quantity <sup>(1)</sup> | Friable | Condition | Accessibility | % Asbestos and Type | Asbestos Abatement Category | Lead Concentration (mg/kg) | Representative Photograph |
|---|---|---|---|---|---|---|---|---|---|---|---|---|---|
| 750 - 5 Street SE (DNE1, formerly EV1) | Unit 612 | Mercury | Fluorescent Light Tubes Containing Mercury-Vapour | N/A | N/A | 3 Each | N/A | N/A | N/A | N/A | N/A | N/A | |

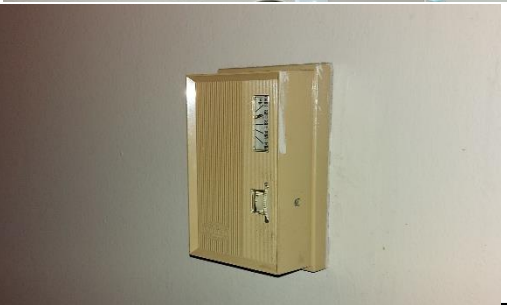
| Building / Component Name (#) | Location | Material Category | Material & Description | Homogeneous Sample Group (HSG) / Sample # | Sample I.D. | Quantity <sup>(1)</sup> | Friable | Condition | Accessibility | % Asbestos and Type | Asbestos Abatement Category | Lead Concentration (mg/kg) | Representative Photograph |
|---|---|---|---|---|---|---|---|---|---|---|---|---|---|
| 750 - 5 Street SE (DNE1, formerly EV1) | Unit 612 | Mercury | Mercury Capsules in Thermostat | N/A | N/A | 1 Each | N/A | N/A | N/A | N/A | N/A | N/A | |

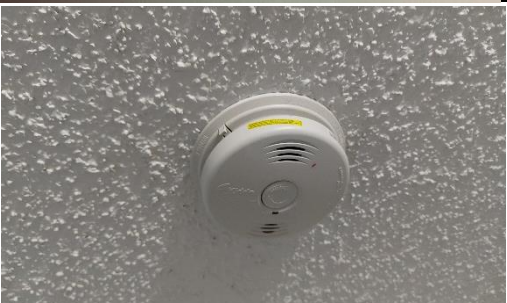
| Building / Component Name (#) | Location | Material Category | Material & Description | Homogeneous Sample Group (HSG) / Sample # | Sample I.D. | Quantity <sup>(1)</sup> | Friable | Condition | Accessibility | % Asbestos and Type | Asbestos Abatement Category | Lead Concentration (mg/kg) | Representative Photograph |
|---|---|---|---|---|---|---|---|---|---|---|---|---|---|
| 750 - 5 Street SE (DNE1, formerly EV1) | Unit 612 | Radioactive Materials | Radioactive Material in Smoke Detectors | N/A | N/A | 1 Each | N/A | N/A | N/A | N/A | N/A | N/A | |

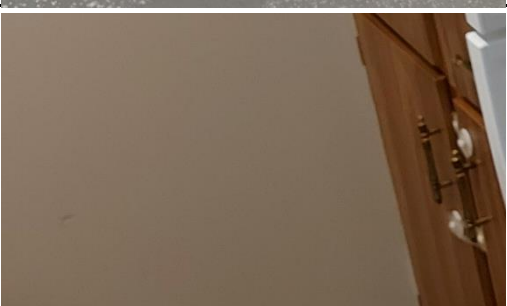
| Building / Component Name (#) | Location | Material Category | Material & Description | Homogeneous Sample Group (HSG) / Sample # | Sample I.D. | Quantity <sup>(1)</sup> | Friable | Condition | Accessibility | % Asbestos and Type | Asbestos Abatement Category | Lead Concentration (mg/kg) | Representative Photograph |
|---|---|---|---|---|---|---|---|---|---|---|---|---|---|
| 750 - 5 Street SE (DNE1, formerly EV1) | Unit 607 | Asbestos | Drywall Joint Compound on Walls | DNE1-A-01 | Reference | 2,100 Square Feet | Moderate | Good | High | None Detected | N/A | N/A | |

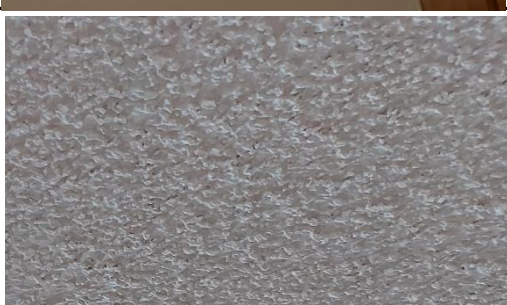
| Building / Component Name (#) | Location | Material Category | Material & Description | Homogeneous Sample Group (HSG) / Sample # | Sample I.D. | Quantity <sup>(1)</sup> | Friable | Condition | Accessibility | % Asbestos and Type | Asbestos Abatement Category | Lead Concentration (mg/kg) | Representative Photograph |
|---|---|---|---|---|---|---|---|---|---|---|---|---|---|
| 750 - 5 Street SE (DNE1, formerly EV1) | Unit 607 | Asbestos | Ceiling Stipple Coat | DNE1-A-11 | Reference | 650 Square Feet | High | Good | Low | None Detected | N/A | N/A | |

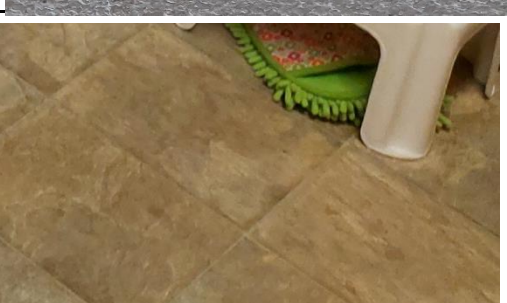
| Building / Component Name (#) | Location | Material Category | Material & Description | Homogeneous Sample Group (HSG) / Sample # | Sample I.D. | Quantity <sup>(1)</sup> | Friable | Condition | Accessibility | % Asbestos and Type | Asbestos Abatement Category | Lead Concentration (mg/kg) | Representative Photograph |
|---|---|---|---|---|---|---|---|---|---|---|---|---|---|
| 750 - 5 Street SE (DNE1, formerly EV1) | Unit 607 | Asbestos | 9" x 9" Beige Tile Patterned Vinyl Sheet Floor | DNE1-A-12 | C | 70 Square Feet | High | Good | High | None Detected | N/A | N/A | |

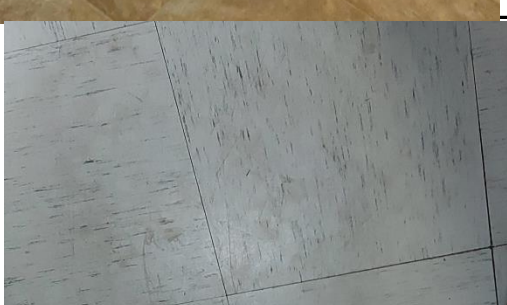
| Building / Component Name (#) | Location | Material Category | Material & Description | Homogeneous Sample Group (HSG) / Sample # | Sample I.D. | Quantity <sup>(1)</sup> | Friable | Condition | Accessibility | % Asbestos and Type | Asbestos Abatement Category | Lead Concentration (mg/kg) | Representative Photograph |
|---|---|---|---|---|---|---|---|---|---|---|---|---|---|
| 750 - 5 Street SE (DNE1, formerly EV1) | Unit 607 | Asbestos | 12" x 12" White with Blue Streaks Patterned Vinyl Floor Tile<br>Mastic | DNE1-A-13 | Reference | 35 Square Feet | Low | Good | High | 5% Chrysotile<br>None Detected | Low-Risk | N/A | |

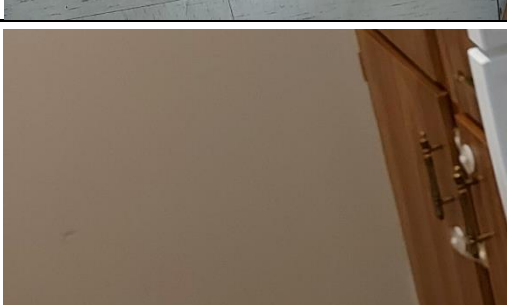
| Building / Component Name (#) | Location | Material Category | Material & Description | Homogeneous Sample Group (HSG) / Sample # | Sample I.D. | Quantity <sup>(1)</sup> | Friable | Condition | Accessibility | % Asbestos and Type | Asbestos Abatement Category | Lead Concentration (mg/kg) | Representative Photograph |
|---|---|---|---|---|---|---|---|---|---|---|---|---|---|
| 750 - 5 Street SE (DNE1, formerly EV1) | Unit 607 | Lead Paint | Beige Paint on Drywall | DNE1-L-04 | Reference | 2,100 Square Feet | N/A | Good | N/A | N/A | N/A | <5 (Not considered to be lead-containing) | |

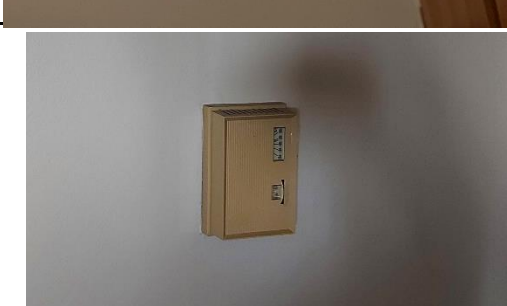
| Building / Component Name (#) | Location | Material Category | Material & Description | Homogeneous Sample Group (HSG) / Sample # | Sample I.D. | Quantity <sup>(1)</sup> | Friable | Condition | Accessibility | % Asbestos and Type | Asbestos Abatement Category | Lead Concentration (mg/kg) | Representative Photograph |
|---|---|---|---|---|---|---|---|---|---|---|---|---|---|
| 750 - 5 Street SE (DNE1, formerly EV1) | Unit 607 | Mercury | Mercury Capsules in Thermostat | N/A | N/A | 1 Each | N/A | N/A | N/A | N/A | N/A | N/A | |

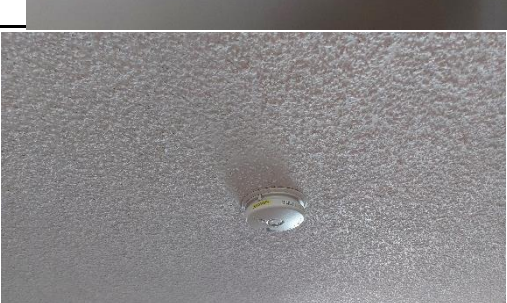
| Building / Component Name (#) | Location | Material Category | Material & Description | Homogeneous Sample Group (HSG) / Sample # | Sample I.D. | Quantity <sup>(1)</sup> | Friable | Condition | Accessibility | % Asbestos and Type | Asbestos Abatement Category | Lead Concentration (mg/kg) | Representative Photograph |
|---|---|---|---|---|---|---|---|---|---|---|---|---|---|
| 750 - 5 Street SE (DNE1, formerly EV1) | Unit 607 | Radioactive Materials | Radioactive Material in Smoke Detectors | N/A | N/A | 1 Each | N/A | N/A | N/A | N/A | N/A | N/A | |

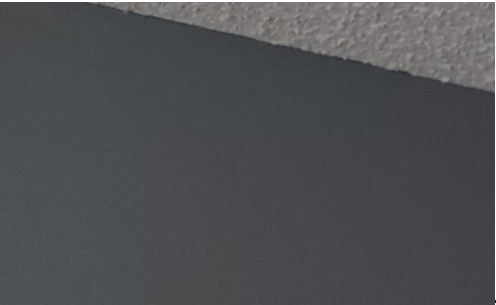
| Building / Component Name (#) | Location | Material Category | Material & Description | Homogeneous Sample Group (HSG) / Sample # | Sample I.D. | Quantity <sup>(1)</sup> | Friable | Condition | Accessibility | % Asbestos and Type | Asbestos Abatement Category | Lead Concentration (mg/kg) | Representative Photograph |
|---|---|---|---|---|---|---|---|---|---|---|---|---|---|
| 750 - 5 Street SE (DNE1, formerly EV1) | Unit 502 | Asbestos | Drywall Joint Compound on Walls | DNE1-A-01 | Reference | 2,100 Square Feet | Moderate | Good | High | None Detected | N/A | N/A | |

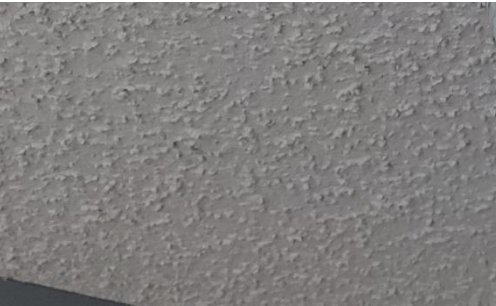
| Building / Component Name (#) | Location | Material Category | Material & Description | Homogeneous Sample Group (HSG) / Sample # | Sample I.D. | Quantity <sup>(1)</sup> | Friable | Condition | Accessibility | % Asbestos and Type | Asbestos Abatement Category | Lead Concentration (mg/kg) | Representative Photograph |
|---|---|---|---|---|---|---|---|---|---|---|---|---|---|
| 750 - 5 Street SE (DNE1, formerly EV1) | Unit 502 | Asbestos | Ceiling Stipple Coat | DNE1-A-11 | Reference | 650 Square Feet | High | Good | Low | None Detected | N/A | N/A | |

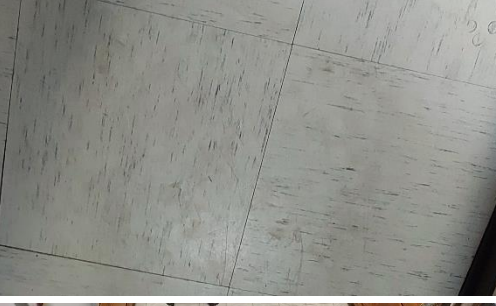
| Building / Component Name (#) | Location | Material Category | Material & Description | Homogeneous Sample Group (HSG) / Sample # | Sample I.D. | Quantity <sup>(1)</sup> | Friable | Condition | Accessibility | % Asbestos and Type | Asbestos Abatement Category | Lead Concentration (mg/kg) | Representative Photograph |
|---|---|---|---|---|---|---|---|---|---|---|---|---|---|
| 750 - 5 Street SE (DNE1, formerly EV1) | Unit 502 | Asbestos | 12" x 12" White with Blue Streaks Patterned Vinyl Floor Tile<br>Mastic | DNE1-A-13 | Reference | 75 Square Feet | Low | Good | High | 5% Chrysotile<br>None Detected | Low-Risk | N/A | |

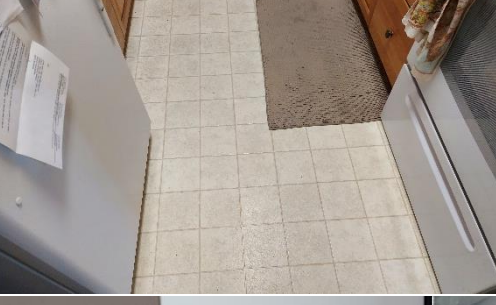
| Building / Component Name (#) | Location | Material Category | Material & Description | Homogeneous Sample Group (HSG) / Sample # | Sample I.D. | Quantity <sup>(1)</sup> | Friable | Condition | Accessibility | % Asbestos and Type | Asbestos Abatement Category | Lead Concentration (mg/kg) | Representative Photograph |
|---|---|---|---|---|---|---|---|---|---|---|---|---|---|
| 750 - 5 Street SE (DNE1, formerly EV1) | Unit 502 | Asbestos | 6" x 6" Tile Patterned Vinyl Sheet Floor | DNE1-A-15 | Reference | 80 Square Feet | Low | Good | High | None Detected | N/A | N/A | |

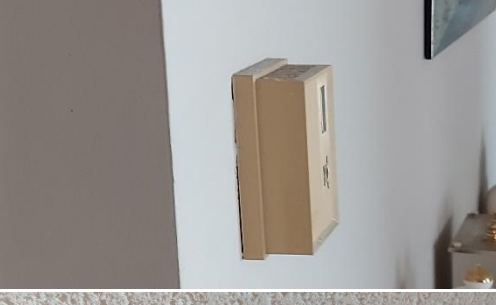
| Building / Component Name (#) | Location | Material Category | Material & Description | Homogeneous Sample Group (HSG) / Sample # | Sample I.D. | Quantity <sup>(1)</sup> | Friable | Condition | Accessibility | % Asbestos and Type | Asbestos Abatement Category | Lead Concentration (mg/kg) | Representative Photograph |
|---|---|---|---|---|---|---|---|---|---|---|---|---|---|
| 750 - 5 Street SE (DNE1, formerly EV1) | Unit 502 | Mercury | Mercury Capsules in Thermostat | N/A | N/A | 1 Each | N/A | N/A | N/A | N/A | N/A | N/A | |

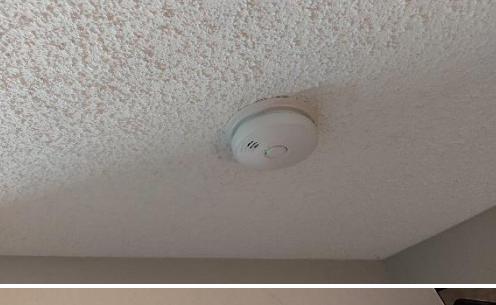
| Building / Component Name (#) | Location | Material Category | Material & Description | Homogeneous Sample Group (HSG) / Sample # | Sample I.D. | Quantity <sup>(1)</sup> | Friable | Condition | Accessibility | % Asbestos and Type | Asbestos Abatement Category | Lead Concentration (mg/kg) | Representative Photograph |
|---|---|---|---|---|---|---|---|---|---|---|---|---|---|
| 750 - 5 Street SE (DNE1, formerly EV1) | Unit 502 | Radioactive Materials | Radioactive Material in Smoke Detectors | N/A | N/A | 1 Each | N/A | N/A | N/A | N/A | N/A | N/A | |

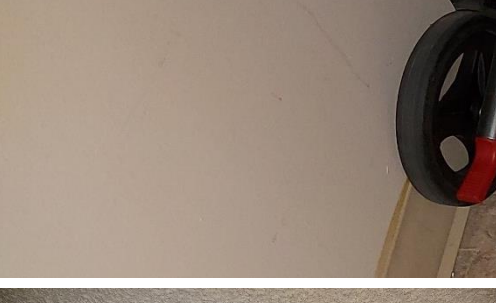
| Building / Component Name (#) | Location | Material Category | Material & Description | Homogeneous Sample Group (HSG) / Sample # | Sample I.D. | Quantity <sup>(1)</sup> | Friable | Condition | Accessibility | % Asbestos and Type | Asbestos Abatement Category | Lead Concentration (mg/kg) | Representative Photograph |
|---|---|---|---|---|---|---|---|---|---|---|---|---|---|
| 750 - 5 Street SE (DNE1, formerly EV1) | Unit 405 | Asbestos | Drywall Joint Compound on Walls | DNE1-A-01 | Reference | 2,100 Square Feet | Moderate | Good | High | None Detected | N/A | N/A | |

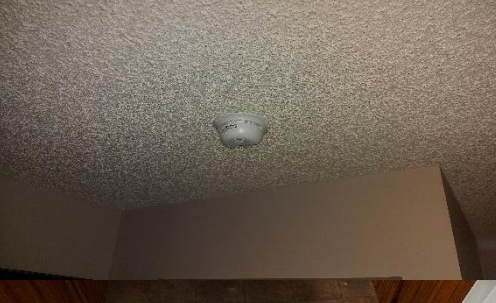
| Building / Component Name (#) | Location | Material Category | Material & Description | Homogeneous Sample Group (HSG) / Sample # | Sample I.D. | Quantity <sup>(1)</sup> | Friable | Condition | Accessibility | % Asbestos and Type | Asbestos Abatement Category | Lead Concentration (mg/kg) | Representative Photograph |
|---|---|---|---|---|---|---|---|---|---|---|---|---|---|
| 750 - 5 Street SE (DNE1, formerly EV1) | Unit 405 | Asbestos | Ceiling Stipple Coat | DNE1-A-11 | Reference | 650 Square Feet | High | Good | Low | None Detected | N/A | N/A | |

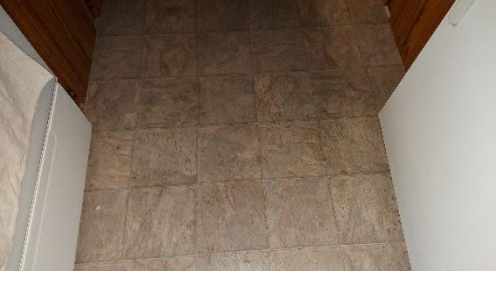
| Building / Component Name (#) | Location | Material Category | Material & Description | Homogeneous Sample Group (HSG) / Sample # | Sample I.D. | Quantity <sup>(1)</sup> | Friable | Condition | Accessibility | % Asbestos and Type | Asbestos Abatement Category | Lead Concentration (mg/kg) | Representative Photograph |
|---|---|---|---|---|---|---|---|---|---|---|---|---|---|
| 750 - 5 Street SE (DNE1, formerly EV1) | Unit 405 | Asbestos | 9" x 9" Beige Tile Patterned Vinyl Sheet Floor | DNE1-A-12 | Reference | 170 Square Feet | High | Good | High | None Detected | N/A | N/A | |

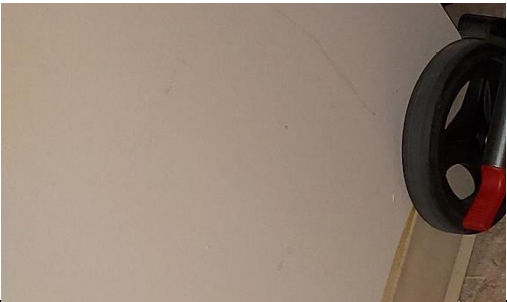
| Building / Component Name (#) | Location | Material Category | Material & Description | Homogeneous Sample Group (HSG) / Sample # | Sample I.D. | Quantity <sup>(1)</sup> | Friable | Condition | Accessibility | % Asbestos and Type | Asbestos Abatement Category | Lead Concentration (mg/kg) | Representative Photograph |
|---|---|---|---|---|---|---|---|---|---|---|---|---|---|
| 750 - 5 Street SE (DNE1, formerly EV1) | Unit 405 | Lead Paint | Beige Paint on Drywall | DNE1-L-04 | Reference | 2,100 Square Feet | N/A | Good | N/A | N/A | N/A | <5 (Not considered to be lead-containing) | |

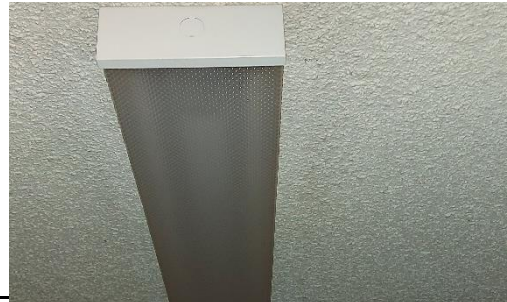
| Building / Component Name (#) | Location | Material Category | Material & Description | Homogeneous Sample Group (HSG) / Sample # | Sample I.D. | Quantity <sup>(1)</sup> | Friable | Condition | Accessibility | % Asbestos and Type | Asbestos Abatement Category | Lead Concentration (mg/kg) | Representative Photograph |
|---|---|---|---|---|---|---|---|---|---|---|---|---|---|
| 750 - 5 Street SE (DNE1, formerly EV1) | Unit 405 | PCB | PCB-Containing Ballasts in Fluorescent Light Fixtures | N/A | N/A | 1 Each | N/A | N/A | N/A | N/A | N/A | N/A | |

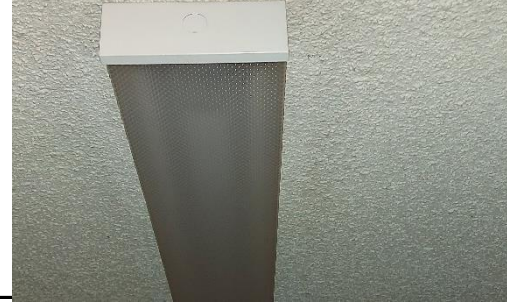
| Building / Component Name (#) | Location | Material Category | Material & Description | Homogeneous Sample Group (HSG) / Sample # | Sample I.D. | Quantity <sup>(1)</sup> | Friable | Condition | Accessibility | % Asbestos and Type | Asbestos Abatement Category | Lead Concentration (mg/kg) | Representative Photograph |
|---|---|---|---|---|---|---|---|---|---|---|---|---|---|
| 750 - 5 Street SE (DNE1, formerly EV1) | Unit 405 | Mercury | Fluorescent Light Tubes Containing Mercury-Vapour | N/A | N/A | 2 Each | N/A | N/A | N/A | N/A | N/A | N/A | |

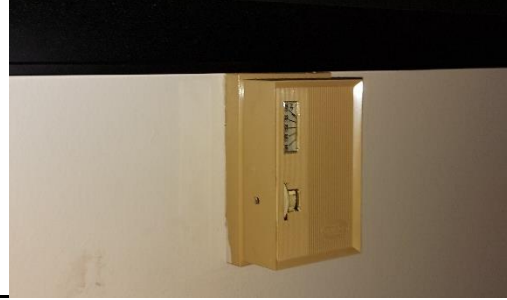
| Building / Component Name (#) | Location | Material Category | Material & Description | Homogeneous Sample Group (HSG) / Sample # | Sample I.D. | Quantity <sup>(1)</sup> | Friable | Condition | Accessibility | % Asbestos and Type | Asbestos Abatement Category | Lead Concentration (mg/kg) | Representative Photograph |
|---|---|---|---|---|---|---|---|---|---|---|---|---|---|
| 750 - 5 Street SE (DNE1, formerly EV1) | Unit 405 | Mercury | Mercury Capsules in Thermostat | N/A | N/A | 1 Each | N/A | N/A | N/A | N/A | N/A | N/A | |

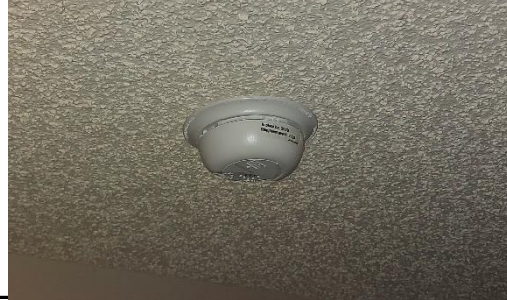
| Building / Component Name (#) | Location | Material Category | Material & Description | Homogeneous Sample Group (HSG) / Sample # | Sample I.D. | Quantity <sup>(1)</sup> | Friable | Condition | Accessibility | % Asbestos and Type | Asbestos Abatement Category | Lead Concentration (mg/kg) | Representative Photograph |
|---|---|---|---|---|---|---|---|---|---|---|---|---|---|
| 750 - 5 Street SE (DNE1, formerly EV1) | Unit 405 | Radioactive Materials | Radioactive Material in Smoke Detectors | N/A | N/A | 1 Each | N/A | N/A | N/A | N/A | N/A | N/A | |

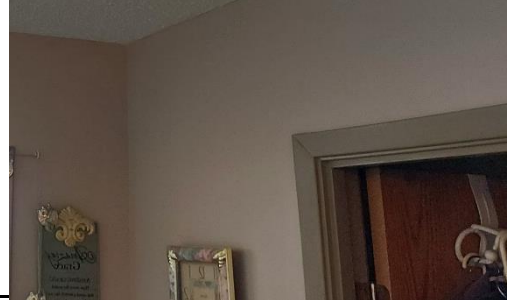
| Building / Component Name (#) | Location | Material Category | Material & Description | Homogeneous Sample Group (HSG) / Sample # | Sample I.D. | Quantity <sup>(1)</sup> | Friable | Condition | Accessibility | % Asbestos and Type | Asbestos Abatement Category | Lead Concentration (mg/kg) | Representative Photograph |
|---|---|---|---|---|---|---|---|---|---|---|---|---|---|
| 750 - 5 Street SE (DNE1, formerly EV1) | Unit 411 | Asbestos | Drywall Joint Compound on Walls | DNE1-A-01 | Reference | 2,100 Square Feet | Moderate | Good | High | None Detected | N/A | N/A | |

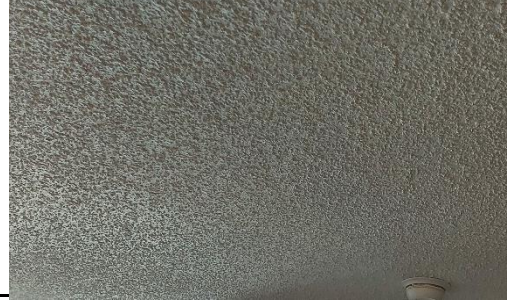
| Building / Component Name (#) | Location | Material Category | Material & Description | Homogeneous Sample Group (HSG) / Sample # | Sample I.D. | Quantity <sup>(1)</sup> | Friable | Condition | Accessibility | % Asbestos and Type | Asbestos Abatement Category | Lead Concentration (mg/kg) | Representative Photograph |
|---|---|---|---|---|---|---|---|---|---|---|---|---|---|
| 750 - 5 Street SE (DNE1, formerly EV1) | Unit 411 | Asbestos | Ceiling Stipple Coat | DNE1-A-11 | Reference | 650 Square Feet | High | Good | Low | None Detected | N/A | N/A | |

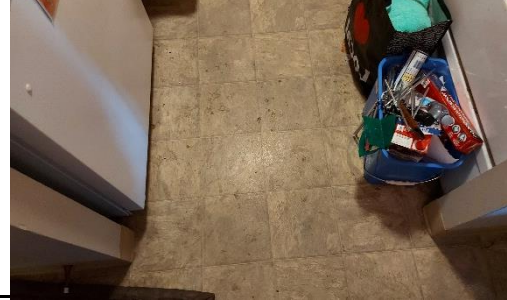
| Building / Component Name (#) | Location | Material Category | Material & Description | Homogeneous Sample Group (HSG) / Sample # | Sample I.D. | Quantity <sup>(1)</sup> | Friable | Condition | Accessibility | % Asbestos and Type | Asbestos Abatement Category | Lead Concentration (mg/kg) | Representative Photograph |
|---|---|---|---|---|---|---|---|---|---|---|---|---|---|
| 750 - 5 Street SE (DNE1, formerly EV1) | Unit 411 | Asbestos | 9" x 9" Beige Tile Patterned Vinyl Sheet Floor | DNE1-A-12 | Reference | 170 Square Feet | High | Good | High | None Detected | N/A | N/A | |

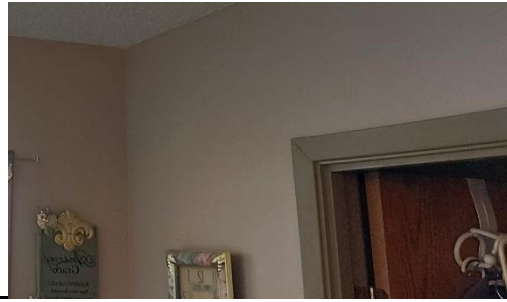
| Building / Component Name (#) | Location | Material Category | Material & Description | Homogeneous Sample Group (HSG) / Sample # | Sample I.D. | Quantity <sup>(1)</sup> | Friable | Condition | Accessibility | % Asbestos and Type | Asbestos Abatement Category | Lead Concentration (mg/kg) | Representative Photograph |
|---|---|---|---|---|---|---|---|---|---|---|---|---|---|
| 750 - 5 Street SE (DNE1, formerly EV1) | Unit 411 | Lead Paint | Beige Paint on Drywall | DNE1-L-04 | Reference | 2,100 Square Feet | N/A | Good | N/A | N/A | N/A | <5 (Not considered to be lead-containing) | |

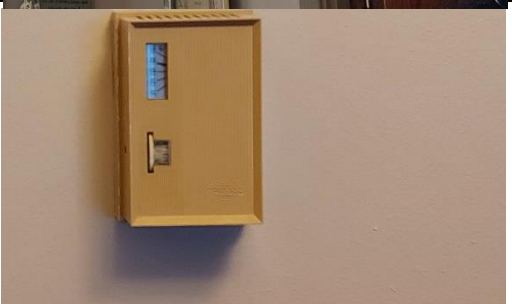
| Building / Component Name (#) | Location | Material Category | Material & Description | Homogeneous Sample Group (HSG) / Sample # | Sample I.D. | Quantity <sup>(1)</sup> | Friable | Condition | Accessibility | % Asbestos and Type | Asbestos Abatement Category | Lead Concentration (mg/kg) | Representative Photograph |
|---|---|---|---|---|---|---|---|---|---|---|---|---|---|
| 750 - 5 Street SE (DNE1, formerly EV1) | Unit 411 | Mercury | Mercury Capsules in Thermostat | N/A | N/A | 1 Each | N/A | N/A | N/A | N/A | N/A | N/A | |

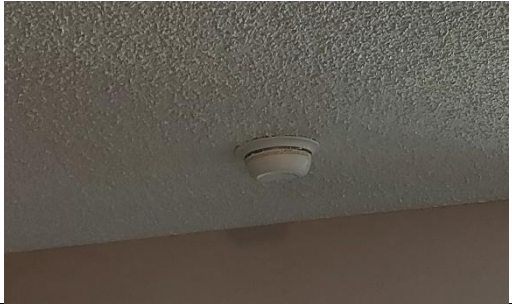
| Building / Component Name (#) | Location | Material Category | Material & Description | Homogeneous Sample Group (HSG) / Sample # | Sample I.D. | Quantity <sup>(1)</sup> | Friable | Condition | Accessibility | % Asbestos and Type | Asbestos Abatement Category | Lead Concentration (mg/kg) | Representative Photograph |
|---|---|---|---|---|---|---|---|---|---|---|---|---|---|
| 750 - 5 Street SE (DNE1, formerly EV1) | Unit 411 | Radioactive Materials | Radioactive Material in Smoke Detectors | N/A | N/A | 1 Each | N/A | N/A | N/A | N/A | N/A | N/A | |

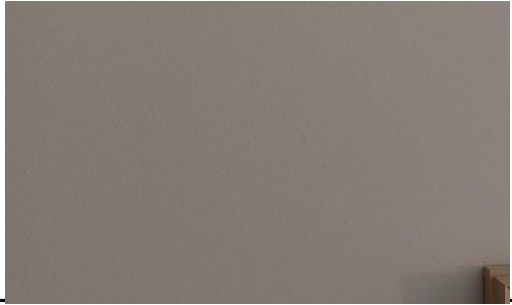
| Building / Component Name (#) | Location | Material Category | Material & Description | Homogeneous Sample Group (HSG) / Sample # | Sample I.D. | Quantity <sup>(1)</sup> | Friable | Condition | Accessibility | % Asbestos and Type | Asbestos Abatement Category | Lead Concentration (mg/kg) | Representative Photograph |
|---|---|---|---|---|---|---|---|---|---|---|---|---|---|
| 750 - 5 Street SE (DNE1, formerly EV1) | Unit 307 | Asbestos | Drywall Joint Compound on Walls | DNE1-A-01 | Reference | 3,600 Square Feet | Moderate | Good | High | None Detected | N/A | N/A | |

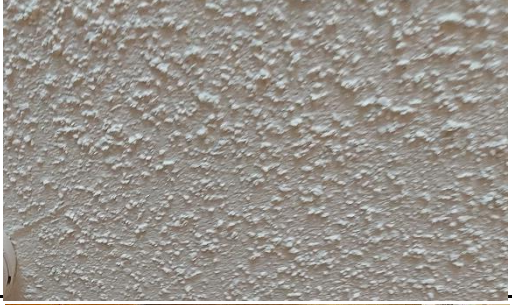
| Building / Component Name (#) | Location | Material Category | Material & Description | Homogeneous Sample Group (HSG) / Sample # | Sample I.D. | Quantity <sup>(1)</sup> | Friable | Condition | Accessibility | % Asbestos and Type | Asbestos Abatement Category | Lead Concentration (mg/kg) | Representative Photograph |
|---|---|---|---|---|---|---|---|---|---|---|---|---|---|
| 750 - 5 Street SE (DNE1, formerly EV1) | Unit 307 | Asbestos | Ceiling Stipple Coat | DNE1-A-11 | Reference | 900 Square Feet | High | Good | Low | None Detected | N/A | N/A | |

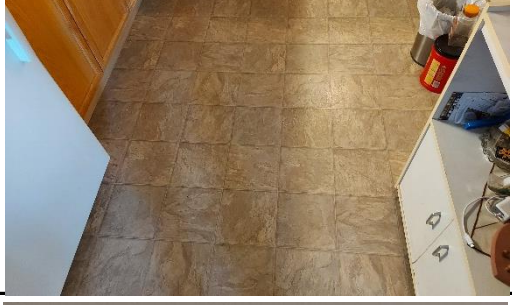
| Building / Component Name (#) | Location | Material Category | Material & Description | Homogeneous Sample Group (HSG) / Sample # | Sample I.D. | Quantity <sup>(1)</sup> | Friable | Condition | Accessibility | % Asbestos and Type | Asbestos Abatement Category | Lead Concentration (mg/kg) | Representative Photograph |
|---|---|---|---|---|---|---|---|---|---|---|---|---|---|
| 750 - 5 Street SE (DNE1, formerly EV1) | Unit 307 | Asbestos | 9" x 9" Beige Tile Patterned Vinyl Sheet Floor | DNE1-A-12 | Reference | 230 Square Feet | High | Good | High | None Detected | N/A | N/A | |
