# Hazardous Building Materials Assessment, Property DNE1 formerly EV1, Calgary Housing Company

750 5 Street NE, Calgary, Alberta

*Assessment Completed: August 18 and September 13, 2021*

4 February 2022

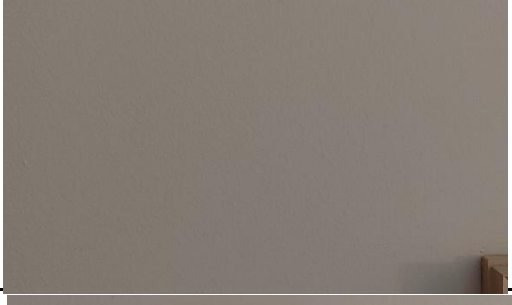
| Building / Component Name (#) | Location | Material Category | Material & Description | Homogeneous Sample Group (HSG) / Sample # | Sample I.D. | Quantity <sup>(1)</sup> | Friable | Condition | Accessibility | % Asbestos and Type | Asbestos Abatement Category | Lead Concentration (mg/kg) | Representative Photograph |
|---|---|---|---|---|---|---|---|---|---|---|---|---|---|
| 750 - 5 Street SE (DNE1, formerly EV1) | Unit 307 | Lead Paint | Beige Paint on Drywall | DNE1-L-04 | Reference | 3,600 Square Feet | N/A | Good | N/A | N/A | N/A | <5 (Not considered to be lead-containing) | |

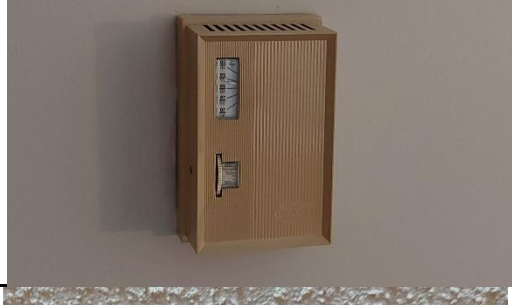
| Building / Component Name (#) | Location | Material Category | Material & Description | Homogeneous Sample Group (HSG) / Sample # | Sample I.D. | Quantity <sup>(1)</sup> | Friable | Condition | Accessibility | % Asbestos and Type | Asbestos Abatement Category | Lead Concentration (mg/kg) | Representative Photograph |
|---|---|---|---|---|---|---|---|---|---|---|---|---|---|
| 750 - 5 Street SE (DNE1, formerly EV1) | Unit 307 | Mercury | Mercury Capsules in Thermostat | N/A | N/A | 1 Each | N/A | N/A | N/A | N/A | N/A | N/A | |

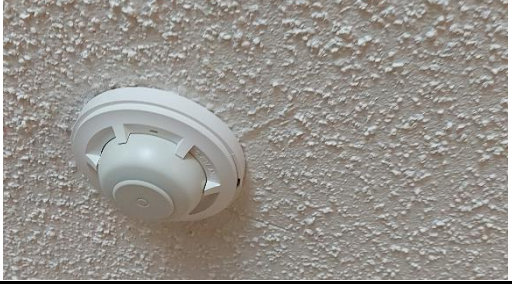
| Building / Component Name (#) | Location | Material Category | Material & Description | Homogeneous Sample Group (HSG) / Sample # | Sample I.D. | Quantity <sup>(1)</sup> | Friable | Condition | Accessibility | % Asbestos and Type | Asbestos Abatement Category | Lead Concentration (mg/kg) | Representative Photograph |
|---|---|---|---|---|---|---|---|---|---|---|---|---|---|
| 750 - 5 Street SE (DNE1, formerly EV1) | Unit 307 | Radioactive Materials | Radioactive Material in Smoke Detectors | N/A | N/A | 2 Each | N/A | N/A | N/A | N/A | N/A | N/A | |
