# Hazardous Building Materials Assessment Property HIL2 (formerly HU2), Calgary Housing Company

*325 - 10 Street NW, Calgary, Alberta*

*Assessment Completed: July 22, 2021*

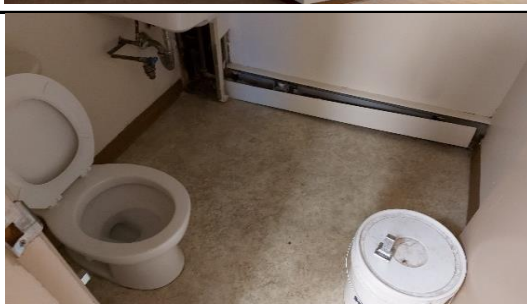
| Building / Component Name (#) | Location | Material Category | Material & Description | Homogeneous Sample Group (HSG) / Sample # | Sample I.D. | Quantity <sup>(1)</sup> | Friable | Condition | Accessibility | % Asbestos and Type | Asbestos Abatement Category | Lead Concentration (mg/kg) | Representative Photograph |
|---|---|---|---|---|---|---|---|---|---|---|---|---|---|
| 325 - 10 Street NW (HIL2, formerly HU2) | Common Areas (Former Daycare) | Asbestos | Vinyl Sheet Floor, Beige Marble Pattern | HIL2-A-13 | Reference | 120 square Feet | Low | Good | High | None Detected | N/A | N/A | |

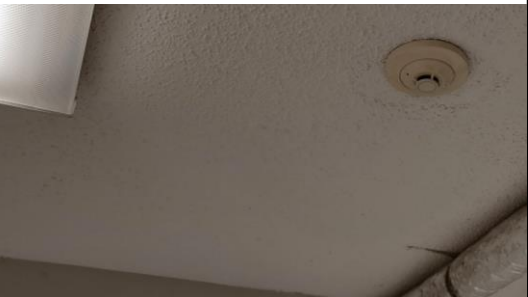
| Building / Component Name (#) | Location | Material Category | Material & Description | Homogeneous Sample Group (HSG) / Sample # | Sample I.D. | Quantity <sup>(1)</sup> | Friable | Condition | Accessibility | % Asbestos and Type | Asbestos Abatement Category | Lead Concentration (mg/kg) | Representative Photograph |
|---|---|---|---|---|---|---|---|---|---|---|---|---|---|
| 325 - 10 Street NW (HIL2, formerly HU2) | Common Areas (Main Floor) | Asbestos | Ceiling Stipple | HIL2-A-06 | Reference | 710 Square Feet | High | Good | High | 10% Chrysotile | High-Risk | N/A | |

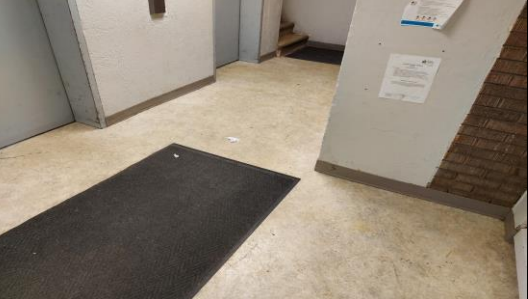
| Building / Component Name (#) | Location | Material Category | Material & Description | Homogeneous Sample Group (HSG) / Sample # | Sample I.D. | Quantity <sup>(1)</sup> | Friable | Condition | Accessibility | % Asbestos and Type | Asbestos Abatement Category | Lead Concentration (mg/kg) | Representative Photograph |
|---|---|---|---|---|---|---|---|---|---|---|---|---|---|
| 325 - 10 Street NW (HIL2, formerly HU2) | Common Areas (Main Floor) | Asbestos | Vinyl Sheet Floor, Beige Marble Pattern | HIL2-A-13 | A to C | 700 Square Feet | Low | Good | High | None Detected | N/A | N/A | |

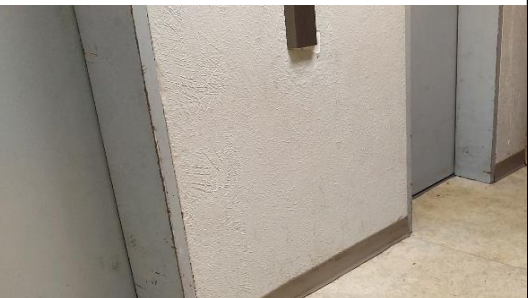
| Building / Component Name (#) | Location | Material Category | Material & Description | Homogeneous Sample Group (HSG) / Sample # | Sample I.D. | Quantity <sup>(1)</sup> | Friable | Condition | Accessibility | % Asbestos and Type | Asbestos Abatement Category | Lead Concentration (mg/kg) | Representative Photograph |
|---|---|---|---|---|---|---|---|---|---|---|---|---|---|
| 325 - 10 Street NW (HIL2, formerly HU2) | Common Areas (Main Floor) | Lead-Paint | Beige Paint on Drywall | HIL2-L-07 | Reference | 2,300 Square Feet | N/A | Good | N/A | N/A | N/A | 120 (Considered to be lead-containing) | |

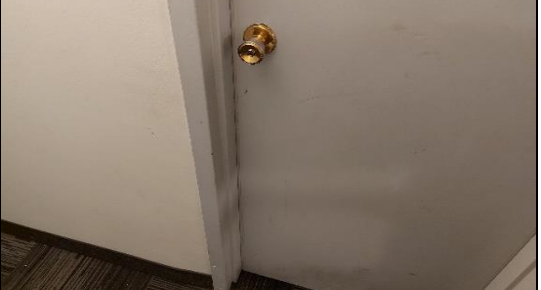
| Building / Component Name (#) | Location | Material Category | Material & Description | Homogeneous Sample Group (HSG) / Sample # | Sample I.D. | Quantity <sup>(1)</sup> | Friable | Condition | Accessibility | % Asbestos and Type | Asbestos Abatement Category | Lead Concentration (mg/kg) | Representative Photograph |
|---|---|---|---|---|---|---|---|---|---|---|---|---|---|
| 325 - 10 Street NW (HIL2, formerly HU2) | Common Areas (Corridors, Stairwells, Garbage Room) | Lead-Paint | Light Grey Paint on Metal | HIL2-L-08 | HIL2-L-08 | 88 Doors and Frames | N/A | Good | N/A | N/A | N/A | 717 (Considered to be lead-containing) | |

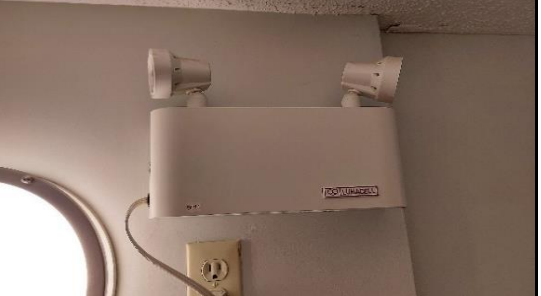
| Building / Component Name (#) | Location | Material Category | Material & Description | Homogeneous Sample Group (HSG) / Sample # | Sample I.D. | Quantity <sup>(1)</sup> | Friable | Condition | Accessibility | % Asbestos and Type | Asbestos Abatement Category | Lead Concentration (mg/kg) | Representative Photograph |
|---|---|---|---|---|---|---|---|---|---|---|---|---|---|
| 325 - 10 Street NW (HIL2, formerly HU2) | Common Areas (Corridors and Stairwells) | Lead Batteries | Emergency Lights | N/A | N/A | 32 Each | N/A | N/A | N/A | N/A | N/A | N/A | |

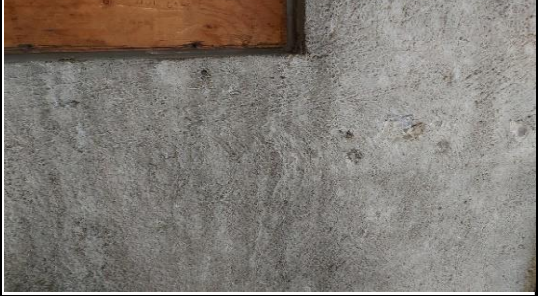
| Building / Component Name (#) | Location | Material Category | Material & Description | Homogeneous Sample Group (HSG) / Sample # | Sample I.D. | Quantity <sup>(1)</sup> | Friable | Condition | Accessibility | % Asbestos and Type | Asbestos Abatement Category | Lead Concentration (mg/kg) | Representative Photograph |
|---|---|---|---|---|---|---|---|---|---|---|---|---|---|
| 325 - 10 Street NW (HIL2, formerly HU2) | Rooftop Elevator Room | Asbestos | Concrete Texture Coat | HIL2-A-03 | A | 450 Square Feet | High | Good | Low | None Detected | N/A | N/A | |

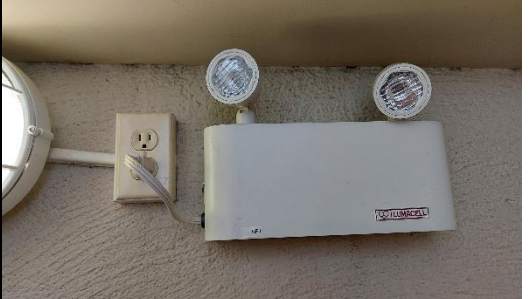
| Building / Component Name (#) | Location | Material Category | Material & Description | Homogeneous Sample Group (HSG) / Sample # | Sample I.D. | Quantity <sup>(1)</sup> | Friable | Condition | Accessibility | % Asbestos and Type | Asbestos Abatement Category | Lead Concentration (mg/kg) | Representative Photograph |
|---|---|---|---|---|---|---|---|---|---|---|---|---|---|
| 325 - 10 Street NW (HIL2, formerly HU2) | Rooftop Elevator Room | Lead Batteries | Emergency Lights | N/A | N/A | 1 Each | N/A | N/A | N/A | N/A | N/A | N/A | |

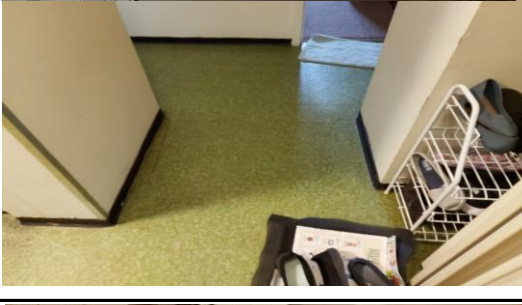
| Building / Component Name (#) | Location | Material Category | Material & Description | Homogeneous Sample Group (HSG) / Sample # | Sample I.D. | Quantity <sup>(1)</sup> | Friable | Condition | Accessibility | % Asbestos and Type | Asbestos Abatement Category | Lead Concentration (mg/kg) | Representative Photograph |
|---|---|---|---|---|---|---|---|---|---|---|---|---|---|
| 325 - 10 Street NW (HIL2, formerly HU2) | Unit 404 | Asbestos | Vinyl Sheet Floor - Green and Brown Mosaic Pattern, Paper Backing | HIL2-A-07 | D to E | 320 Square Feet | Low | Good | High | 40% Chrysotile | High-Risk (>100 ft²)<br>Moderate-Risk (<100 ft²) | N/A | |

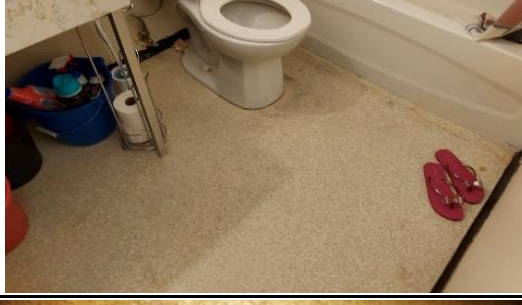
| Building / Component Name (#) | Location | Material Category | Material & Description | Homogeneous Sample Group (HSG) / Sample # | Sample I.D. | Quantity <sup>(1)</sup> | Friable | Condition | Accessibility | % Asbestos and Type | Asbestos Abatement Category | Lead Concentration (mg/kg) | Representative Photograph |
|---|---|---|---|---|---|---|---|---|---|---|---|---|---|
| 325 - 10 Street NW (HIL2, formerly HU2) | Unit 404 | Asbestos | Vinyl Sheet Floor, Cream and Beige Mosaic Pattern | HIL2-A-10 | A to C | 80 Square Feet | Low | Good | High | 20% Chrysotile | Moderate-Risk | N/A | |

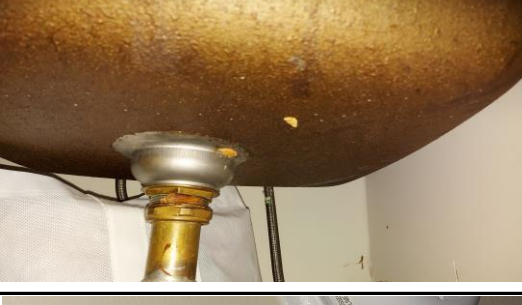
| Building / Component Name (#) | Location | Material Category | Material & Description | Homogeneous Sample Group (HSG) / Sample # | Sample I.D. | Quantity <sup>(1)</sup> | Friable | Condition | Accessibility | % Asbestos and Type | Asbestos Abatement Category | Lead Concentration (mg/kg) | Representative Photograph |
|---|---|---|---|---|---|---|---|---|---|---|---|---|---|
| 325 - 10 Street NW (HIL2, formerly HU2) | Unit 404 | Asbestos | Brown Acoustic Sink Insulation | HIL2-A-11 | A | 1 Sink | Low | Good | Moderate | 3% Chrysotile | Low-Risk | N/A | |

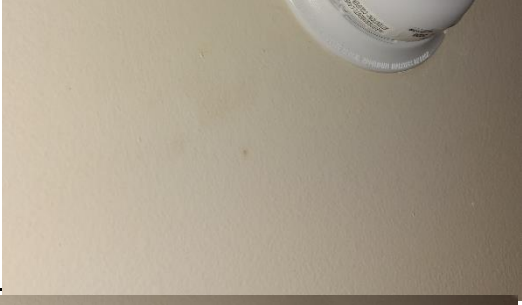
| Building / Component Name (#) | Location | Material Category | Material & Description | Homogeneous Sample Group (HSG) / Sample # | Sample I.D. | Quantity <sup>(1)</sup> | Friable | Condition | Accessibility | % Asbestos and Type | Asbestos Abatement Category | Lead Concentration (mg/kg) | Representative Photograph |
|---|---|---|---|---|---|---|---|---|---|---|---|---|---|
| 325 - 10 Street NW (HIL2, formerly HU2) | Unit 404 | Lead-Paint | Beige Paint on Drywall | HIL2-L-07 | Reference | 1,600 Square Feet | N/A | Good | N/A | N/A | N/A | 120 (Considered to be lead-containing) | |

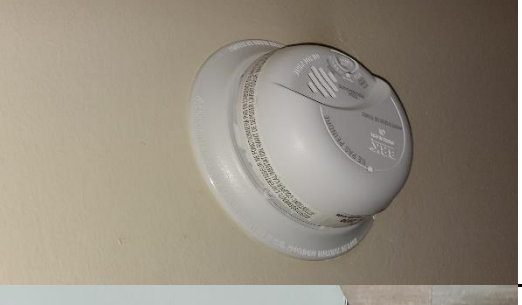
| Building / Component Name (#) | Location | Material Category | Material & Description | Homogeneous Sample Group (HSG) / Sample # | Sample I.D. | Quantity <sup>(1)</sup> | Friable | Condition | Accessibility | % Asbestos and Type | Asbestos Abatement Category | Lead Concentration (mg/kg) | Representative Photograph |
|---|---|---|---|---|---|---|---|---|---|---|---|---|---|
| 325 - 10 Street NW (HIL2, formerly HU2) | Unit 404 | Radioactive Materials | Smoke Detectors | N/A | N/A | 1 Each | N/A | N/A | N/A | N/A | N/A | N/A | |
